Docket No. 96-CE-46-AD; Amendment 39-9884; AD 97-01-13

Airworthiness Directives; Cessna 100, 200, 300, and 400 Series Airplanes

97-01-13 Cessna Aircraft Company: Amendment 39-9884; Docket No. 96-CE-46-AD.

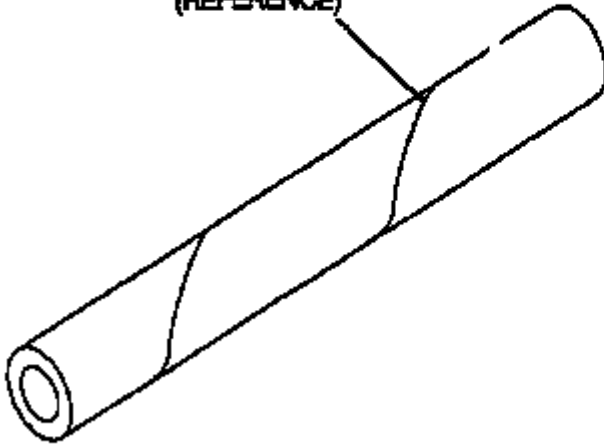
AD 97-01-13
Figure 1

The FAA has recently received several incident reports of fuel flow blockage to the engines of certain Cessna 208 series airplanes. Examination of the Cessna part number (P/N) S51-10 rubber hoses installed on these airplanes revealed a deterioration to the point of delamination of the inner

tube from the external wrap. This rubber hose is utilized on fuel, oil, and hydraulic hoses on Cessna 100, 200, 300, and 400 series airplanes. This kind of deterioration eventually causes the rubber hose to collapse, which could result in failure of the fuel, oil, or hydraulic systems.

NOTE 2: Figure 1 of this AD is included to show the diagonal or spiral external reinforcement wrap on the hose that is referenced in the check required by paragraph (b) of this AD.

REINFORCEMENT
WRAPPED IN ONLY ONE
(DIAGONAL) DIRECTION
(REFERENCE)

OLD STYLE S51-10 HOSE
WITH REINFORCEMENT
WRAPPED IN ONLY ONE
(DIAGONAL) DIRECTION THE
LENGTH OF THE HOSE
(REMOVE AND REPLACE WITH
REPLACEMENT STYLE HOSE)

(c) Prior to further flight after the check required by paragraph (b) of this AD, replace any Cessna P/N S51-10 that has a diagonal or spiral pattern external reinforcement wrap with a Cessna P/N S51-10 hose that has a criss-cross pattern external wrap. Accomplish this replacement in accordance with the ACCOMPLISHMENT INSTRUCTIONS of the applicable service bulletin in paragraph (b) of this AD.

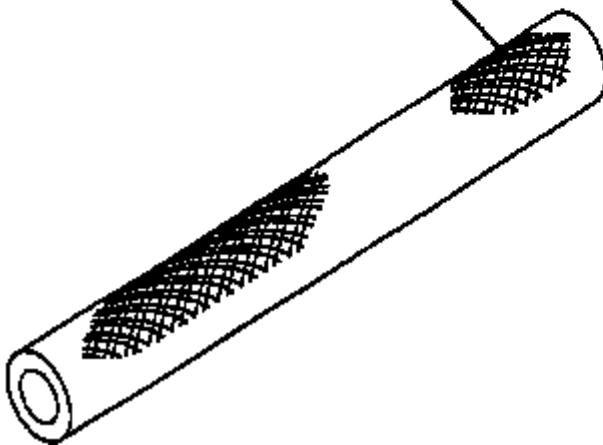
CRISSCROSS
OR BRAIDED
REINFORCEMENT
(REFERENCE)

REPLACEMENT STYLE S51-10
HOSE WITH A CRISS-CROSS
OR BRAIDED REINFORCEMENT
PATTERN
