**[Docket No. FAA-2013-0725; Directorate Identifier 98-CE-01-AD; Amendment 39-17690; AD 98-15-18 R1]**

#### **Airworthiness Directives; Maule Aerospace Technology, Inc. Airplanes**

**98-15-18 R1 Maule Aerospace Technology, Inc.:** Amendment 39-17690; Docket No. FAA-2013-0725; Directorate Identifier 98-CE-01-AD.

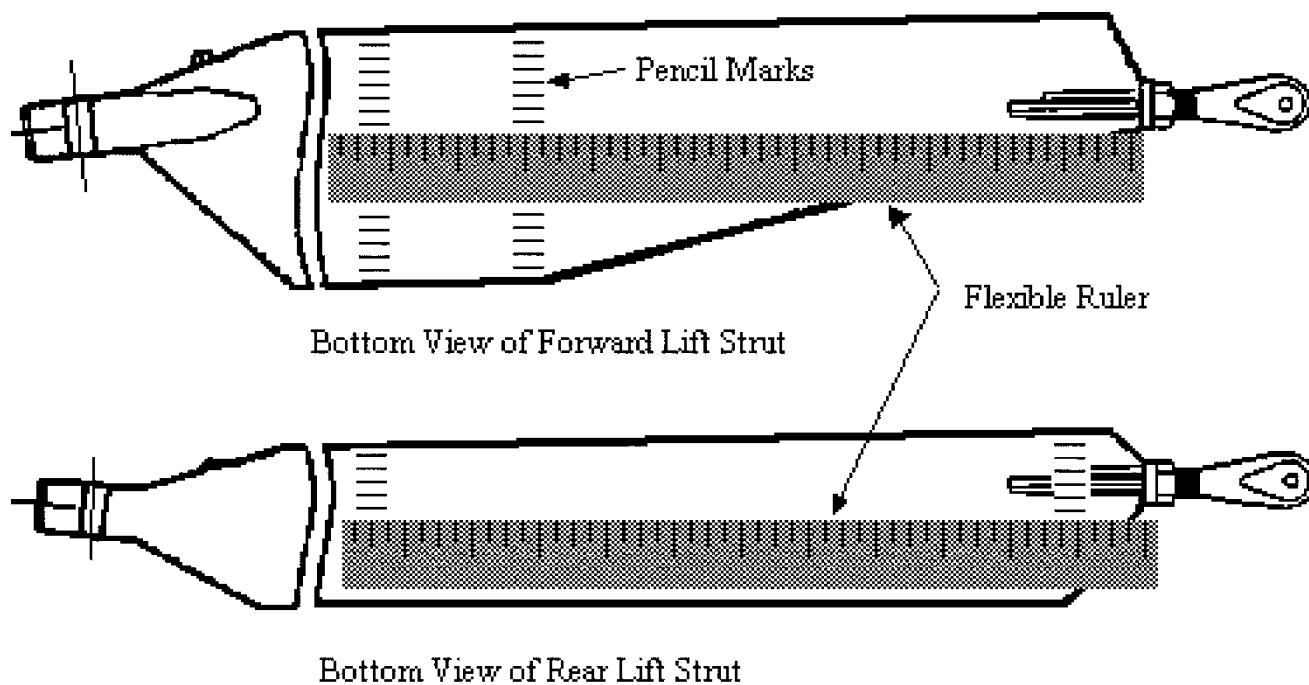
**Figure 1**

2. Using a flexible ruler, draw a 1/4-inch grid on the surface of the first 11 inches from the lower end of the strut as shown in Maule Air, Inc. Service Bulletin No. 11, dated October 30, 1995, as applicable. This can be done using a soft (2) pencil and should be done on both faces of the strut. As an alternative to drawing a complete grid, make two rows of marks spaced every 1/4 inch across the width of the strut. One row of marks should be about 11 inches from the lower end of the strut, and the second row should be several inches away where the strut starts to narrow. Lay the flexible ruler between respective tick marks of the two rows and use tape or a rubber band to keep the ruler in place. See Figure 1.
