FAA
Aviation Safety

SPECIAL AIRWORTHINESS INFORMATION BULLETIN

SUBJ: Wing, Attach Fittings (JASC 5740)

SAIB: AIR-21-10

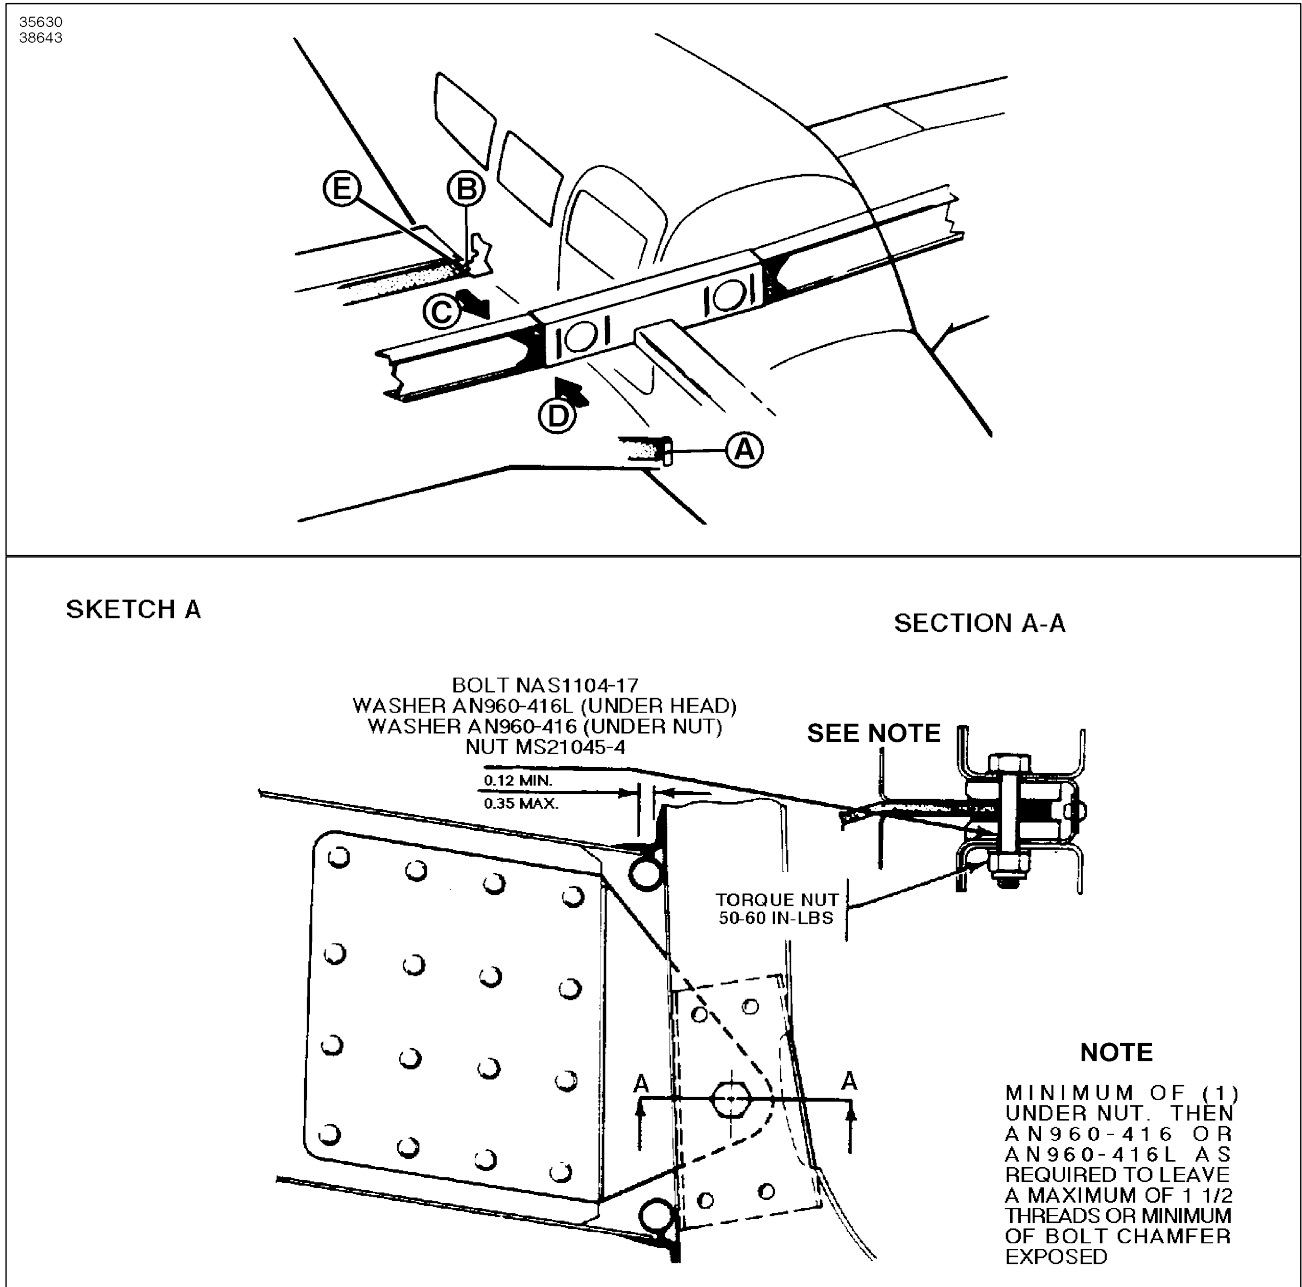
Since then, the FAA became aware of several cases of severe corrosion on the forward attach fittings from operators in Florida. While no evidence exists of water intrusion at the forward locations, the potential exists for galvanic corrosion between the dissimilar metals of the steel fittings and aluminum spar. Due to the restricted accessibility of the forward attach fittings in some airplanes, owners may be neglecting to have this area inspected. See Figures 1 through 3 depicting corrosion location and characteristics.

Figure 1. Forward Attach Fitting

The FAA is recommending that owners take special care to ensure that the forward wing attach fittings are visually inspected during annual or 100-hour inspections in accordance with the applicable Piper Aircraft, Inc. Maintenance Manual. Some operators have had inspection panels or borescope inspection holes installed to facilitate inspection (contact Piper Aircraft, Inc. for acceptable options). "Powdery" rivets in the attach fitting are indicative of corrosion between the

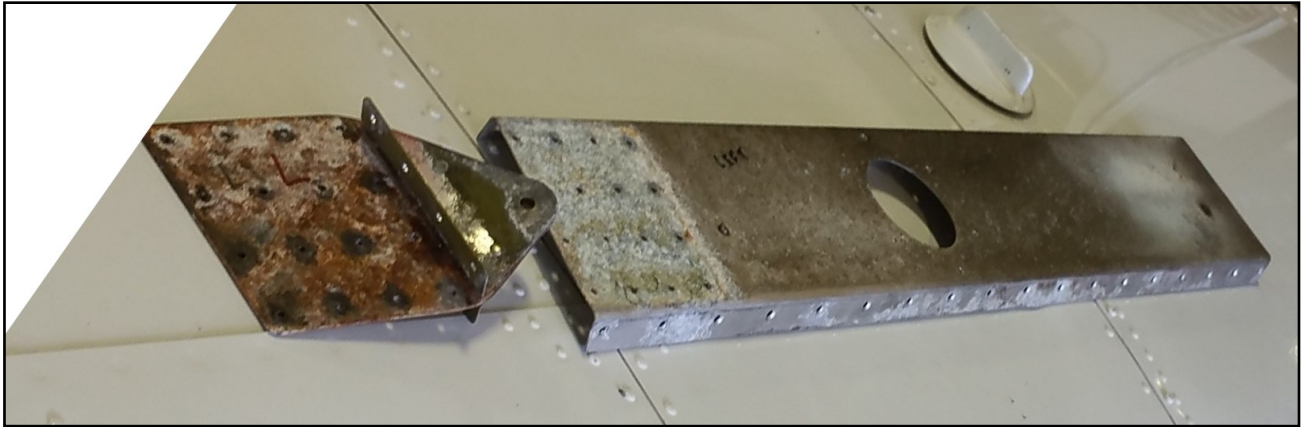
Figure 2. PA-28 Corroded Forward Attach Fitting and Spar Section (removed)

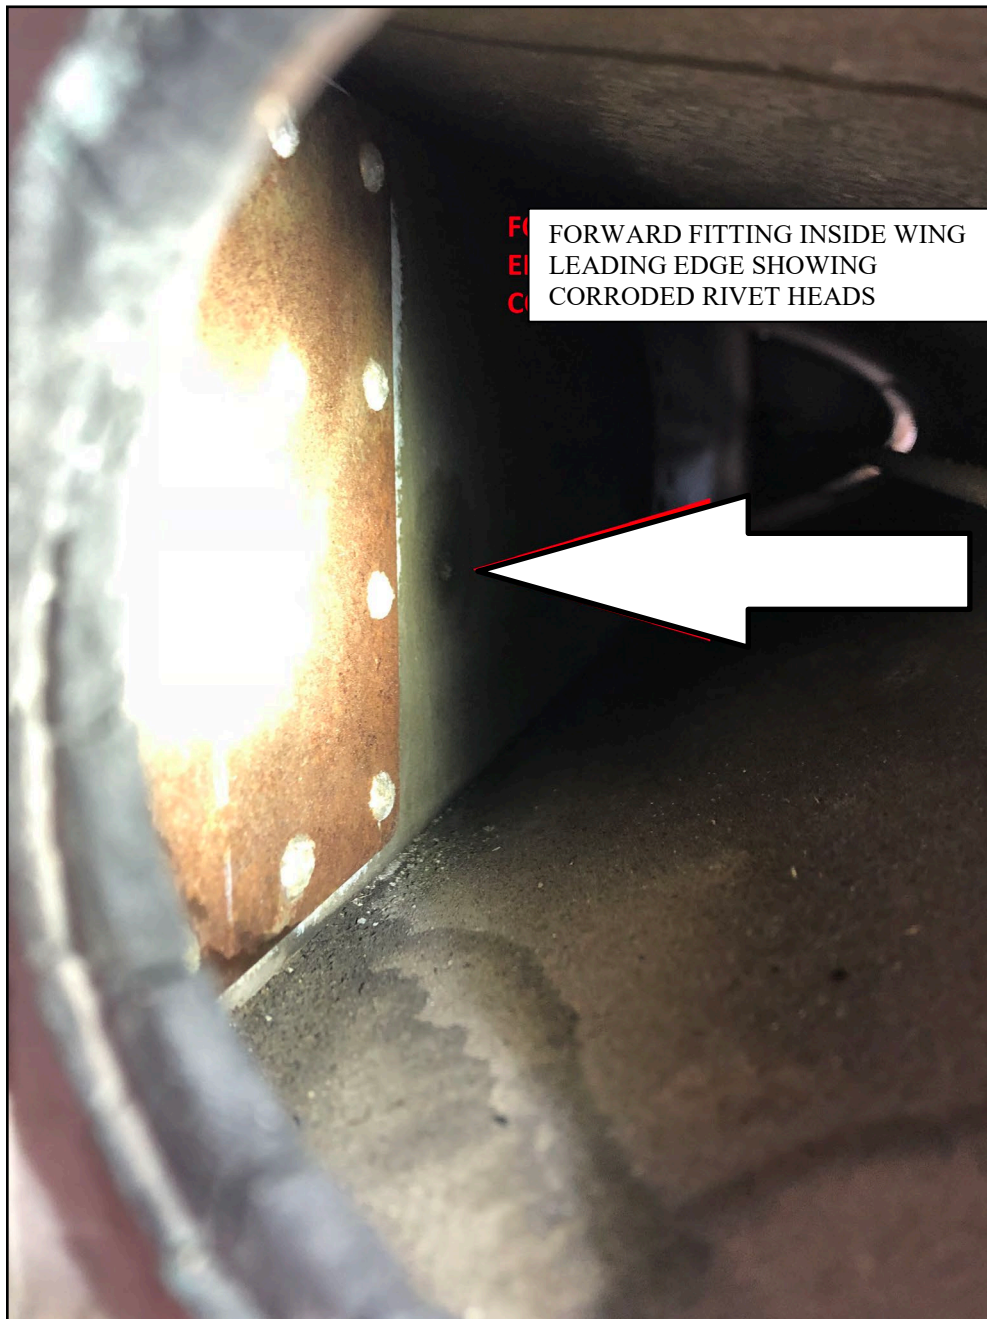
Figure 3. Wing Interior Showing Galvanic Corrosion
