SPECIAL AIRWORTHINESS INFORMATION BULLETIN

SAIB: AIR-22-15

SUBJ: Bonded Structure Inspection

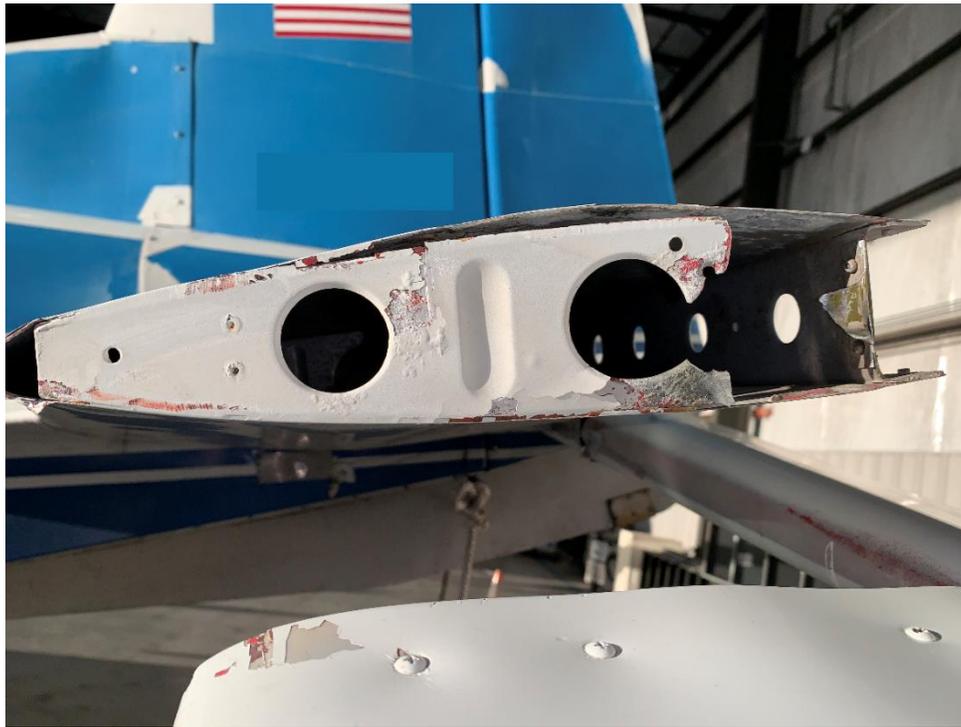
Following an accident involving a True Flight Model AA-5 airplane in January 2021, the FAA issued AD 2021-14-12 on July 12, 2021, which applies to Model AA-1, AA-1A, AA-1B, AA-1C, and AA-5 airplanes. AD 2021-14-12 requires a one-time inspection for bondline corrosion and delamination of the horizontal stabilizer, including the attachment point of the elevator. The accident airplane's elevator partially separated from its attachment to the horizontal stabilizer, which resulted in flutter of the elevator and near loss of pitch control. This airplane was later found to have severe bondline corrosion and delamination in certain areas, including the outboard rib of the horizontal stabilizer and the trailing edges of the elevator trim tabs. The damage can readily be seen in Figure 1, below.

Figure 1. Severely Damaged Horizontal Stabilizer with Skin Delamination and Indications of Bondline Corrosion, Model AA-5

The FAA recommends that the actions outlined in the affected airplanes’ maintenance manual, as well as SB-195A, be followed at the earliest opportunity and at the annual or 100-hour inspections.
