# Airworthiness Concern Sheet

Twin Commander Aircraft LLC (Twin Commander) issued [Maintenance Alert MA23001](#) on July 24, 2023 following two reports of cracks initiating at the radii of the lower wing skin cutouts for the main landing gear truss. These cracks were initially discovered on piston-powered aircraft conducting low-level surveys. There is a concern that such cracks might go undetected during routine maintenance, leading to continued cracking and reduction in wing residual strength. Maintenance Alert MA23001 recommends a recurring visual inspection, supplemented by either a high frequency eddy current inspection or a liquid penetrant inspection, of the skin cut-out area to detect any cracks within six months and annually thereafter. Since the issuance of MA23001, additional aircraft including turboprop models have been identified with similar lower wing skin cracking.

## **Maintenance Alert**

**SUBJECT: INSPECTION FOR CRACKS IN LOWER WING SKINS AROUND MLG TRUSS CUTOUTS.**

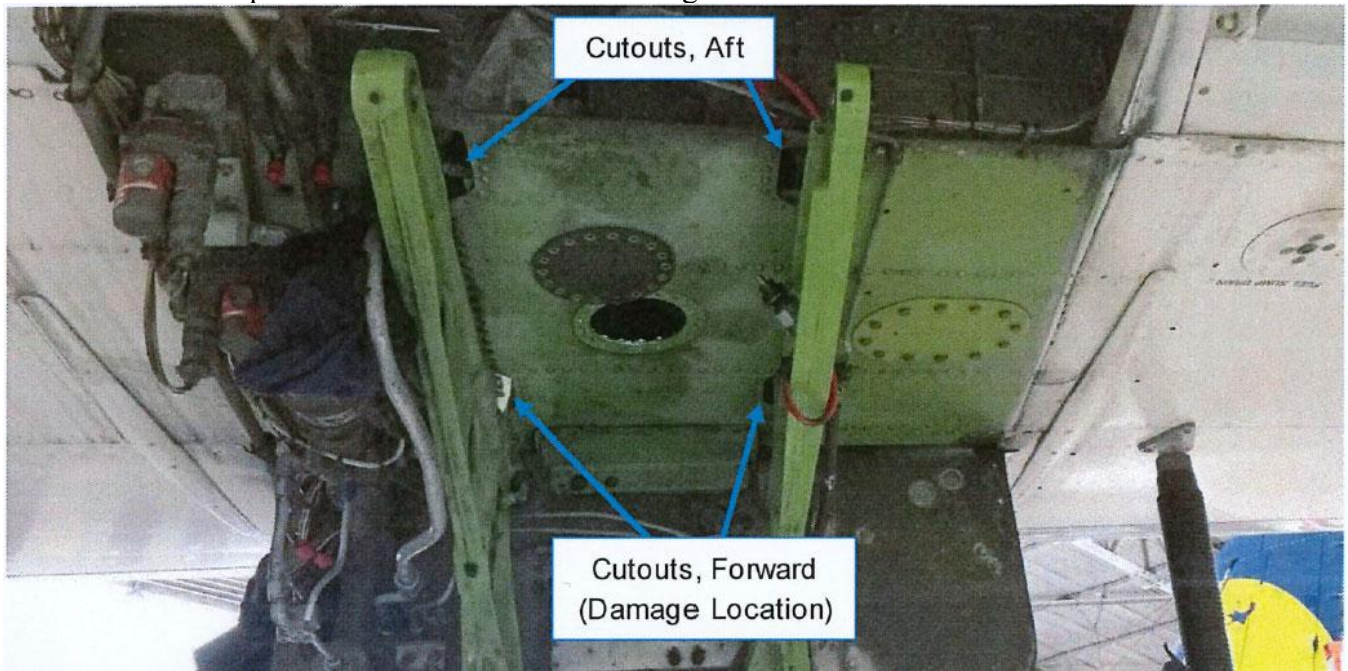
- b. Removal of the lower wing access door inside the nacelle may also aid in accessing the cutouts (Figure 1).
3. If cutouts are filled with sealant, carefully remove sealant, using plastic scraper and tools, around FWD and AFT radii of cutout to gain access to edge of cutouts. Clean area and edges of skins.

5. In addition, perform either,
  - 1) HFEC inspection of the cutout radii following the procedure laid out below,
    - a. HFEC Procedure: Perform High Frequency Eddy Current, on the lower wing skin – both inner and outer skins, and around the entire cutout edge, at the FWD MLG Truss cutouts (see Figure 1). Min detectible flaw length is 0.050” long. Skin alloy is Aluminum Alloy 2000 Series.

**Figure 1, View looking forward and slightly up.**

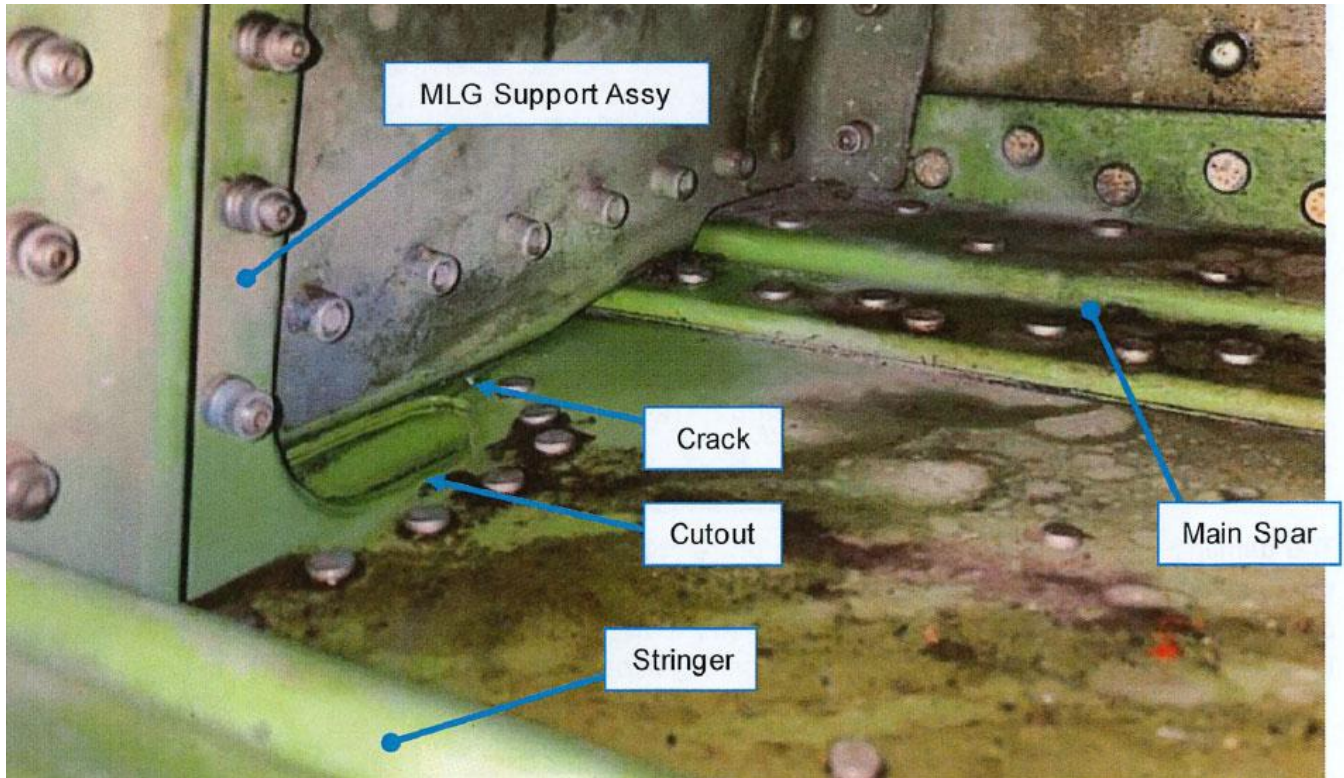
**REASON FOR PUBLICATION:** Two reports from the field noted small cracks extending forward and aft from the radii of the lower wing skin cutouts in each nacelle for the FWD portion of the MLG Truss. This Alert is to highly recommend detail visual inspection and either high frequency eddy current inspection (HFEC), or liquid penetrant inspection (LPI) of the lower wing skin at the FWD cutout areas, and to request feedback post inspection to help Twin Commander Aircraft in determining the prevalence of cracks in these locations.

4. Visually inspect the cutout area for cracks using good light (min 100fc). If possible, take photos of noticeable cracks and include these photos with your compliance card, which can be mailed or emailed to the address shown. See Figure 2 for typical crack locations.

Figure 2. View inside the nacelle, looking forward and slightly down (crack propagating forward of FWD cutout radius towards front spar).

- 2) Liquid Penetrant Inspection (LPI) per ASTM E1417 the inner and outer skin surfaces, for cracks. For LPI, the skin surfaces must be stripped of surface finish. Acceptance Criteria per MIL-STD-1907, Grade A.
6. If cracks are found, contact Twin Commander Aircraft, LLC at the address below, and report findings on compliance card.
