**SAFETY RECOMMENDATION**

Subject: Boeing 737/400, registration marks EI-COI. Accident occurred on June 15<sup>th</sup>, 2006, at Catania Fontanarossa airport (Italy).

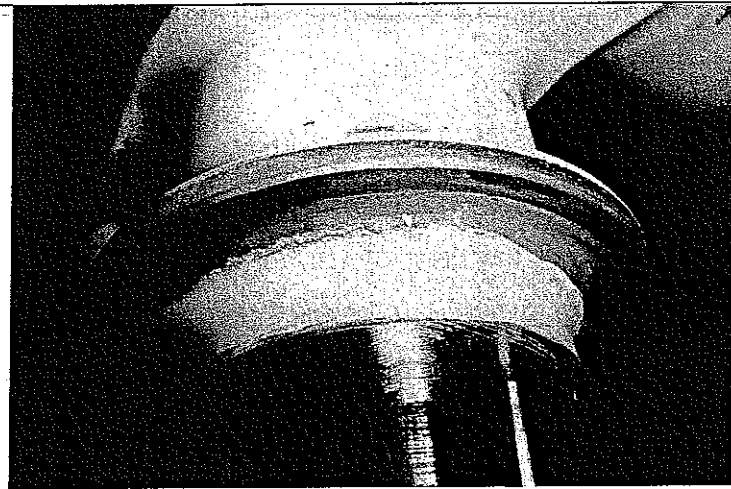
Photo n.1 – Corrosion signs on NLG axle

Up to now 2 over 7 of the inspected aircraft have revealed corrosion signs on the area (photo 1), otherwise masked by the spacer.

The axle failure was due to a crack nucleated from a corrosion attack in the region of the external surface where the highest stresses are concentrated.

1. consider requiring a revision of the current Corrosion Prevention Task Card P-32-00-01 for the aircraft Boeing 737-400, explicitly calling out removal of the spacer and visual check for corrosion on the area beneath it, with particular attention to be focused at the 6 'o clock position.

- if corrosion is detected in that specific area an additional NDT for cracks (e.g. MPI) has to be implemented;
  - in absence of cracks, protective finishes have to be restored as practical.
- (ANSV-17/341-06/1/A/06)
