# Boletim Especial de Aeronavegabilidade (*Special Airworthiness Bulletin*)

**BEA** Nº 2023-01

**Subject:** Rotary Switches Pull-to-Turn Feature inspection

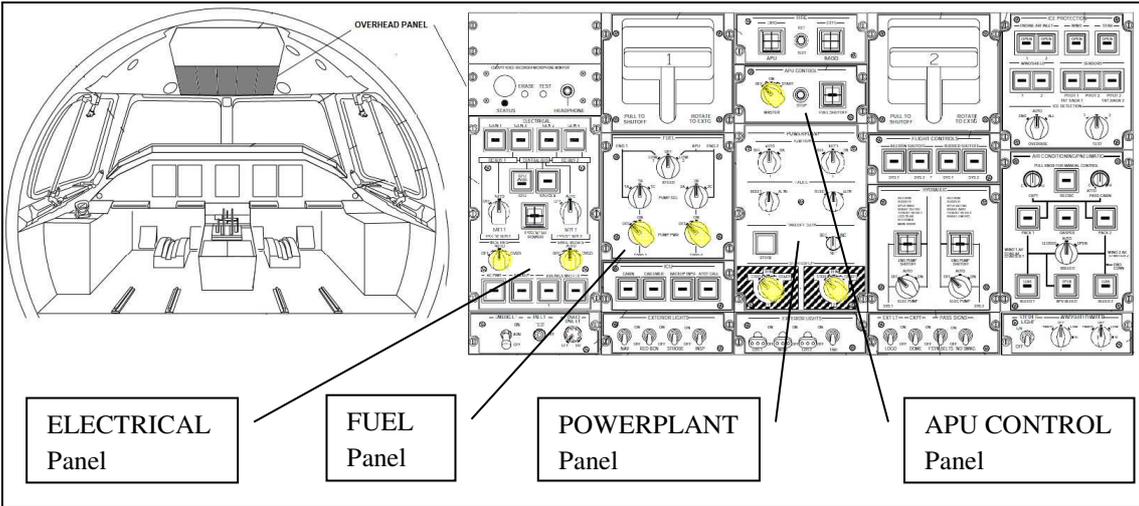
Figure 1 – EMB-135/145 Overhead Panel (typical) – Relevant switches are highlighted

- 1- Visually inspect the panel face markings adjacent to the rotary switches identified in Table 2 below (see Figures 1 through 5 below for the locations of the switches for each aircraft family – Table 2 switches are highlighted in yellow), for obscured / erased paint markings. Ensure that the panel markings are clearly visible and legible. Obscured / erased panel markings can prevent the crew to accurately set the switch to the position intended;

If any of the switches listed in Table 2 have unreadable / obscure / erased markings, and/or if there is no need to pull the switch first before turning them, replace the discrepant switch.

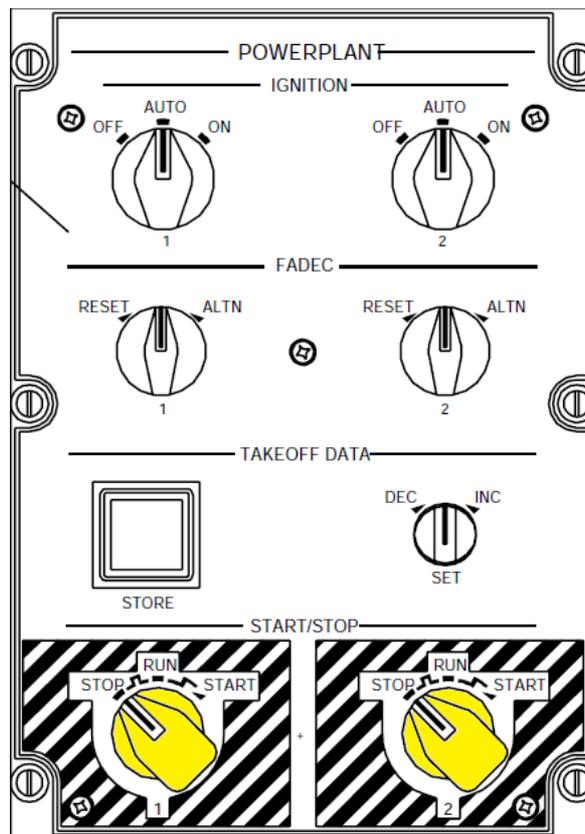
Figure 6 – EMB-135/145 Powerplant panel (typical) – Engine Start/Stop switches are highlighted

- a) Set the switch (see Figures 6 and 7 above) to the initial position indicated in Table 3 below:

- b) Verify that turning the switch to the Test Position 1 (see Table 3) is only possible if, before turning, it is necessary to pull the switch first.
- c) Verify that turning the switch back to the Initial Position (see Table 3) is only possible if, before turning, it is necessary to pull the switch first.
- d) Verify that turning the switch to the momentary Test Position 2 (see Table 3) is only possible if, before turning, it is necessary to pull the switch first.
