# Boletim Especial de Aeronavegabilidade (*Special Airworthiness Bulletin*)

**ATA: 30** – Ice and rain protection

**BEA Nº 2023-03**

**Subject: Operation in icing conditions – adherence to standard operating procedures**    **Date:** May 12<sup>th</sup>, 2023

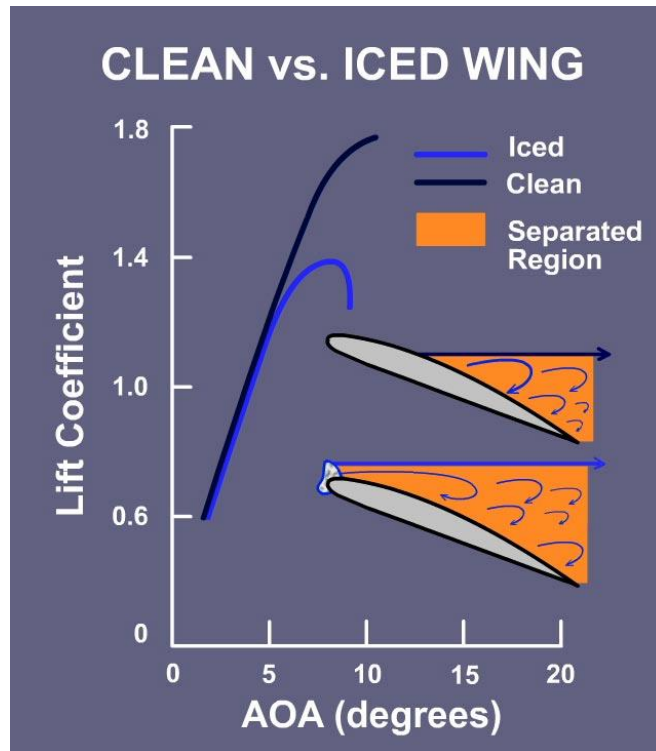
The ice formation decreases both the angle of attack in which stall occurs and the maximum lift that the airfoil is capable to provide, as shown in Figure 1. Consequently, the stall speed increases.

**Figure 1:** Ice formation on the airfoil. Source: <https://aircrafticing.grc.nasa.gov/>

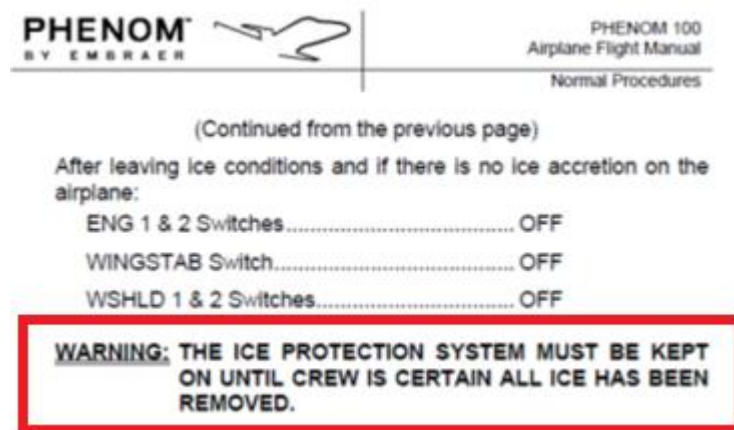
**Figure 4** – Extract of the AFM Normal Procedures Section

The highlighted warning note is essential. The ice protection system minimizes ice accretion in protected areas when the airplane is flying in ice conditions, but it does not eliminate completely the ice accretion. In addition, there are unprotected areas such as wing roots and wing tips. When the airplane exits the ice condition it is possible that ice formation still exists in the airplane. The stall warning and protection system must be maintained in the ice conditions configuration (SWPS ICE SPEED) and in the EMB-500 design it results in the WINGSTAB protection system maintained activated (WINGSTAB switch must remain at the ON position).

The ice protection system **MUST NOT** be turned off in approach and landings if it is not possible to be sure that all ice accretion in the airplane is removed, as in the accidents described in this BEA.

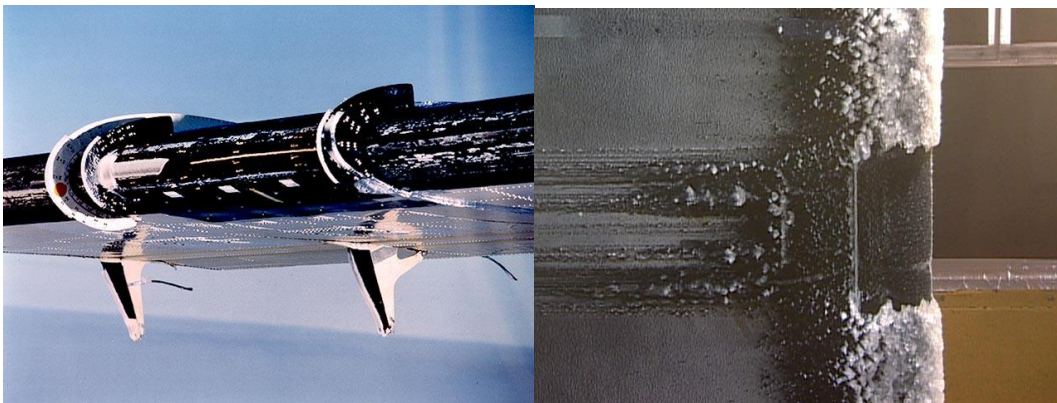
The impact on airplane performance is usually higher in airplanes equipped with boots systems because a higher residual ice formation is natural even with the system functioning properly. In thermal ice protection systems, the leading edge is kept clean of ice although an ice accretion after the protected area is possible (runback ice).

**Figure 5:** Residual ice formation in the boots system (left) and runback ice in thermal systems (right). source: <https://aircrafticing.grc.nasa.gov/>
