SUBJ: ELEVATOR TORQUE TUBE – Inspections for cracks and corrosion
in elevator torque tubes

SAIB: CE-17-25

Date: August 25, 2017

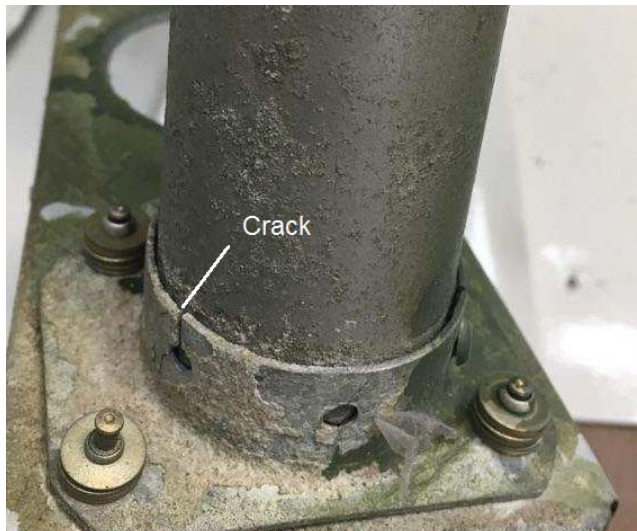
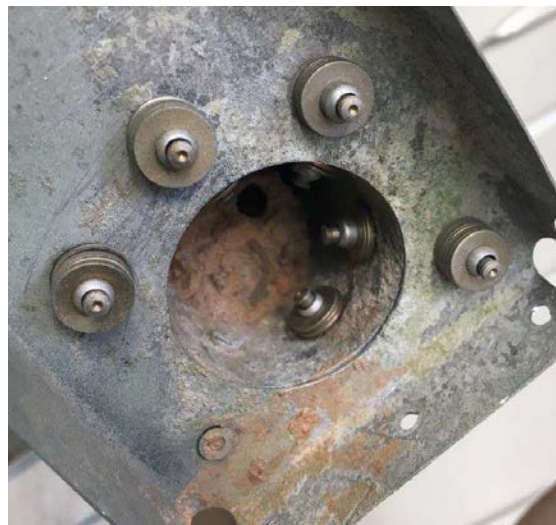
The elevator torque tube pictured below was removed from a Cessna Model 172C airplane during an annual inspection for cracks, corrosion and improper repairs. The airplane had spent 24 years in Florida (a high corrosion area). During the annual inspection, a blind rivet installation (not approved) was found. The date of this blind rivet installation could not be determined.

These elevator torque tubes have been installed on Cessna 100 airplanes since the 1950s and continue to be installed on production Cessna 172 and 182 airplanes. The tubes are made of aluminum. They are exposed to wheel spray during landings or spray from floats during water landings. The tube is oriented horizontally so it tends to retain water. Exposure to moisture over many years leads to corrosion damage. Airplanes used in coastal areas are especially prone to corrosion.

For Cessna 100 airplanes and Cessna 208/208B airplanes, we recommend adherence to the applicable Textron Aviation SIDs and maintenance manuals for corrosion inspections. Airplanes based or operated in high corrosion areas are recommended to be inspected more frequently. Pilots should check this area for corrosion or obvious damage during preflight inspections. If minor surface corrosion is found, remove the corrosion in accordance with Textron Aviation procedures. If cracks or severe corrosion is found, replace the affected parts.
