**SAIB:** CE-09-13

**Date:** February 23, 2009

**SUBJ:** Landing Gear: Engine Mount-Nose Landing Gear Attach Section

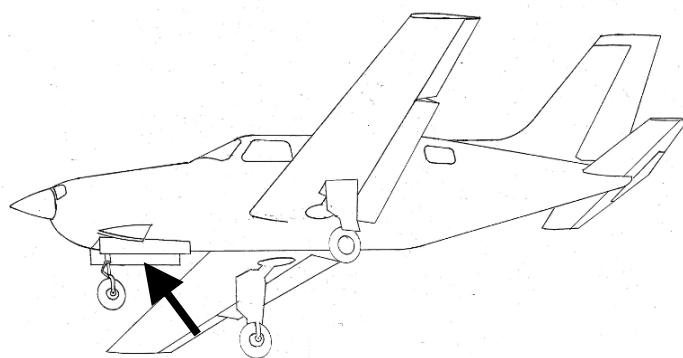
This SAIB is a result of reported cracks being found in the engine mount, both where the actuator for the nose landing gear attaches, and at the pivot where the NLG trunnion attaches. The picture below shows the general area.

Arrow Shows General Location of  
Potential Engine Mount Cracks

After reviewing the above data, we recommend that you **inspect the engine mount where the nose landing gear trunnion and actuator attach**. You should perform this inspection following the appropriate Piper service information SL 1001, SB 1103C, and/or SB 1154C, as appropriate, for the model and serial number of your aircraft and the configuration of your engine mount

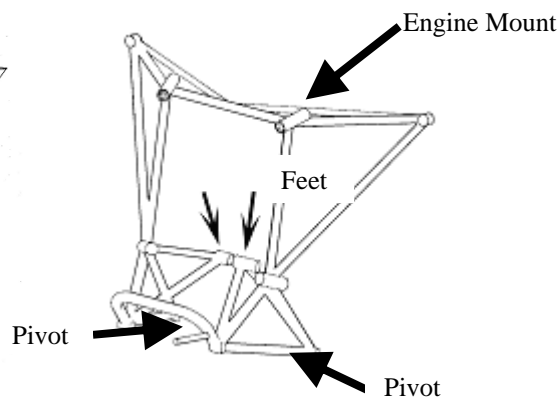
Typical Engine Mount Crack Locations

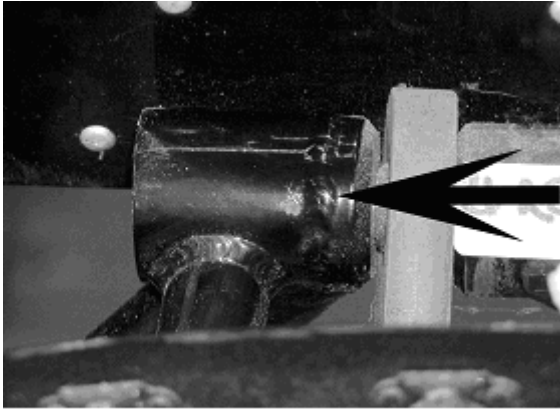
There are two types of cracking to be aware of at the NLG actuator attachment. The first type, and the subject of Piper Service Bulletin (SB) 1103C, is cracking around the circumference of the “foot” (the metal tube where the actuator bolt attaches). Some aircraft have a one-piece machined foot and do not

The “foot” cracks only occur on some early engine mounts where the “foot” is made up of two parts; a metal disk welded to a metal tube. The cracks have been found in the welded area between the disk and tube.

Old Engine Mount  
Weld Indicates Two (2) Piece Foot

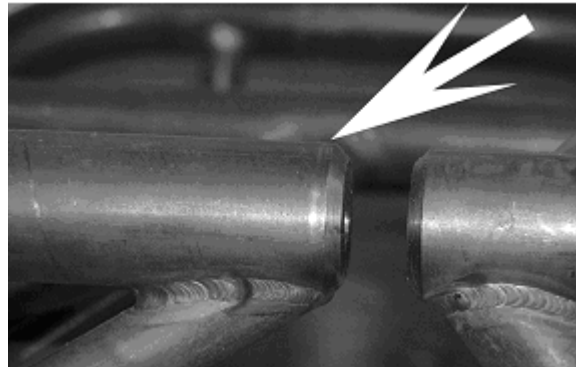
New Engine Mount  
Note One Piece Machined Foot

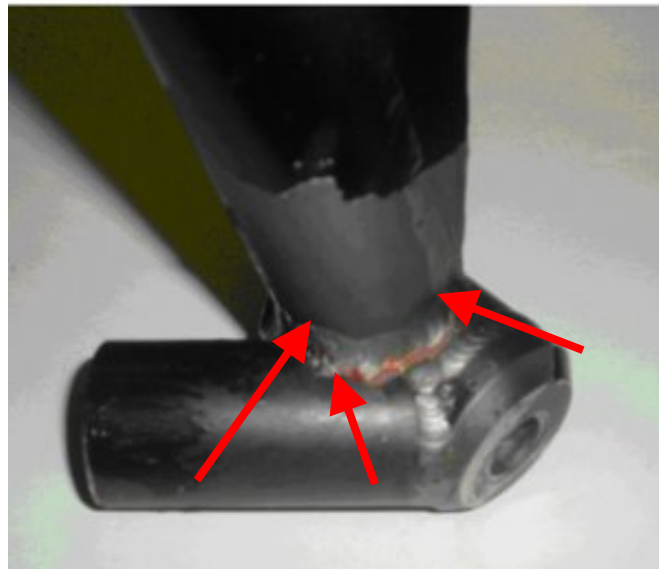
The second type of cracking is in the **actuator cluster weld**, which attaches the “foot” to the engine mount tubing and is the subject of service bulletin 1154C. This second type of cracking occurs in the welded joints where the foot attaches to the engine mount tubes (cluster weld). See picture below.

Cracks around Tube Cluster  
(Note crack extends into tube)
