**SPECIAL AIRWORTHINESS**  
**INFORMATION BULLETIN**

**SAIB:** CE-09-40

**SUBJ:** Flight Controls - Trailing Edge Flap Control System

This Special Airworthiness Information Bulletin (SAIB) is to inform you, a registered owner or operator of **Commander Aircraft Company (Rockwell International) Models 112 and 112A airplanes**, of an airworthiness concern, specifically the potential for improper operation or installation of the wing flap switch.

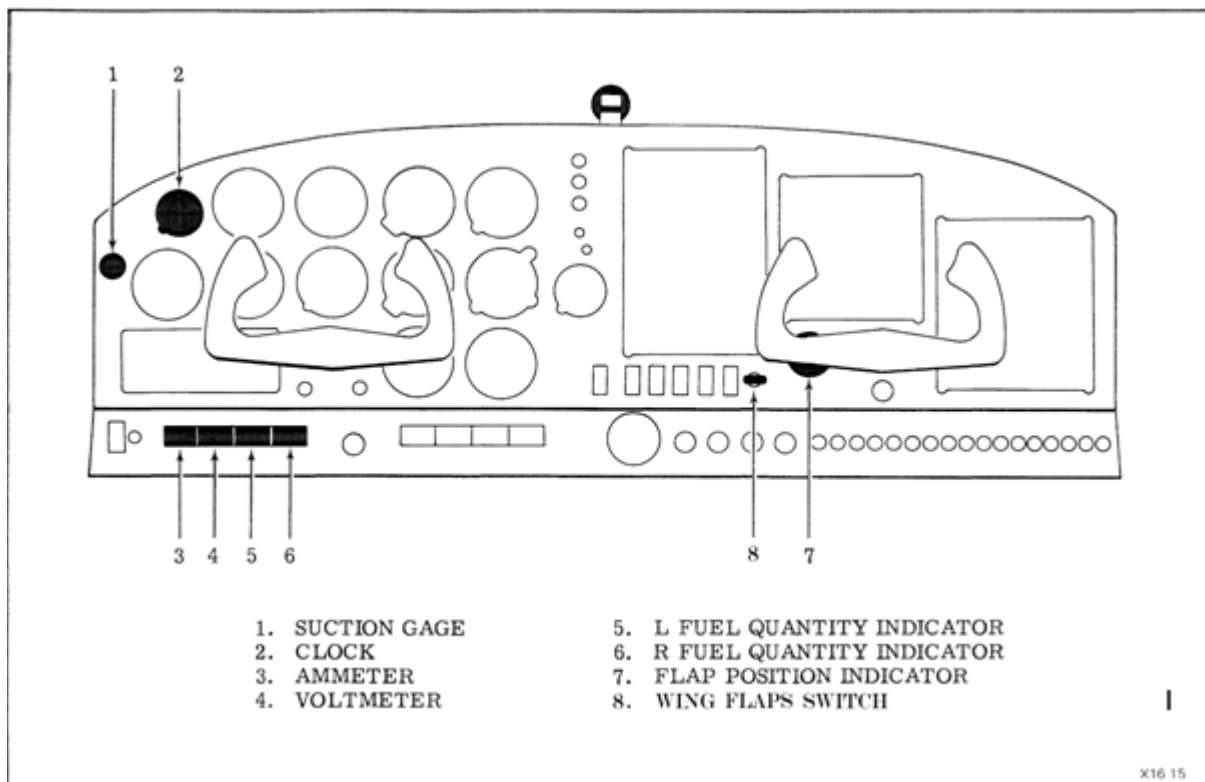
Figure 1  
(Flight Manual "Figure 3-7", modified to show flap switch.)

*The wing flaps are electrically operated... Flap position is controlled by a switch labeled "WING FLAPS" (Item 8 of Figure 1)... Flap position is electrically indicated by a gauge mounted above, and to the right of, the flap switch (Item 7 of Figure 1).*

The Aero Commander Model 112 flap switch (Commander P/N 65853 or P/NMS25201-6) as explained above is a three-position switch; Up (**not spring loaded to re-center**), Center (power off), Down (**spring loaded to re-center**).

It is possible that the flap switch spring may break, thus not allowing the switch to re-center, providing a continuous contact closure, and driving the flaps to full down within 9 seconds. The flap indicator (as shown in Item 7 of Figure 1) is located outside the pilot's normal scan and may be obstructed by the copilot's yoke. This configuration can become critical to the performance of the airplane if the following occur:

We have also become aware of incidences where a mechanic has installed the flap switch upside down, where **Up was spring loaded to center**, and **Down was not spring loaded to re-center**. Thus, while the flap switch is placed in a down position, the flap switch will stay down, and the flaps will continue down until they are fully extended. This can also become critical.

- Cycle the flaps on preflight to assure the condition of the flap system is satisfactory for flight.
- Assure that the wing flap switch operates correctly, specifically the switch springs back to neutral after the pilot releases downward pressure, and the flaps stop the travel.

- If any inoperative or improperly install switches are found, replace before the next flight.
- Report any inoperative switches and those improperly installed to the FAA point of contact listed below.
