SAIB: CE-09-40R1

Date: October 19, 2009

**SUBJ:** Flight Controls - Trailing Edge Flap Control System

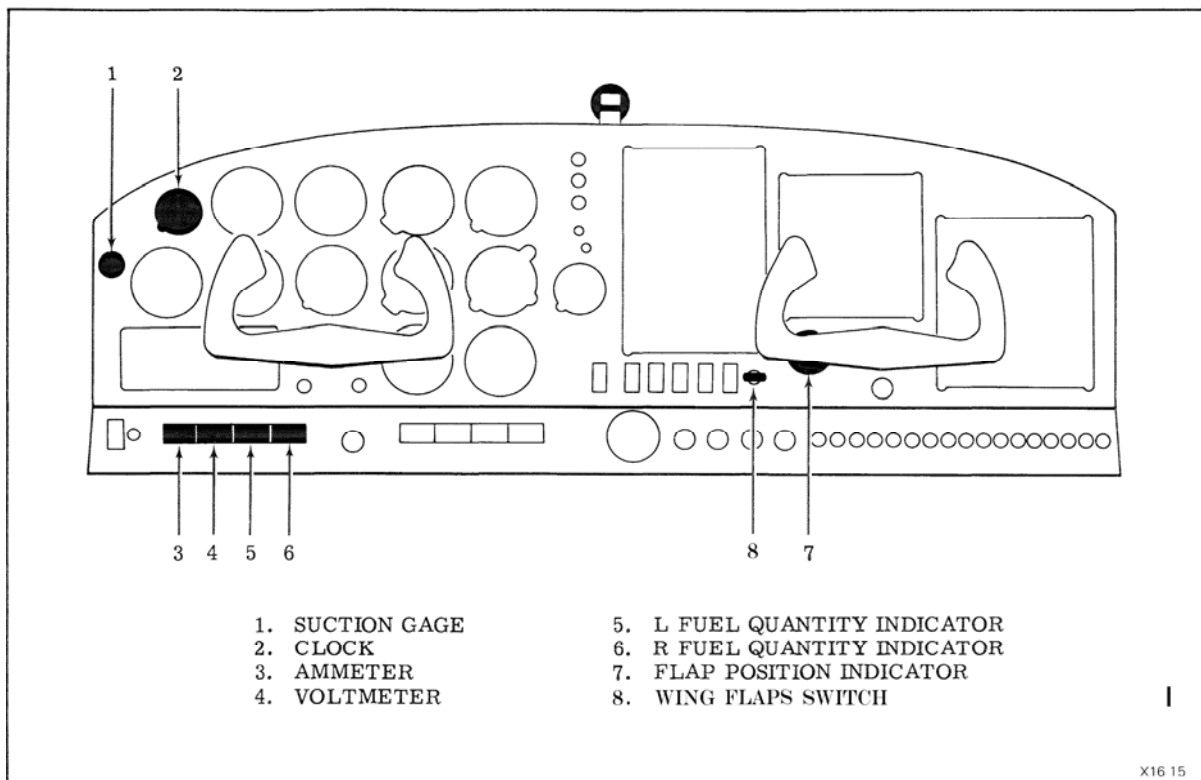
Figure 1  
(Flight manual “figure 3-7,” modified to show flap switch.)

*The wing flaps are electrically operated... Flap position is controlled by a switch labeled "WING FLAPS" (item 8 of figure 1)... Flap position is electrically indicated by a gauge mounted above, and to the right of, the flap switch (item 7 of figure 1).*

It is possible that the flap switch spring may break, thus not allowing the switch to re-center, providing a continuous contact closure, and driving the flaps to full down within 9 seconds.

The flap indicator (as shown in item 7 of figure 1) is located outside the pilot’s normal scan and may be obstructed by the copilot’s yoke. This configuration can become critical to the performance of the airplane if the following occur:

We have also become aware of incidences where a mechanic has installed the flap switch upside down, where Up was spring loaded to center, and Down was not spring loaded to re-center. Thus, while the flap switch is placed in a down position, the flap switch will stay down, and the flaps will continue down until they are fully extended. This can also become critical.

- Cycle the flaps on preflight to assure the condition of the flap system is satisfactory for flight.
- Assure that the wing flap switch operates correctly, specifically the switch springs back to neutral after the pilot releases downward pressure, and the flaps stop the travel.

- If any inoperative or improperly install switches are found, replace before the next flight. It was brought to the FAA's attention that the MS25201-6 switches are now "Momentary On" in both directions, and per Commander Engineering Change Notice 3 the authorized part is the Cutler Hammer P/N 8832K6. The Cutler Hammer P/N 8832K6 is the allowable replacement.
- Report any inoperative switches and those improperly installed to the FAA point of contact listed below.
