SPECIAL AIRWORTHINESS INFORMATION BULLETIN

SAIB: CE-11-40

SUBJ: Flight Controls: Rudder

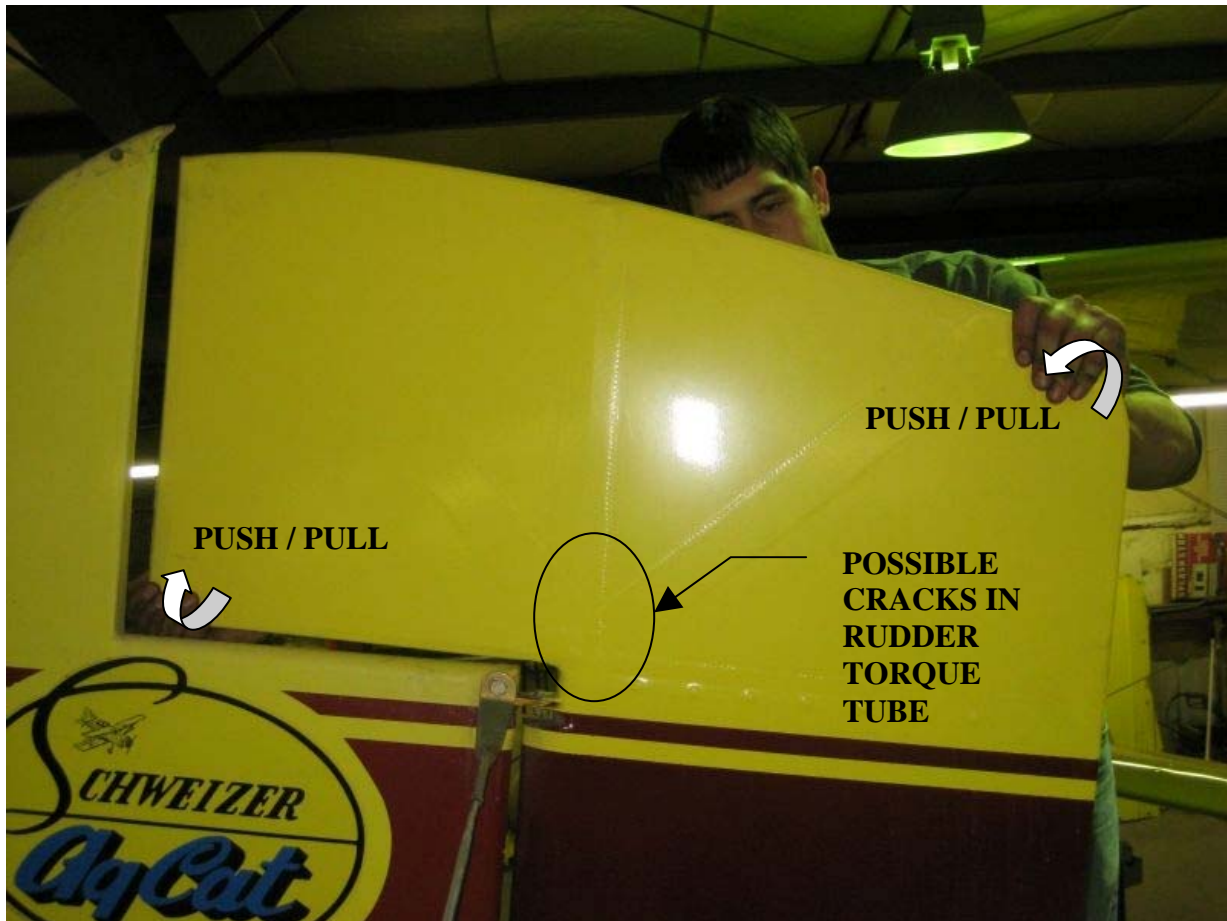
Figure 1

FAA Flight Standards District Office, FSDO-21 Fargo, ND reported cracks being found on the rudder of the Allied Ag Cat G-164 airplanes. Cracking was located in the rudder main spar tube in the area immediately above the upper hinge attach point of "Tall Tail Conversions". Typically the cracks are discovered during aircraft inspection and/or when recovering the rudder.

The FAA has had discussions with the type certificate holder who concurs with the following recommended procedure. Apply light hand pressure in both left and right lateral directions as shown in the Figure 1, Figure 2 and Figure 3 while looking for any deformation or wrinkling of the fabric in the noted area. If any deformation or wrinkling is noted, the rudder should be considered non-airworthy until it can be determined by further visual or other non-destructive inspection of the internal structure of the rudder that no cracking or failure of the structure has occurred.
