SPECIAL AIRWORTHINESS INFORMATION BULLETIN

SAIB: CE-12-08

SUBJ: Flight Controls, Elevator Control System

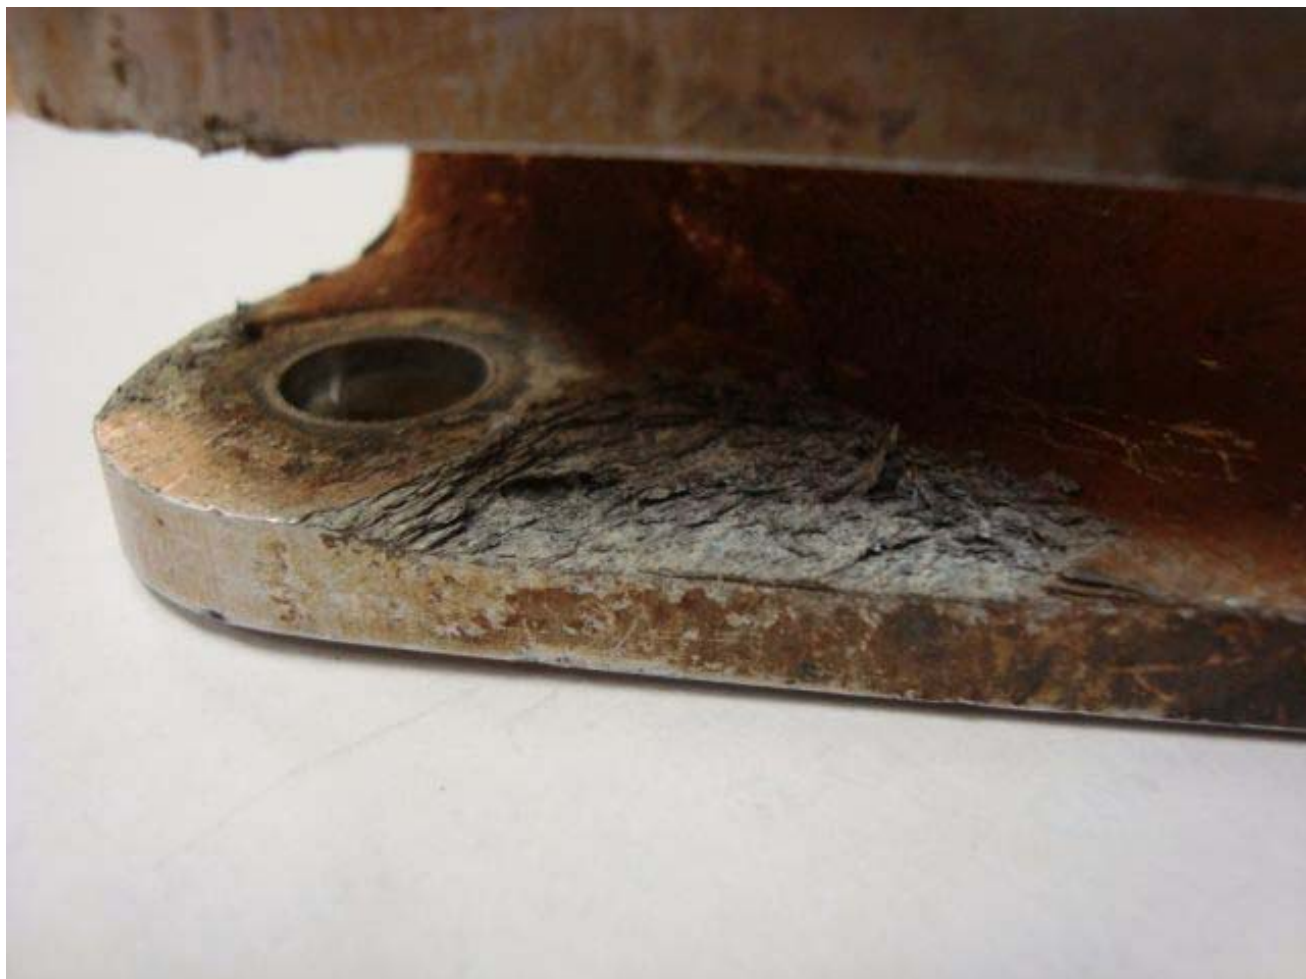
The Federal Aviation Administration (FAA) received reports of corrosion in the pitch trim actuator fuselage fittings, part number (P/N) 27-43060 on certain M7 Aerospace LP SA226 and SA227 series airplanes (specific models referenced above). The corrosion in the attached photo shows what can exist on the exposed fitting lugs.

The FAA recommends inspection of any M7 Aerospace LP SA226 and SA227 airplane (specific models referenced above) pitch trim actuator fuselage fittings, P/N 27-43060, at the time intervals and using the procedures provided in the respective SB's 226-27-073, 227-27-053, and CC7-27-024. We recommend repair or replacement of any pitch trim actuator fuselage fitting found corroded during any inspection following the respective SB before continued flight.
