SPECIAL AIRWORTHINESS INFORMATION BULLETIN

SUBJ: WING SPAR – Main Spar Lower Cap Cracks

SAIB: CE-15-18

Date: June 15, 2015

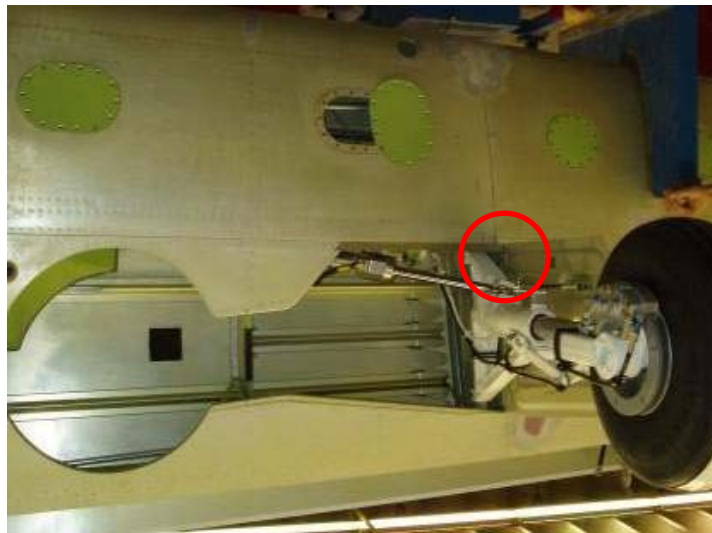
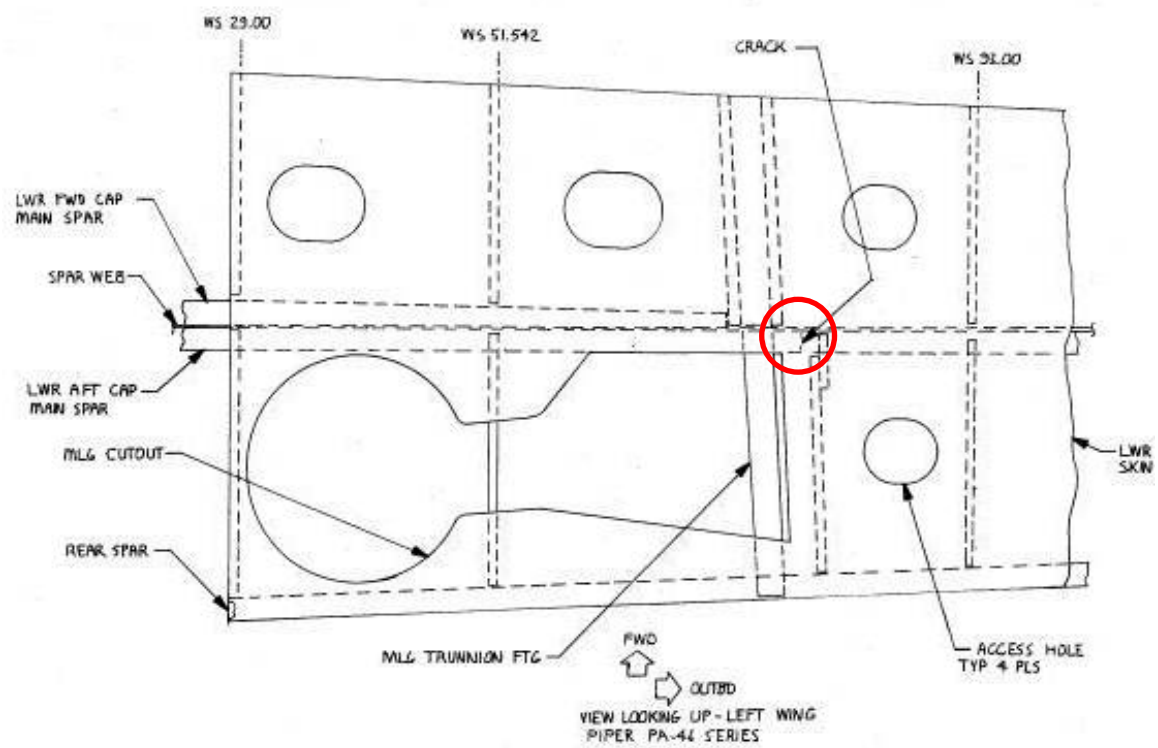
During routine inspection of a Piper Model PA-46-350P airplane, a 1.53-inch crack was discovered in the main spar lower cap (See Figures 1 through 3 to better identify the damage location). The damage was confirmed to be a standard fatigue crack by metallurgical lab evaluation. The crack discovery was at 5,273 hours time-in-service (TIS) versus the type certificated life limit of 15,580 hours TIS.

Figure 1a – Aircraft-level view of damage area

Figure 1b – Aircraft-level view of damage area

You should repair or replace damaged components if you find damage (cracks, corrosion, etc.). Piper Aircraft, Inc. has experience with repairs and rework in this area.

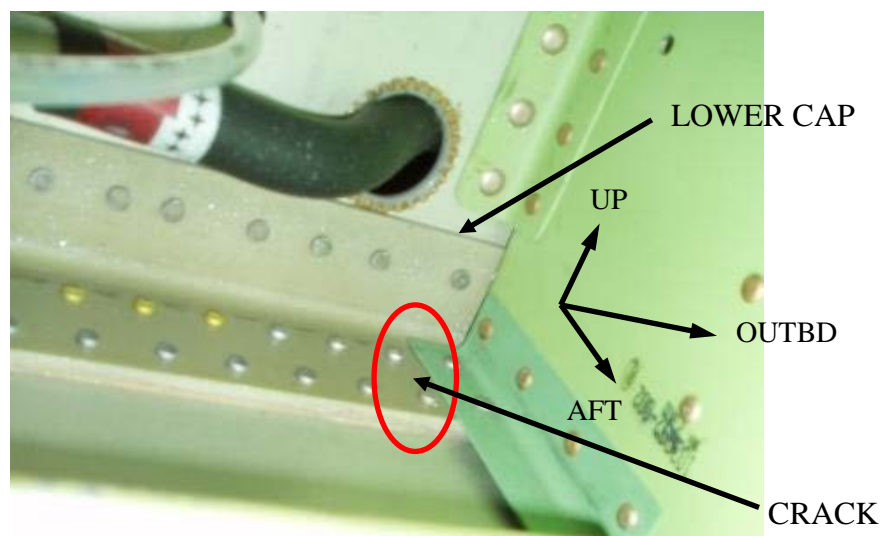
Figure 2 – Detail view of damage area inside wheel well (view looking forward and down)

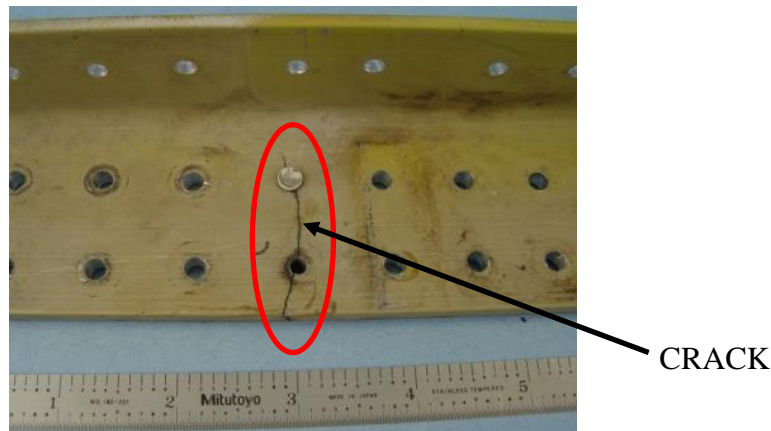
Figure 3 – Detail photographic view of damage area

No single cause has been identified for the cracking. However, several individual contributing factors researched in this area include not applying existing Service Bulletin (SB) 796B, severe aircraft operating environment, and non-conforming fastener installations. Piper has issued several SBs related to the damage area and contributing factors.

The FAA recommends you perform the following Piper SBs on Piper Models PA-46-310P, PA-46-350P, PA-46R-350T, and PA-46-500TP airplanes and recommends you follow the applicability and compliance times included in the SBs.

- SB 796B – Lower Wing Rivet Replacement (PA-46-310P, PA-46-350P)
- SB 1204 – Re-calculation of Wing Structure Life Limit due to Unique Usage (PA-46-310P, PA-46-350P, PA-46R-350T, PA-46-500TP)
- SB 1271 – Wing Spar Inspection (PA-46-310P, PA-46-350P, PA-46-500TP)
