DECISION № RRJ0000-OR-470-8879

on one-time hinge fitting elevator inspection with respect to the lack of hub (bush) p/n T7.92.5101.107.000.73/A.

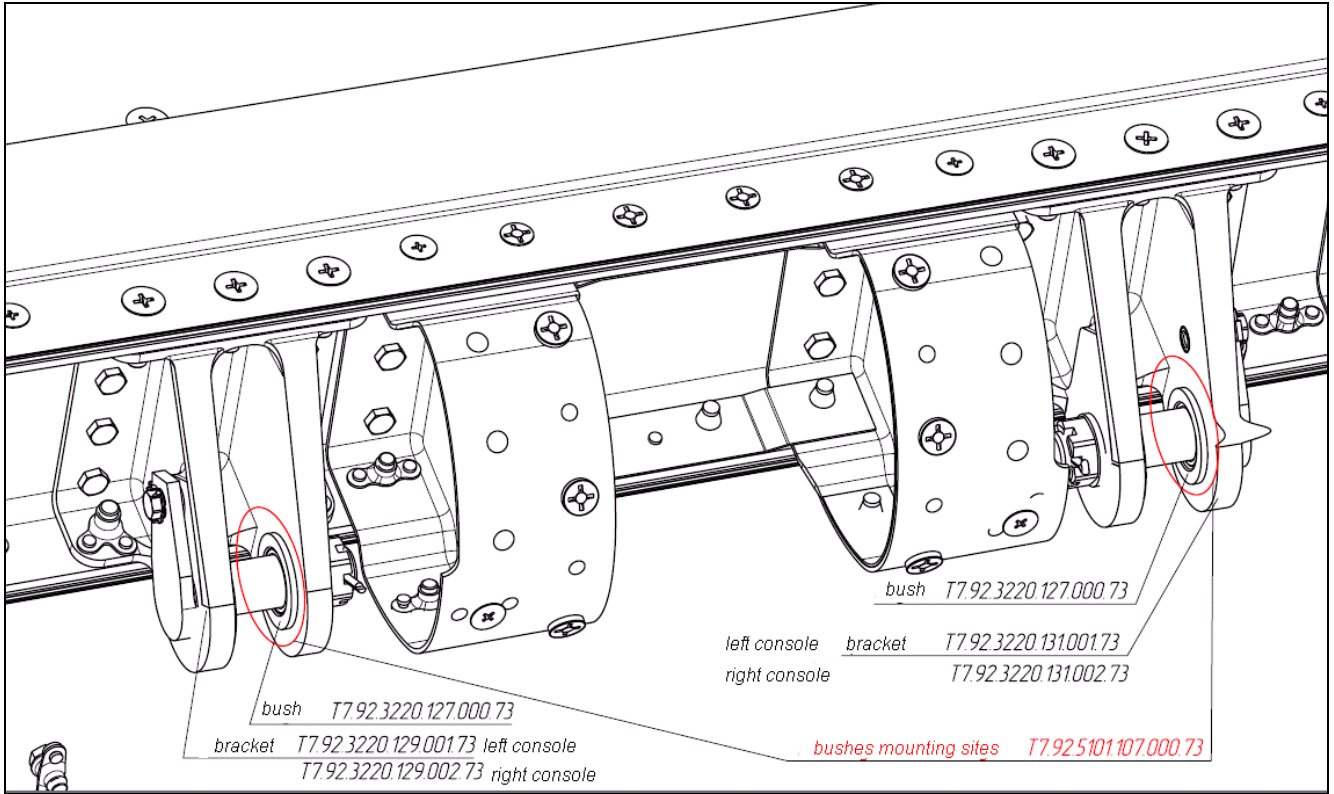
Figure 1

During the aircraft RRJ-95 operation the elevator play (backlash) nonconformity events due to floating bush p/n T7.92.5101.107.000.73/A missing at the mounting bracket were revealed and as a consequence the bolt T7.92.5101.101.000.73/B galling (please, refer to fig. 1).

The elevator backlash symptom effect was inability for the autopilot to maintain the prescribed altitude (within 30-50 ft range altitude).

The lack of the bush T7.92.5101.107.000.73/A the elevator actuator mounting bracket (1-C273, 2-C273, 3-C273, 4-C273) is caused by non-compliance with Design Documentation performed during the manufacturing process. To reveal if the floating bush T7.92.5101.107.000.73/A is not installed at the elevator actuator mounting bracket it is decided to take the following actions

1. At their base airports all Operators' RRJ-95 fleet must be subjected to a one-time inspection of the elevator backlash in accordance with AMM 55-20-00-200-801 during the next maintenance check (WY-check) but no later than 03.08.2016.

3. If the elevator backlash is proved to be out-of-design limits as stated in the AMM 55-20-00-200-801, then the elevator actuator should be detached from the related brackets p/n T7.92.3220.131.001.73/D, T7.92.3220.131.002.73/D, T7.92.3220.129.001.73/C.T7.92.3220.129.002.73/C as required by the AMM 55-26-00-220-801 “ Detailed hinge inspection of fittings and elevator actuator bracket”. Close attention should be paid to detect if the bush p/n T7.92.5101.107.000.73/A is installed at the actuator bracket on the elevator.

3.1. If the lack of bush p/n T7.92.5101.107.000.73/A at the actuator mounting bracket is found, then the mount attachments inspections of, brackets should be held in order to reveal any damages, galling and make a NDT report containing the description (sizes, damages' nature, etc.) by performing the subsequent actions:
