EASA	EMERGENCY AIRWORTHINESS DIRECTIVE

<p>AD No.: 2014-0118-E</p> <p>Date: 13 May 2014</p> <p>Note: This Emergency Airworthiness Directive (AD) is issued by EASA, acting in accordance with Regulation (EC) No 216/2008 on behalf of the European Community, its Member States and of the European third countries that participate in the activities of EASA under Article 66 of that Regulation.</p>
<p>This AD is issued in accordance with EU 748/2012, Part 21.A.3B. In accordance with EC 2042/2003 Annex I, Part M.A.301, the continuing airworthiness of an aircraft shall be ensured by accomplishing any applicable ADs. Consequently, no person may operate an aircraft to which an AD applies, except in accordance with the requirements of that AD, unless otherwise specified by the Agency [EC 2042/2003 Annex I, Part M.A.303] or agreed with the Authority of the State of Registry [EC 216/2008, Article 14(4) exemption].</p>

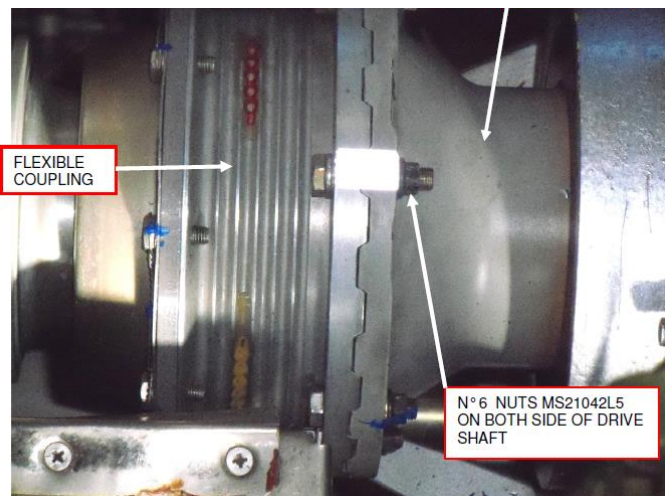
Fig. 1

1. Prepare helicopter for safe ground maintenance; disconnect battery and all the electric power source and/or the external power supply.
2. In accordance with the applicable Maintenance Manual Chapter 63, gain access to the engine-to-transmission drive shaft.
3. Using a source light and a mirror, inspect the nuts P/N MS21042L5 connecting the flexible coupling with the adapter installed on the engine-to-transmission drive shaft (refer to Fig. 1) or inspect the nuts P/N MS21042L4 connecting the flexible coupling with the adapter and nuts P/N MS21042L4 connecting the drive shaft with the flexible coupling (refer to Fig. 2). The configuration depends on the helicopter model and s/n.

4. If no cracks are found, in accordance with the applicable Maintenance Manual Chapter 63, reinstall the access panel and close the access doors previously removed/opened and return the helicopter to a "ready to flight" condition.

1. In accordance with the applicable Maintenance Manual Chapter 63, replace the nuts P/N MS21042L5 with nuts P/N MS21043-5 or the nuts P/N MS21042L4 with nuts MS21043-4, as applicable depending on helicopter configuration (it is recommended to replace the nuts one at a time). Restore witness mark as required.
2. In accordance with the applicable Maintenance Manual Chapter 63, reinstall the access panel and close the access doors previously removed/opened and return the helicopter to a “ready to flight” condition.
