<b>EASA</b>	<b>AIRWORTHINESS DIRECTIVE</b>

<p><b>AD No.: 2015-0102R1</b></p> <p><b>Date: 20 July 2015</b></p> <p>Note: This Airworthiness Directive (AD) is issued by EASA, acting in accordance with Regulation (EC) No 216/2008 on behalf of the European Community, its Member States and of the European third countries that participate in the activities of EASA under Article 66 of that Regulation.</p>	
<p>This AD is issued in accordance with EU 748/2012, Part 21.A.3B. In accordance with EU 1321/2014 Annex I, Part M.A.301, the continuing airworthiness of an aircraft shall be ensured by accomplishing any applicable ADs. Consequently, no person may operate an aircraft to which an AD applies, except in accordance with the requirements of that AD, unless otherwise specified by the Agency [EU 1321/2014 Annex I, Part M.A.303] or agreed with the Authority of the State of Registry [EC 216/2008, Article 14(4) exemption].</p>

<p><b>Design Approval Holder's Name:</b> DASSAULT AVIATION</p>	<p><b>Type/Model designation(s):</b> Falcon 2000EX aeroplanes</p>	
<p>TCDS Numbers : EASA.A.008</p>		
<p>Foreign AD : Not applicable</p>		
<p>Revision: This AD revises EASA Emergency AD 2015-0102-E dated 08 Jun

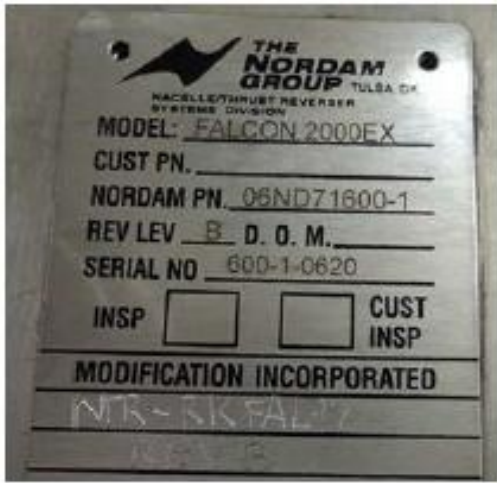
NRK : NTR-RKFAL97

Appendix 2  
Example of air inlet data plate marked with NORDAM Rework Kit (NRK)
