EASA	AIRWORTHINESS DIRECTIVE

<p>AD No.: 2015-0146 [Correction: 24 July 2015]</p> <p>Date: 22 July 2015</p> <p>Note: This Airworthiness Directive (AD) is issued by EASA, acting in accordance with Regulation (EC) No 216/2008 on behalf of the European Community, its Member States and of the European third countries that participate in the activities of EASA under Article 66 of that Regulation.</p>	
<p>This AD is issued in accordance with EU 748/2012, Part 21.A.3B. In accordance with EU 1321/2014 Annex I, Part M.A.301, the continuing airworthiness of an aircraft shall be ensured by accomplishing any applicable ADs. Consequently, no person may operate an aircraft to which an AD applies, except in accordance with the requirements of that AD, unless otherwise specified by the Agency [EU 1321/2014 Annex I, Part M.A.303] or agreed with the Authority of the State of Registry [EC 216/2008, Article 14(4) exemption].</p>

<p>Design Approval Holder's Name: AIRBUS</p>	<p>Type/Model designation(s): A300-600 and A310 aeroplanes</p>	
<p>TCDS Number: EASA.A.172</p>		
<p>Foreign AD: Not applicable</p>		
<p>Supersedure: This AD supersedes EASA Emergency AD 2012-0245-E dated 16 November 2012.</p>		
ATA

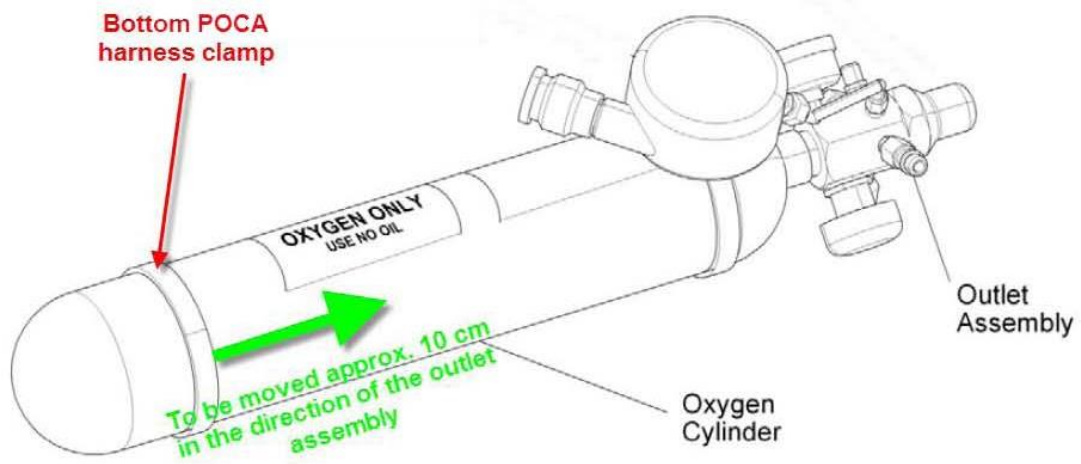
Appendix 1 – POCA Illustration

<p>Since that AD was issued, Airbus issued Service Bulletin (SB) A300-25-6222 and SB A310-25-2210 to improve the POCA installation inside one-frame OHSC.</p> <p>For the reason described above, this AD retains the requirements of EASA AD 2012-0245-E, which is superseded, and requires the installation of a new protection cover as modification of POCA installation inside one-frame OHSC, which constitutes terminating action for the required repetitive DVI.</p> <p>This AD is republished to correct a typographical error in the Reason.</p>
Effective Date:	05 August 2015
Required Action(s) and Compliance Time(s):	<p>Required as indicated, unless accomplished previously:</p> <p>Re-statement of requirements of EASA AD 2012-0245-E:</p> <ol style="list-style-type: none"> (1) For aeroplanes listed in Appendix A of Airbus AOT A25W003-12 at original issue: Within 10 days or 50 flight hours (FH), whichever occurs first after 02 November 2012 [the effective date of EASA AD 2012-0232-E], accomplish a detailed visual inspection (DVI) of the POCA installation(s) inside one-frame OHSC adjacent to L1 and R1 doors and the affected insulation blanket(s) and, depending on findings, accomplish the applicable corrective action(s) before next flight, in accordance with the instructions of Airbus AOT A25W003-12 Revision 1. (2) For aeroplanes not listed in Appendix A of Airbus AOT A25W003-12 at original issue: Within 10 days or 50 FH, whichever occurs first after 20 November 2012 [the effective date of EASA AD 2012-0245-E], accomplish a DVI of the POCA installation(s) inside one-frame OHSC adjacent to L1 and R1 doors and the affected insulation blanket(s) and, depending on findings, accomplish the applicable corrective action(s) before next flight, in accordance with the instructions of Airbus AOT A25W003-12 Revision 1. <p>Note: Appendix 1 of this AD illustrates the affected installation.</p> <ol style="list-style-type: none"> (3) Within 10 days after the inspection as required by paragraph (1) or paragraph (2) of this AD, as applicable, and, thereafter, at intervals not to exceed 10 days, repeat the DVI of the POCA installation(s) inside one-frame OHSC adjacent to L1 and R1 doors in accordance with the instructions of Airbus AOT A25W003-12 Revision 1. (4) If, during any inspection as required by paragraph (3) of this AD, damage is found (e.g. damage of insulation blanket, signs of arcing, wire chafing), before next flight, repair or replace all damaged parts in accordance with the instructions of Airbus AOT A25W003-12 Revision 1. (5) Inspections and corrective actions on an aeroplane, accomplished before 20 November 2012 [the effective date of EASA AD 2012-0245-E] in accordance with the instructions of Airbus AOT A25W003-12 at original issue, are acceptable to comply with the initial requirements of paragraphs (1), (3) and (4) of this AD for that aeroplane. (6) Within 30 calendar days after each inspection as required by paragraphs (1), (2) and (3) of this AD, report the inspection results (only in case findings are made) to Airbus. (7) Accomplishment of corrective actions on an aeroplane, as required by paragraph (4) of this AD, does not constitute terminating action for the repetitive inspections required by paragraph (3) of this AD for that aeroplane. <p>New requirements of this AD:</p> <ol style="list-style-type: none"> (8) Within 24 months after the effective date of this AD, install a protection cover to close the cut-out in OHSC rear panel in accordance with the instructions of Airbus SB A300-25-6222 or SB A310-25-2210, as applicable.

<p>(9) Modification of an aeroplane as required by paragraph (8) of this AD constitutes terminating action for the repetitive inspections required by paragraph (3) of this AD for that aeroplane.</p> <p>(10) After modification of an aeroplane as required by paragraph (8) of this AD, do not install a replacement OHSC on that aeroplane, unless it is verified that the rear panel of the replacement OHSC has been modified in accordance with the instructions of Airbus SB A300-25-6222, or SB A310-25-2210, as applicable.</p>
Ref. Publications:	<p>Airbus AOT A25W003-12 Revision 1 dated 14 November 2012.</p> <p>Airbus SB A300-25-6222 original issue dated 25 February 2015.</p> <p>Airbus SB A310-25-2210 original issue dated 25 February 2015.</p> <p>The use of later approved revisions of these documents is acceptable for compliance with the requirements of this AD.</p>
Remarks:	<ol style="list-style-type: none"> 1. If requested and appropriately substantiated, EASA can approve Alternative Methods of Compliance for this AD. 2. This AD was posted on 11 June 2015 as PAD 15-083 for consultation until 09 July 2015. No comments were received during the consultation period. 3. Enquiries regarding this AD should be referred to the Safety Information Section, Certification Directorate, EASA. E-mail: ADs@easa.europa.eu. 4. For any question concerning the technical content of the requirements in this AD, please contact: AIRBUS – EIAW (Airworthiness Office), E-mail: continued.airworthiness-wb.external@airbus.com.
