## Airworthiness Directive

**AD No.: 2015-0226R6**
**[Correction: 20 December 2021]**
**Issued: 08 December 2021**

**ATA 25 – Equipment / Furnishings – Hoist – Test / Replacement**

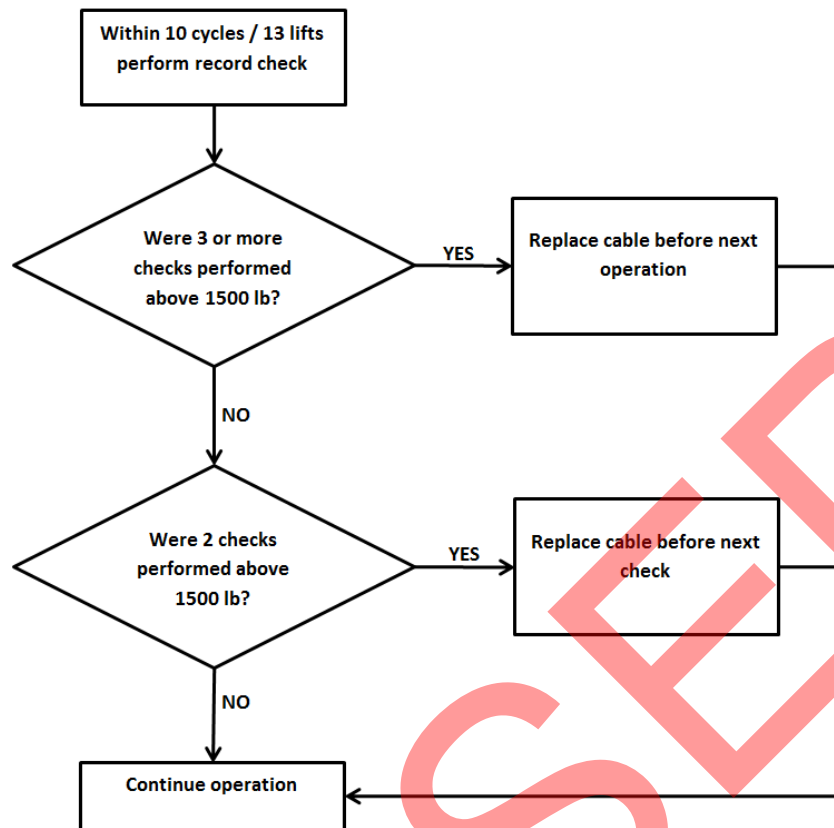
Figure 1

- (1) Within 10 hoist operating cycles or 13 hoist lifts (as applicable, see Note 1 of this AD) after 21 November 2015 [the effective date of the original issue of this AD], determine the P/N of the hoist installed on the helicopter and, if a Goodrich hoist is installed with a P/N listed in Table 1 of this AD, accomplish a records check to determine whether, during any previous hoist load check/test, a cable was load-tested (average of 5 pulls) at 1 500 lb [680 kg] or more. If any cable is identified to have exceeded this limit during three or more hoist load checks/tests, before next hoist operation, replace the affected cable with a serviceable cable. If any cable is identified to have exceeded this limit during two hoist load checks/tests, before the next hoist load check/test, replace the affected cable with a serviceable cable. For replacement of a cable, see figure 1 (flowchart) of this AD.
