Airworthiness Directive

AD No.: 2015-0226R4
Issued: 11 June 2019

AW109SP, AB/AW 139 and AB412

ATA 25 – Equipment / Furnishings – Hoist – Test / Replacement

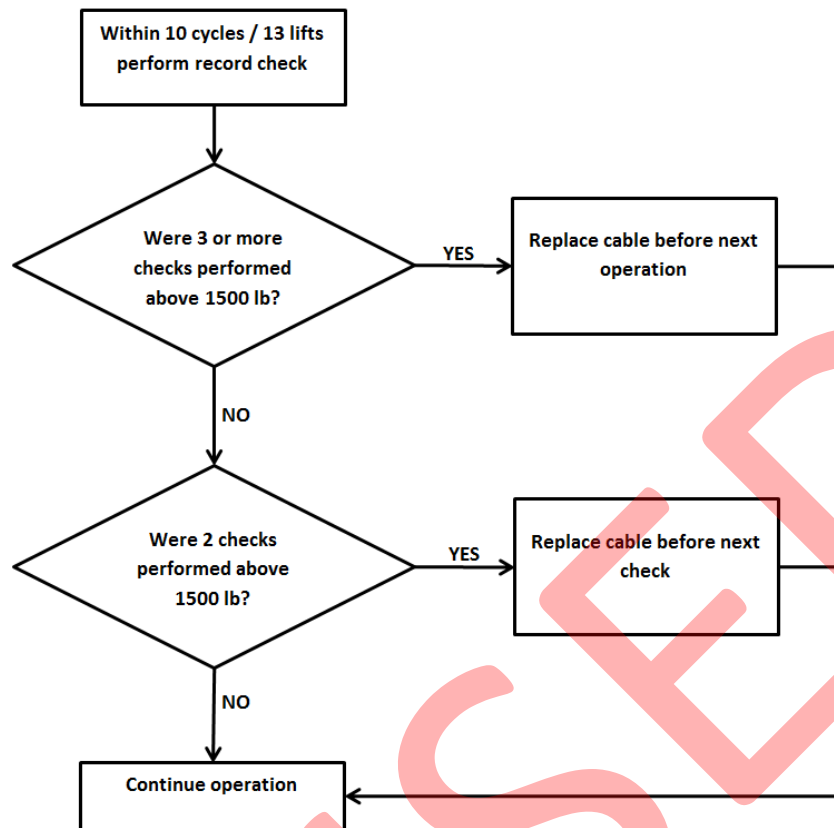
Figure 1

- (1) Within 10 hoist operating cycles or 13 hoist lifts (as applicable, see Note 1 of this AD) after 21 November 2015 [the effective date of the original issue of this AD], determine the P/N of the hoist installed on the helicopter and, if a Goodrich hoist is installed with a P/N listed in Table 1 of this AD, accomplish a records check to determine whether, during any previous hoist load check/test, a cable was load-tested (average of 5 pulls) at 1 500 lb [680 kg] or more. If any cable is identified to have exceeded this limit during three or more hoist load checks/tests, before next hoist operation, replace the affected cable with a serviceable cable. If any cable is identified to have exceeded this limit during two hoist load checks/tests, before the next hoist load check/test, replace the affected cable with a serviceable cable. For replacement of a cable, see figure 1 (flowchart) of this AD.
