Airworthiness Directive

AD No.: 2015-0226R7

AW109SP, AB/AW 139 and AB412

ATA 25 – Equipment / Furnishings – Hoist – Test / Replacement

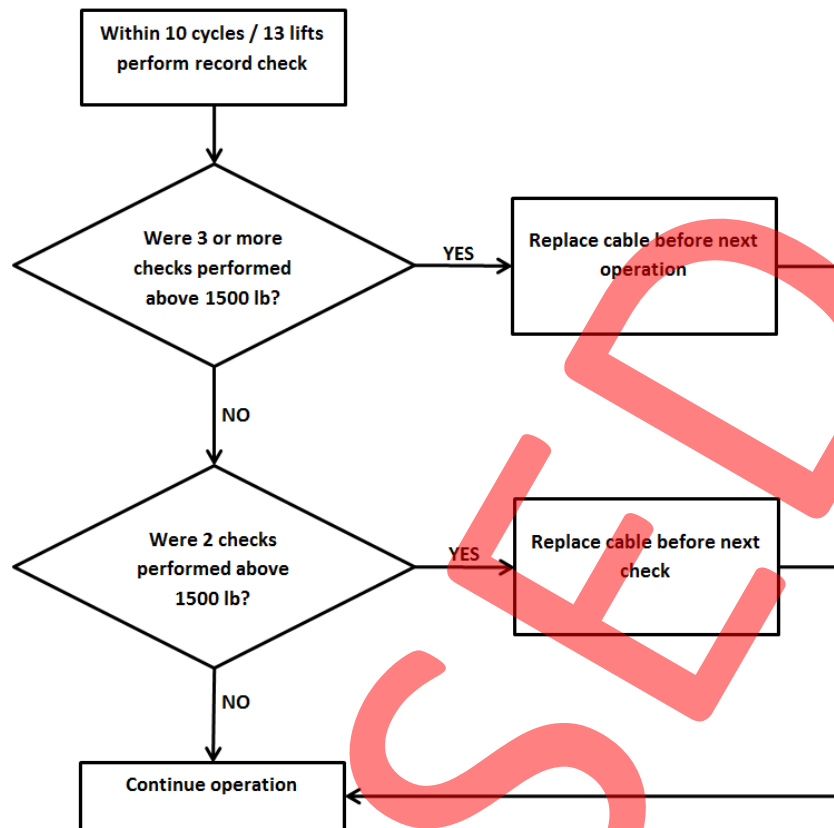
- (1) Within 10 hoist operating cycles or 13 hoist lifts (as applicable, see Note 1 of this AD) after 21 November 2015 [the effective date of the original issue of this AD], determine the P/N of the hoist installed on the helicopter and, if a Goodrich hoist is installed with a P/N listed in Table 1 of this AD, accomplish a records check to determine whether, during any previous hoist load check/test, a cable was load-tested (average of 5 pulls) at 1 500 lb [680 kg] or more. If any cable is identified to have exceeded this limit during three or more hoist load checks/tests, before next hoist operation, replace the affected cable with a serviceable cable. If any cable is identified to have exceeded this limit during two hoist load checks/tests, before the next hoist load check/test, replace the affected cable with a serviceable cable. For replacement of a cable, see Figure 1 (flowchart) of this AD.
