Airworthiness Directive

AD No.: 2016-0144

Rotax 912 and 914 engines

ATA 73 – Engine Fuel and Control – Float – Inspection / Replacement

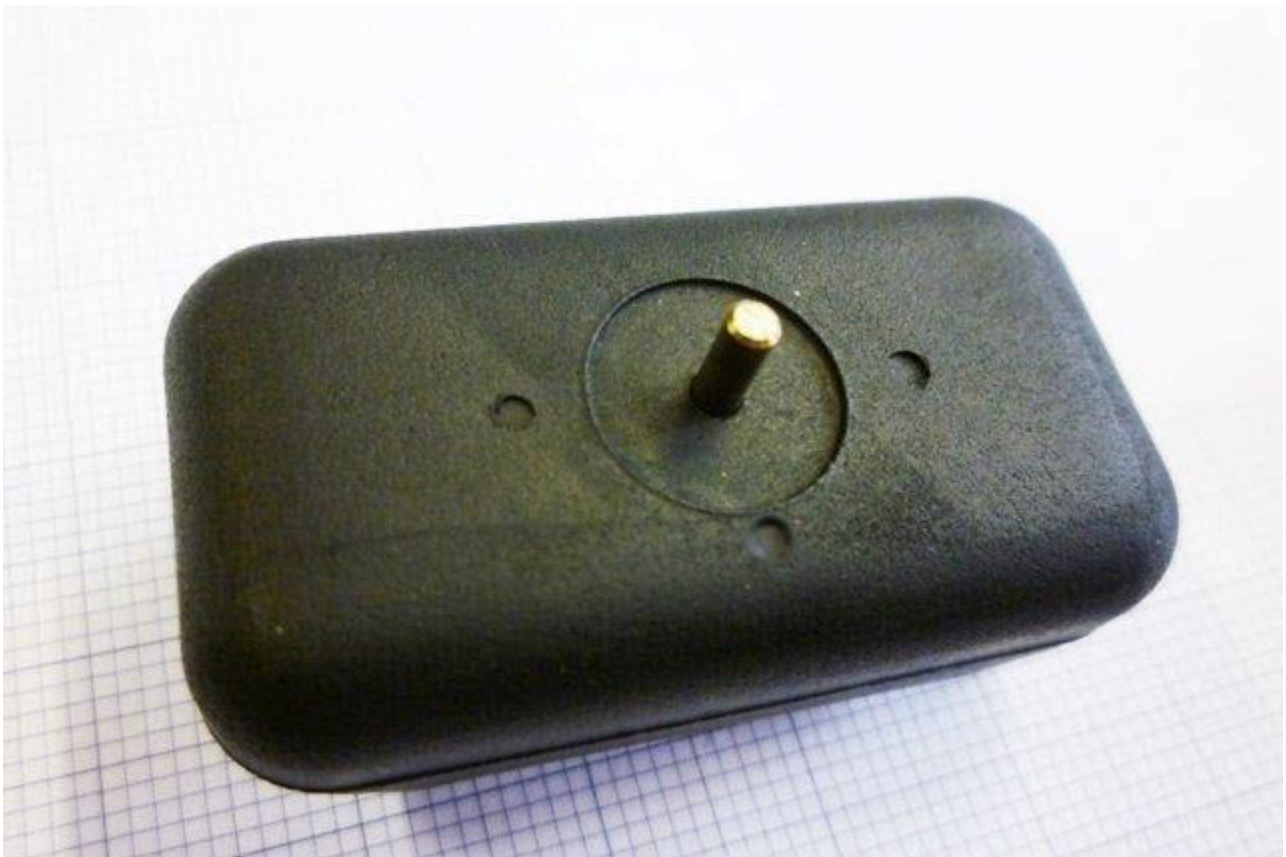
Appendix 3 – Float with 3 dots

Note 2: For the purpose of this AD, an affected float is float having P/N 861185, that has been initially delivered on a date between 09 May 2016 and 17 July 2016 (inclusive), and that does not have 3 dots. Certification documents (e.g., Form 1), delivery document or record of previous installation of the float are acceptable to determine an initial delivery on or before 08 May 2016. An example of a serviceable float having 3 dots is shown in Appendix 3 of this AD.

- (2) For any affected engine, before next flight after the inspection as required by paragraph (1) of this AD, replace any affected float with a serviceable float (see Note 2 and Appendix 3 of this AD) in accordance with the instructions of the ASB.
