## Airworthiness Directive

**AD No.:** 2016-0162

SportStar RTC aeroplanes

### ATA 73 – Engine Fuel and Control – Float – Inspection / Replacement

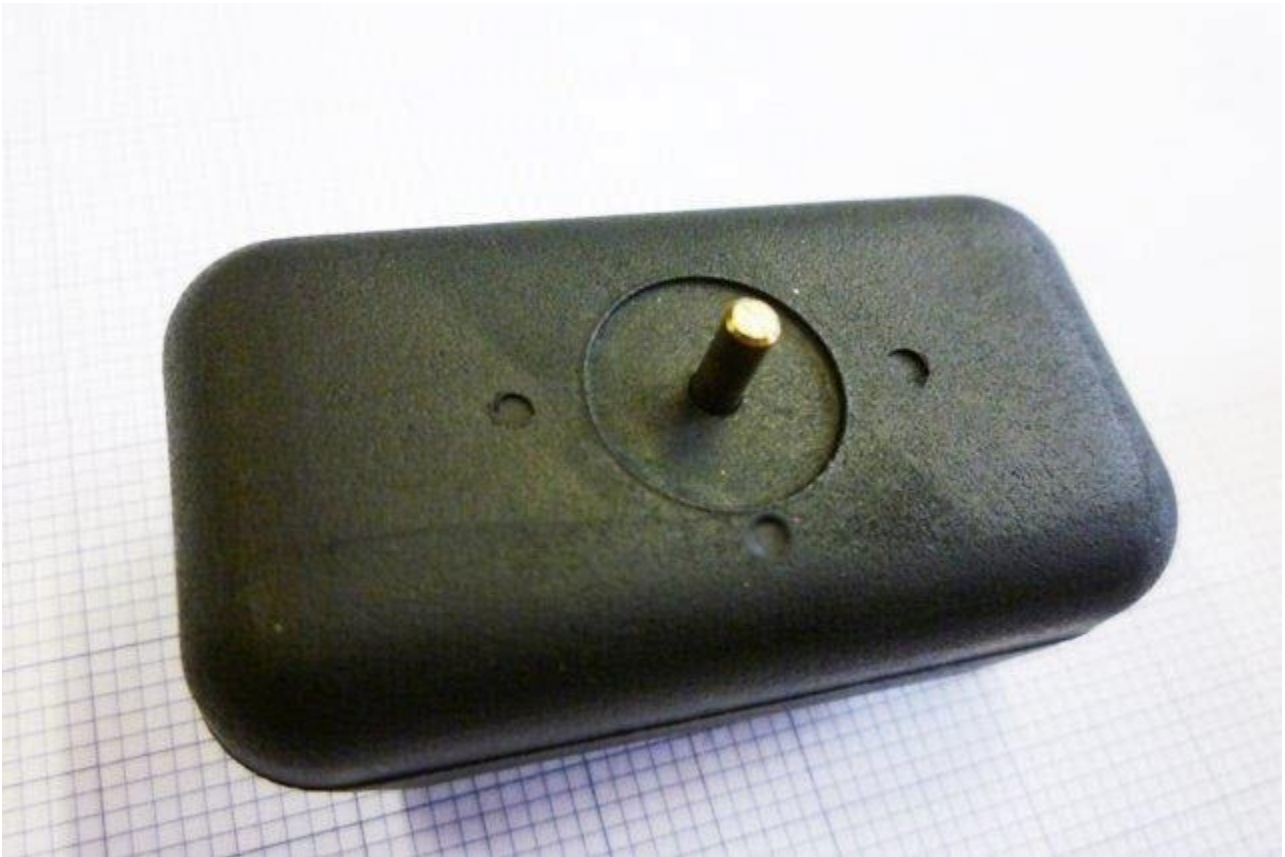
Appendix 2 – Float with 3 dots

Note 2: For the purpose of this AD, an affected float is float having P/N 861185, that has been initially delivered on a date between 09 May 2016 and 17 July 2016 (inclusive), and that does not have 3 dots. Certification documents (e.g., Form 1), delivery document or record of previous installation of the float are acceptable to determine an initial delivery on or before 08 May 2016. An example of a serviceable float having 3 dots is shown in Appendix 2 of this AD.

- (2) For any aeroplane equipped with an affected engine, before next flight after the inspection as required by paragraph (1) of this AD, replace any affected float with a serviceable float (see Note 2 and Appendix 2 of this AD) in accordance with the instructions of Evektor SB RTC-022a.
