Airworthiness Directive

AD No.: 2016-0168

Design Approval Holder's Name: DASSAULT AVIATION
Type/Model designation(s): Falcon 2000EX aeroplanes

ATA 30 – Ice and Rain Protection – Air Inlet Anti-Ice System – Inspection / Repair

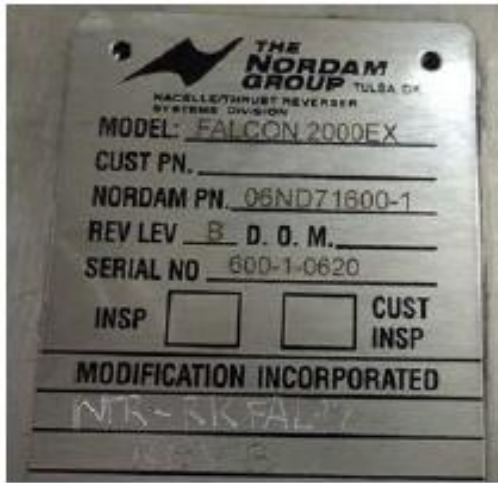
NRK : NTR-RKFAL97

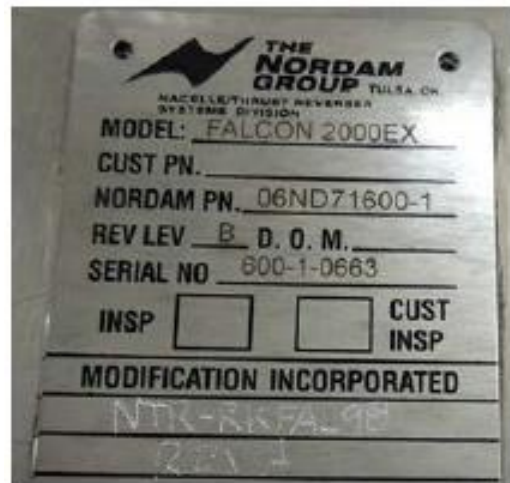
NRK : NTR-RKFAL98
