Emergency Airworthiness Directive

AD No.: 2017-0126-E

ATA 55 – Stabilizers – Horizontal Stabilizer Rear Spar – Inspection

TASK 55-10-00-003**Inspection of the Horizontal Stabilizer Rear Spar Web in the Area of the Cut-Outs Between Ribs 0-1 and 1-2**1. Inspection Purpose

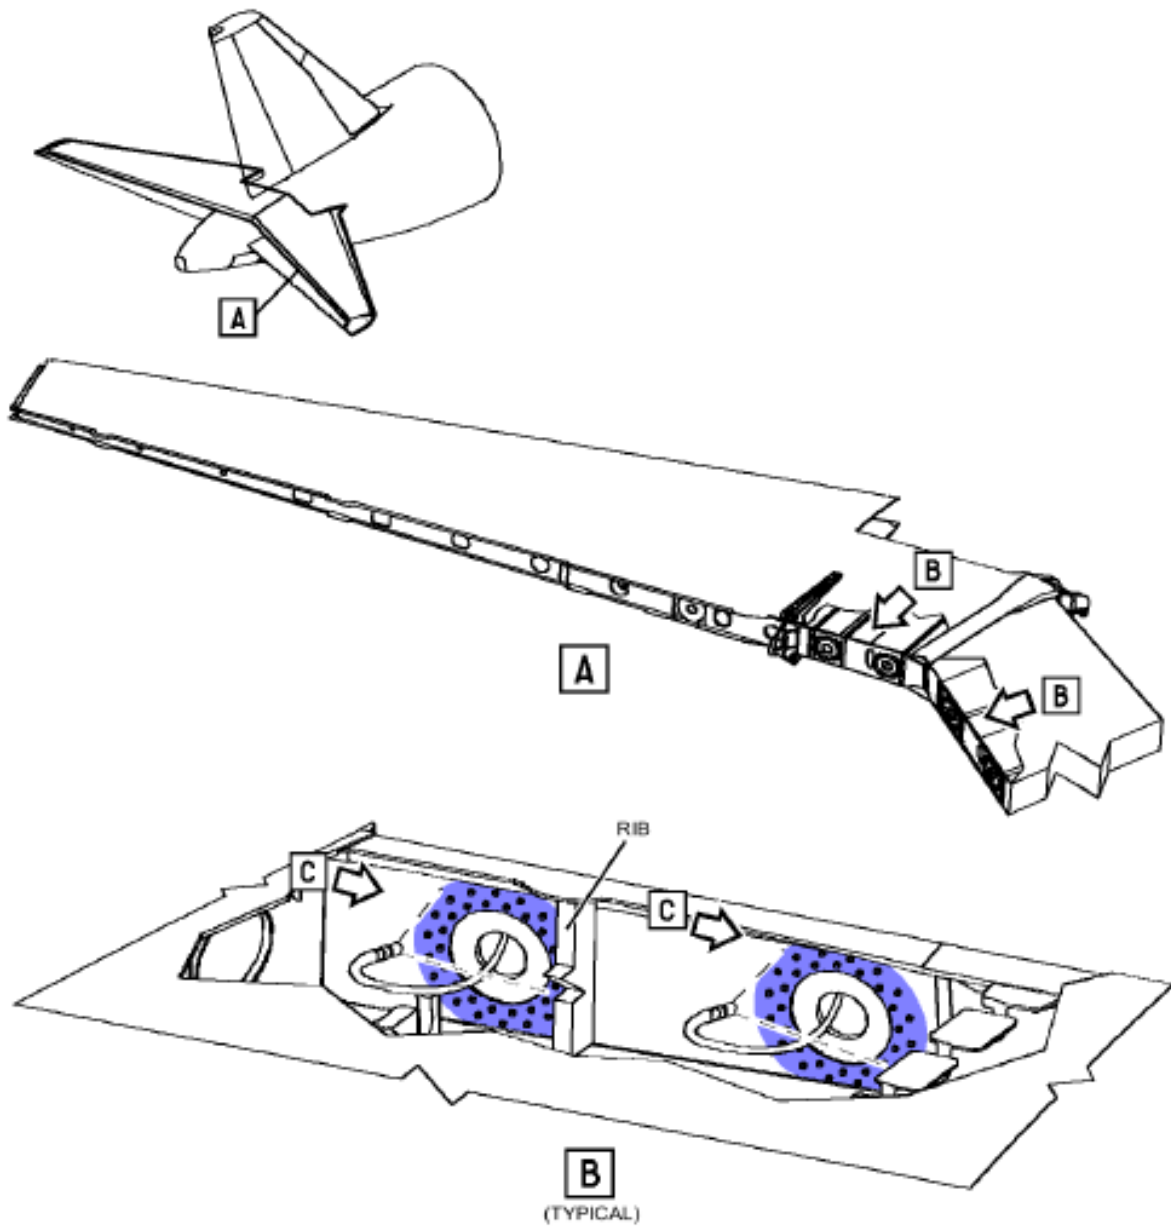
Inspection of the Horizontal Stabilizer Rear Spar Web in the Area of the Cut-Outs Between Ribs 0-1 and 1-2
Figure 401 (Sheet 1 of 2)

Cracks were found on aeroplanes in service in the rear spar of the horizontal stabilizer between ribs 0, 1 and 2.

This condition, if not detected and corrected, could affect the structural integrity of the horizontal stabilizer.

- (1) Before exceeding 1 300 flight cycles (FC) since aeroplane first flight, or within 7 calendar days after the effective date of this AD, whichever occurs later, and, thereafter, at intervals not to exceed 300 FC, accomplish a borescope inspection of the horizontal stabilizer rear spar web cut-out between ribs 0-1 and 1-2 in accordance with the instructions of Sukhoi Civil Aircraft NDT Task 55-10-00-003, as specified in Appendix 1 of this AD.

- (2) If, during any inspection as required by paragraph (1) of this AD, any crack, fastener failure, or corrosion is detected, before next flight, contact Sukhoi Civil Aircraft for approved repair instructions for the affected area and accomplish those instructions accordingly.

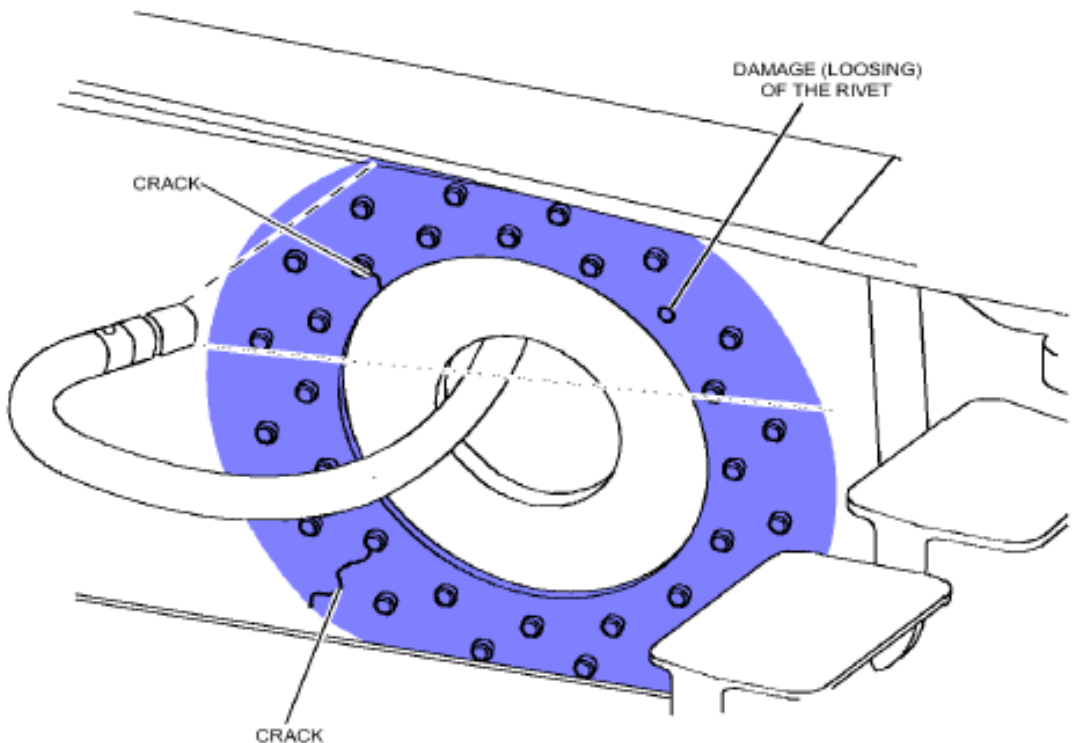
Inspection of the Horizontal Stabilizer Rear Spar Web in the Area of the Cut-Outs Between Ribs 0-1 and 1-2
Figure 401 (Sheet 2 of 2)

AREA TO BE INSPECTED
