Emergency Airworthiness Directive

AD No.: 2017-0126-E

RRJ-95B aeroplanes

ATA 55 – Stabilizers – Horizontal Stabilizer Rear Spar – Inspection

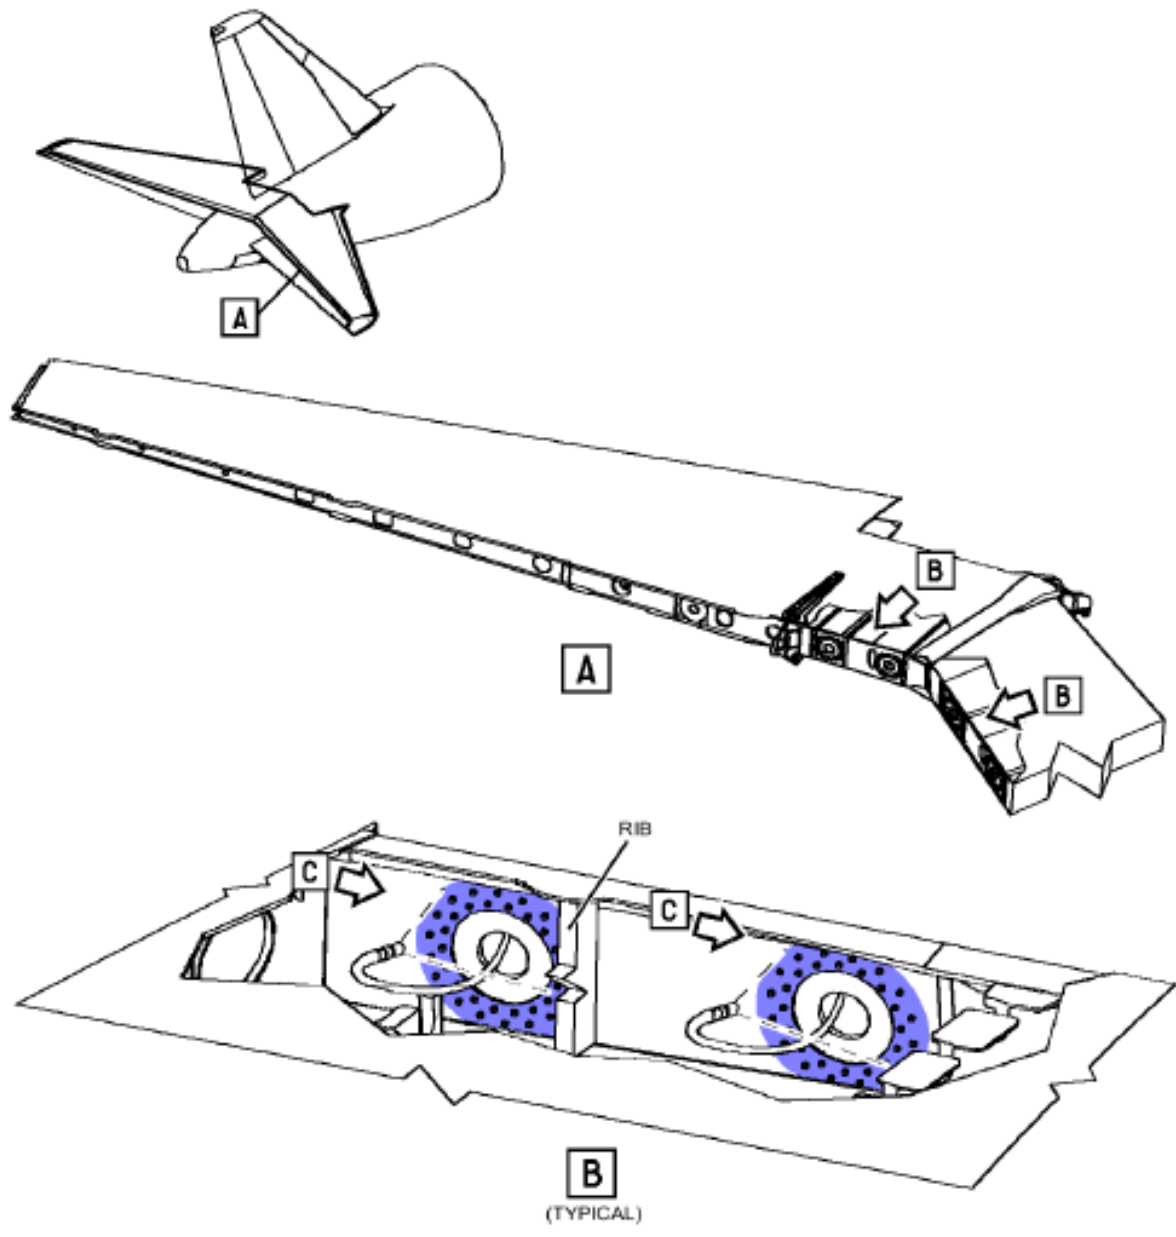
Inspection of the Horizontal Stabilizer Rear Spar Web in the Area of the Cut-Outs Between Ribs 0-1 and 1-2
Figure 401 (Sheet 1 of 2)

- A. Connect the objective lens to the video endoscope.
- B. Bring the distal end of the video endoscope inside the horizontal stabilizer caisson part through the cut-outs between ribs 0-1 and 1-2 and do the inspection (Ref. *Fig. 401, Sheet 1, Fig. 401, Sheet 2*).
- C. In case of flaw detection:
 - (1) Do the measurement of their length using the stereoscopic objective lens in accordance with the video endoscope Operating Manual.
 - (2) Record the image of location of flaws in the inspection area with the help of the video endoscope in the "photo" or "video" mode.
