Airworthiness Directive

AD No.: 2018-0226

A330 and A340 aeroplanes

ATA 55 – Stabilizers - Horizontal Stabilizer Centre Box Top Skin – Inspection / Repair

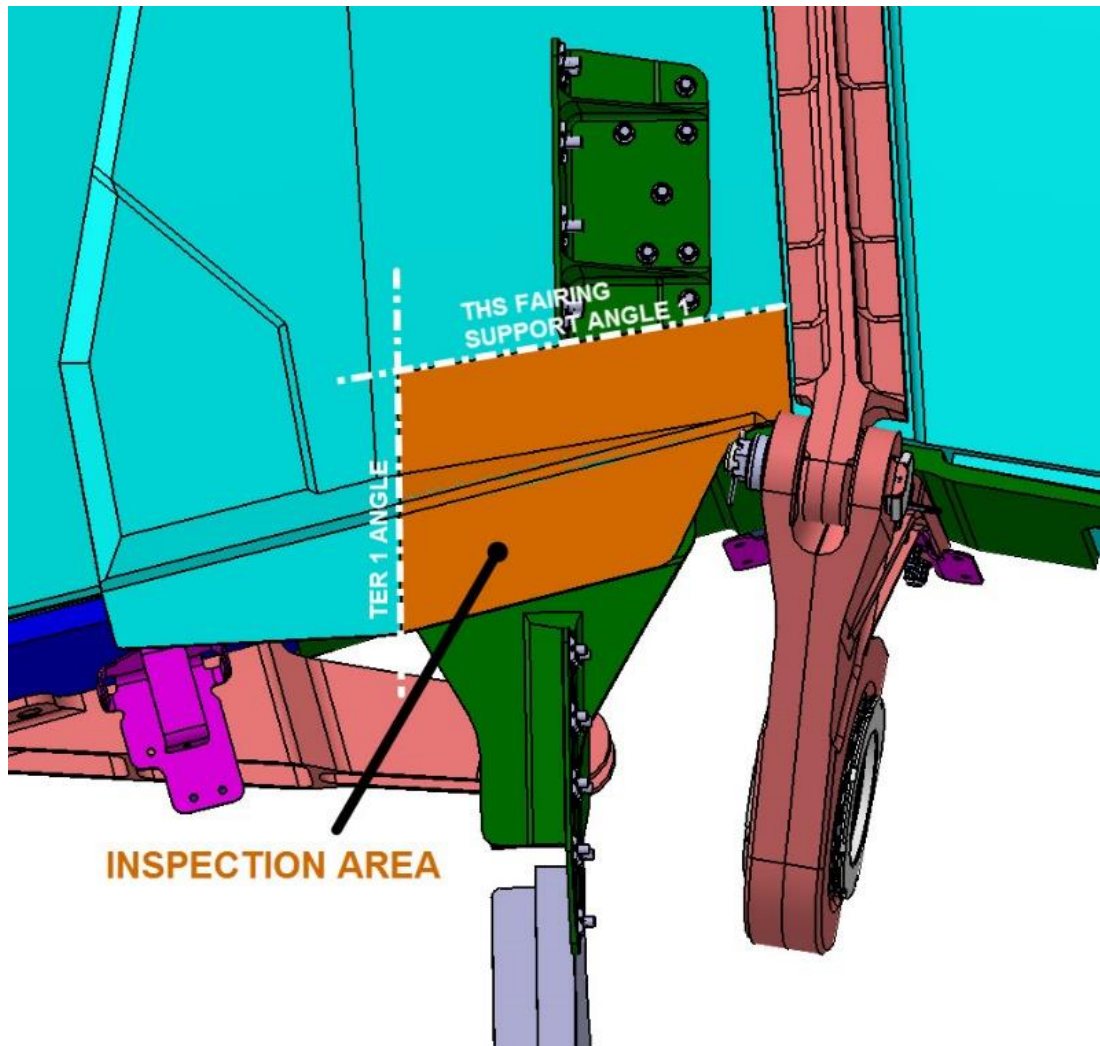
Appendix 1– Affected area to be inspected

Cracks were found in the horizontal stabilizer (HS) centre box (CB) top skin of an A330 aeroplane in pre-mod 41330 configuration. The cracks were initiated at the upper flange corner at Rib 3 rear spar area on left hand side of the CB.

This condition, if not detected and corrected, could lead to reduced structural integrity of the HS CB of the aeroplane.

- (3) For Group 2 aeroplanes: Before exceeding the threshold as defined in Table 1 of this AD, as applicable, or within 6 months after the effective date of this AD, whichever occurs later, and, thereafter, at intervals not to exceed the value as defined in Table 1 of this AD, as applicable, accomplish an SDI of the HS CB top skin integral flange area in accordance with the instructions of the applicable SB.

- (4) If, during any inspection as required by paragraphs (1), (2) or (3) of this AD, as applicable, any crack is found, before next flight, contact Airbus for approved repair instructions and, within the compliance time specified in those instructions, accomplish those instructions accordingly.
