Notification of a Proposal to issue an Airworthiness Directive

PAD No.: 18-132

A330 and A340 aeroplanes

ATA 55 – Stabilizers - Horizontal Stabilizer Centre Box Top Skin – Inspection / Repair

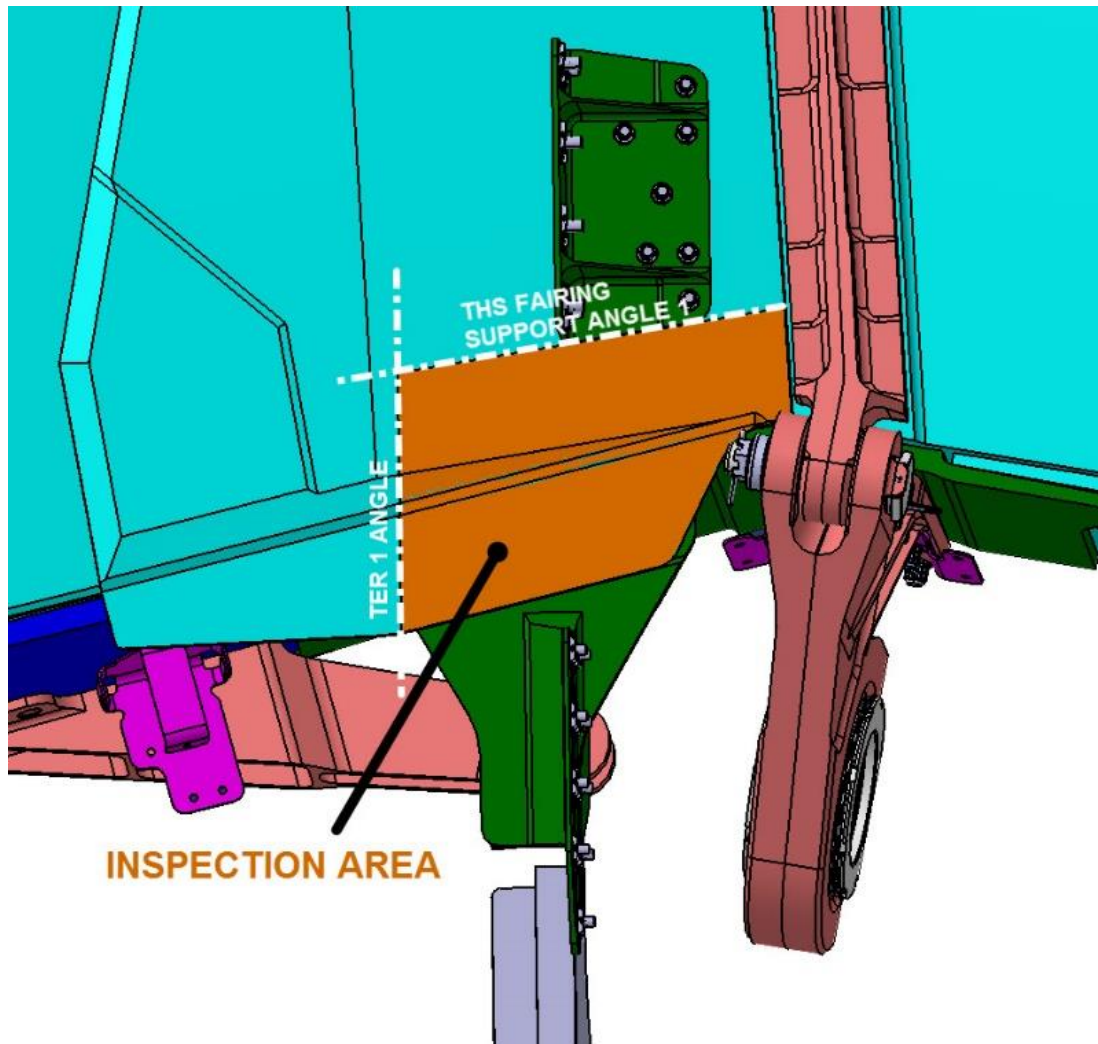
Appendix 1– Affected area to be inspected

Cracks were found in the horizontal stabilizer (HS) centre box (CB) top skin of an A330 aeroplane in pre-mod 41330 configuration. The cracks were initiated at the upper flange corner at Rib 3 rear spar area on left hand side of the CB.

To address this unsafe condition, Airbus published SB A330-55-3046 to provide inspection instructions for the affected area (see Appendix 1 of this AD), only applicable to some pre-mod 41330 A330 MSN. Consequently, EASA issued AD 2017-0078 to require a one-time special detailed inspection (SDI) of the HS CB top skin integral flange area and, depending on findings, accomplishment of applicable corrective action(s).

- (1) For Group 1 aeroplanes: Within 6 months after 17 May 2017 [the effective date of EASA AD 2017-0078], accomplish an SDI of the HS CB top skin integral flange area in accordance with the instructions of Airbus SB A330-55-3046.

- (3) For Group 2 aeroplanes: Before exceeding the threshold as defined in Table 1 of this AD, as applicable, or within 6 months after the effective date of this AD, whichever occurs later, and, thereafter, at intervals not to exceed the value as defined in Table 1 of this AD, as applicable, accomplish an SDI of the HS CB top skin integral flange area in accordance with the instructions of the applicable SB.

- (4) If, during any inspection as required by paragraphs (1), (2) or (3) of this AD, as applicable, any crack is found, before next flight, contact Airbus for approved repair instructions and, within the compliance time specified in those instructions, accomplish those instructions accordingly.
