Airworthiness Directive

AD No.: 2020-0097R1

ATR 42 and ATR 72 aeroplanes

ATA 53 – Fuselage – Passenger Seat Tracks – Inspection / Repair / Replacement

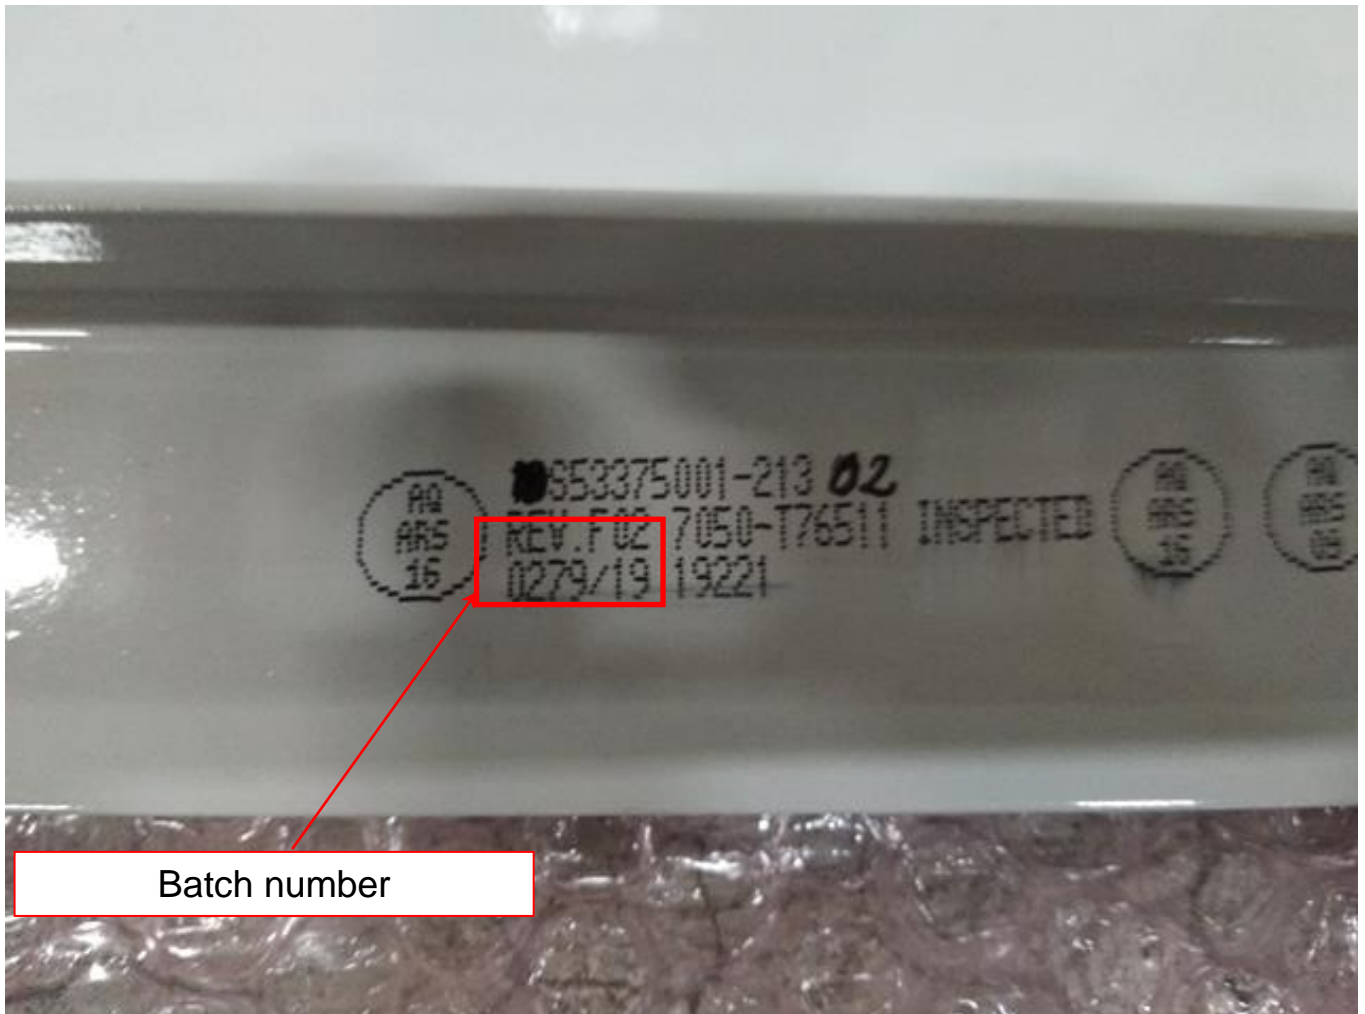
APPENDIX 1 – Seat Track Manufacturing Batch Number

The batch number is located on the lower face of the seat track.

The batch number of the represented seat track above is 0279/19.

/19 represents the production year of the seat track.

All the seat tracks with a batch number having /12 up to /17, or with a batch number not visible/legible, have to be considered as potential affected parts.
