## Airworthiness Directive

**AD No.:** 2020-0097R1

ATR 42 and ATR 72 aeroplanes

### ATA 53 – Fuselage – Passenger Seat Tracks – Inspection / Repair / Replacement

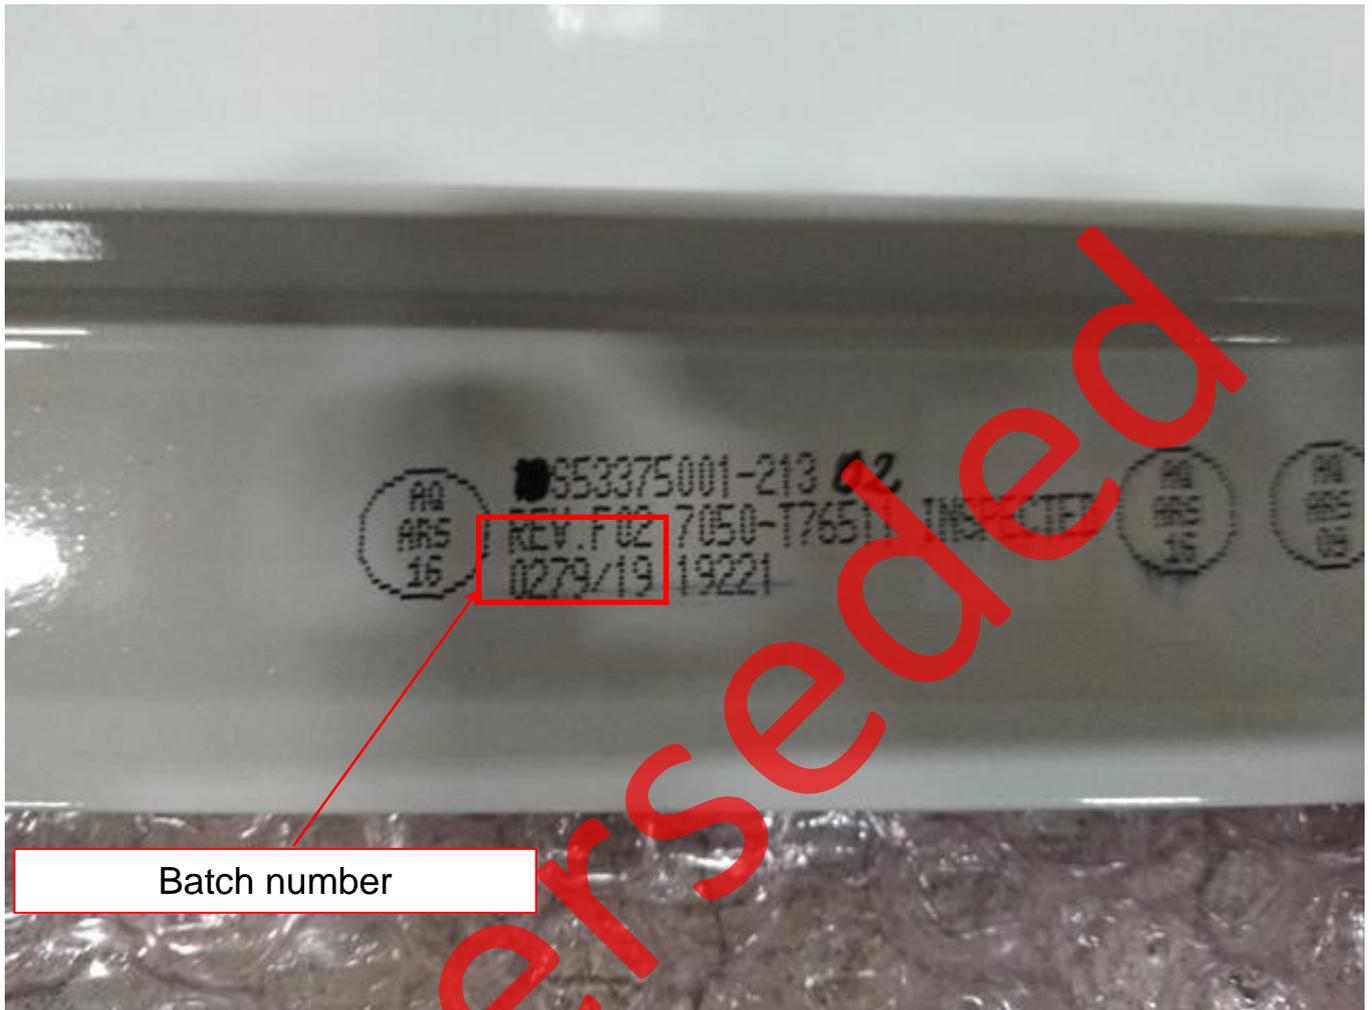
## APPENDIX 1 – Seat Track Manufacturing Batch Number

The batch number is located on the lower face of the seat track.

The batch number of the represented seat track above is 0279/19.

/19 represents the production year of the seat track.

All the seat tracks with a batch number having /12 up to /17, or with a batch number not visible/legible, have to be considered as potential affected parts.
