Airworthiness Directive

AD No.: 2022-0031

A350 aeroplanes

ATA 36 – Pneumatic – Overheat Detection System Sensing Elements – Inspection – Master Minimum Equipment List – Temporary Operational Restrictions

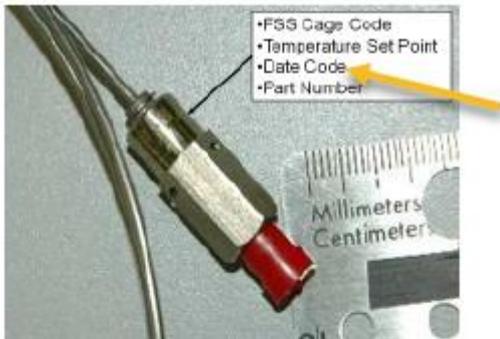
Figure 4-50. Identification Markings on Coaxial SE Male (Pin) Connector

Appendix 1 – Affected Part – Locations of P/N and date code
