Airworthiness Directive

AD No.: 2022-0168R3

EC135, EC635 and MBB-BK117 helicopters

ATA 42 – Integrated Modular Avionics – Ethernet Network – Inspection

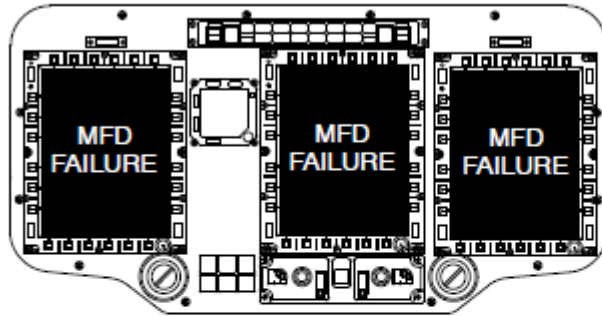
- MFDs:

- MFD FAILURE displayed on all MFDs
- If autopilot upper modes were coupled, they may decouple after 10 seconds (indicated by an „autopilot decouple“ voice message).

1. Aircraft trajectory - Maintain using IESI and stand-by compass.
- Use AFCS “recovery” or “go-around” modes, if desired
- Operate aircraft within the approved performance
2. MFD2 pb - OFF

3. MFD2 pb - ON

4. MFD2 - Maintain in FND format
5. LAND AS SOON AS PRACTICABLE
