Airworthiness Directive

AD No.: 2022-0168

EC135, EC635 and MBB-BK117 helicopters
 EC 175 B and H160-B helicopters

ATA 42 – Integrated Modular Avionics – Ethernet Network – Inspection

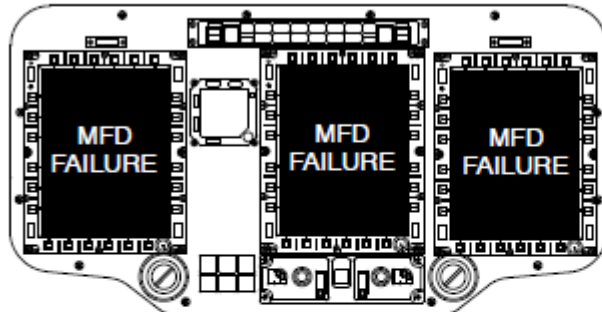
- MFDs:

- MFD FAILURE displayed on all MFDs
- If autopilot upper modes were coupled, they may decouple after 10 seconds (indicated by an „autopilot decouple“ voice message).

1. Double engine emergency shutdown

- Perform

- Maintain using IESI and stand-by compass.
- Use AFCS “recovery” or “go-around” modes, if desired
- Operate aircraft within the approved performance

2. MFD2 pb

- OFF

- ON

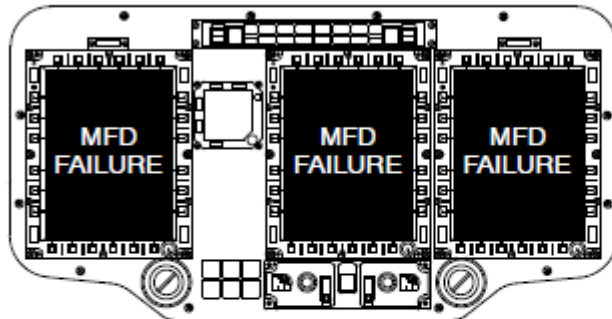
- MFDs:

- MFD FAILURE displayed on all MFDs
- If autopilot upper modes were coupled, they may decouple after 10 seconds (indicated by an „autopilot decouple“ voice message).

1. Double engine emergency shutdown

- Perform

- Maintain using IESI and stand-by compass.
- Use AFCS "recovery" or "go-around" modes, if desired
- Operate aircraft within the approved performance
- OFF

2. MFD2 pb

- ON
