Airworthiness Directive

AD No.: 2024-0096

ATR 42 and ATR 72 aeroplanes

ATA 27 – Flight Controls – Rudder Travel Limiting Unit – Inspection

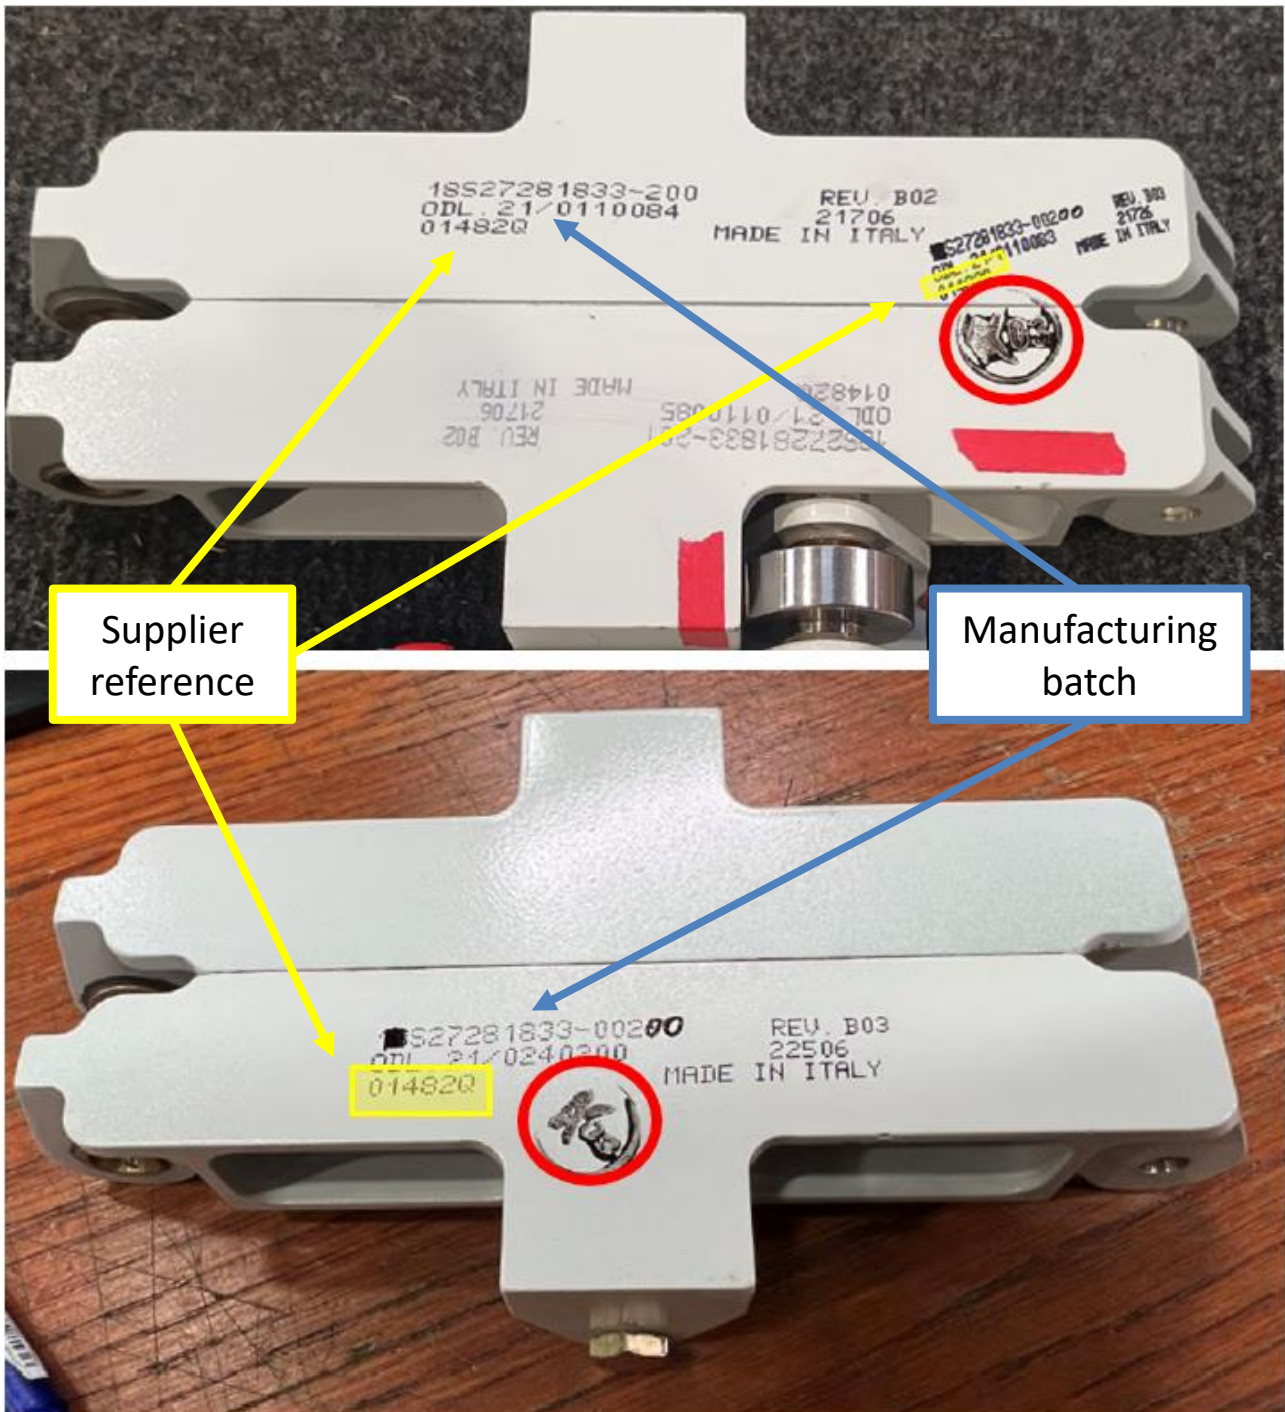
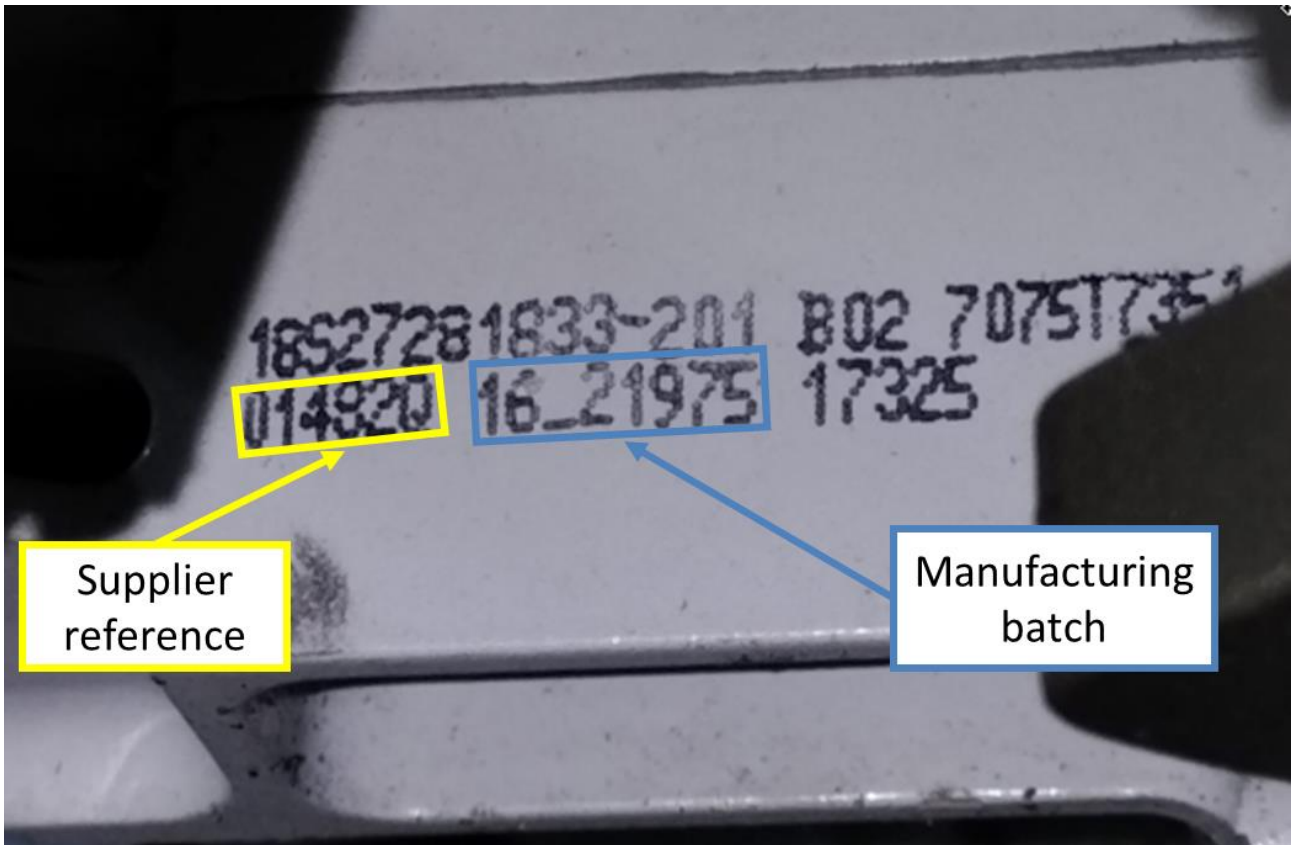
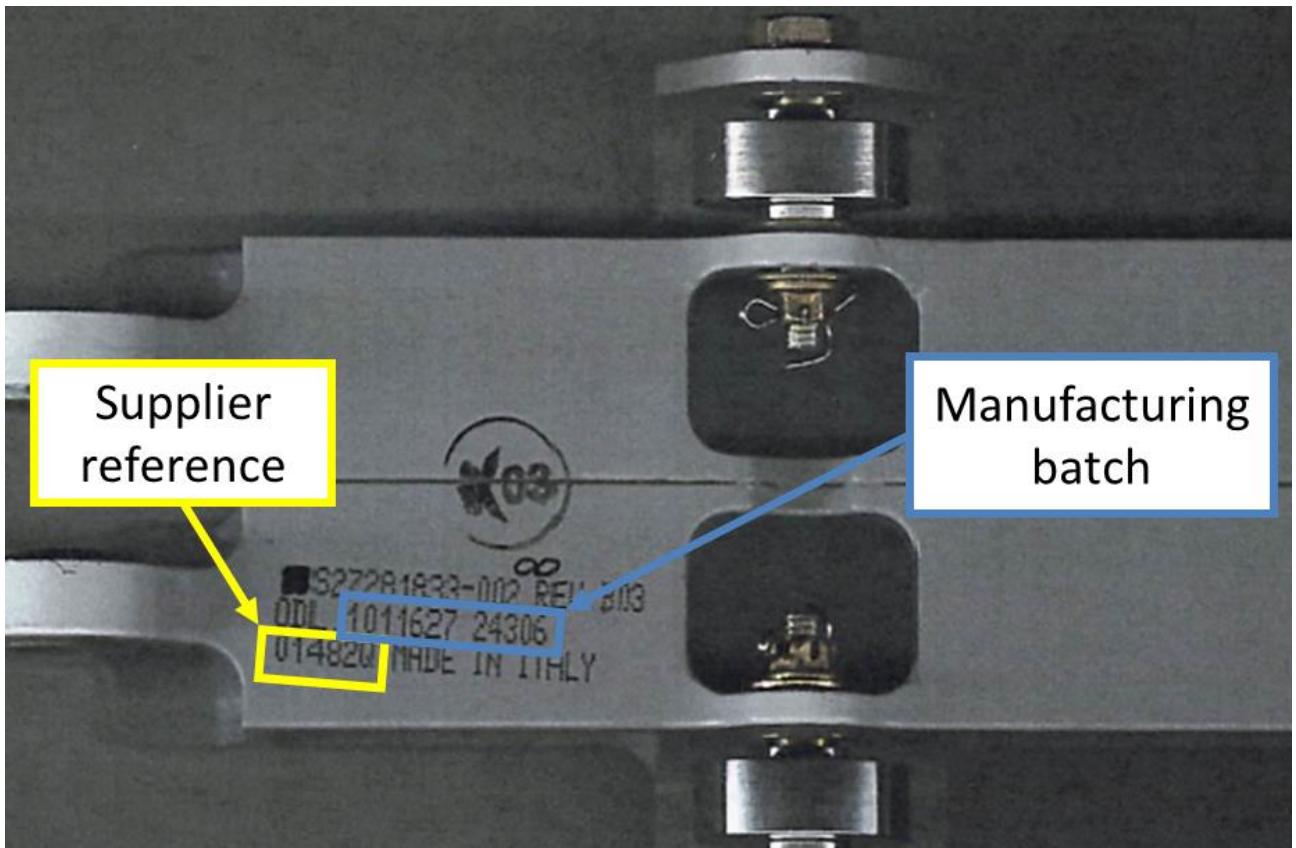
Appendix 1 - TLU Supplier Code and Manufacturing Batch Identification

Note 1: The supplier code and the manufacturing batch of the TLU lever can be identified directly on the part; an example is provided in Appendix 1 of this AD.
