Airworthiness Directive

AD No.: 2024-0096

ATR 42 and ATR 72 aeroplanes

ATA 27 – Flight Controls – Rudder Travel Limiting Unit – Inspection
Manufacturer(s):

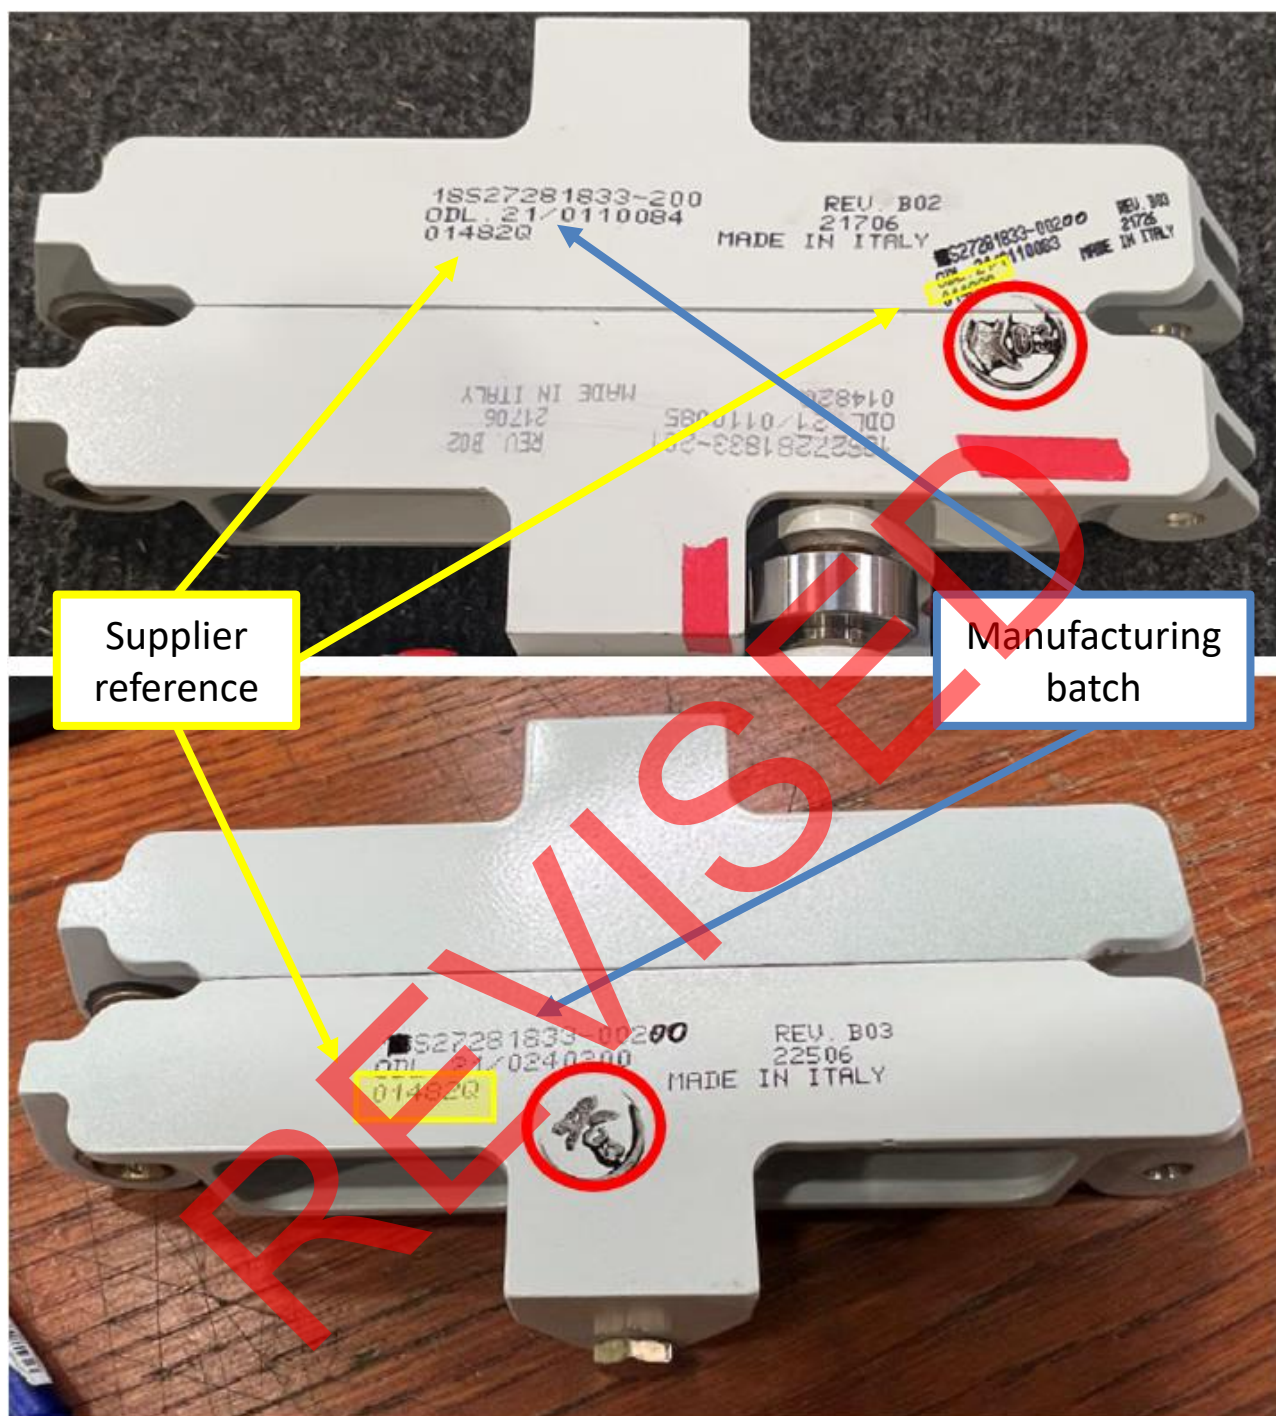
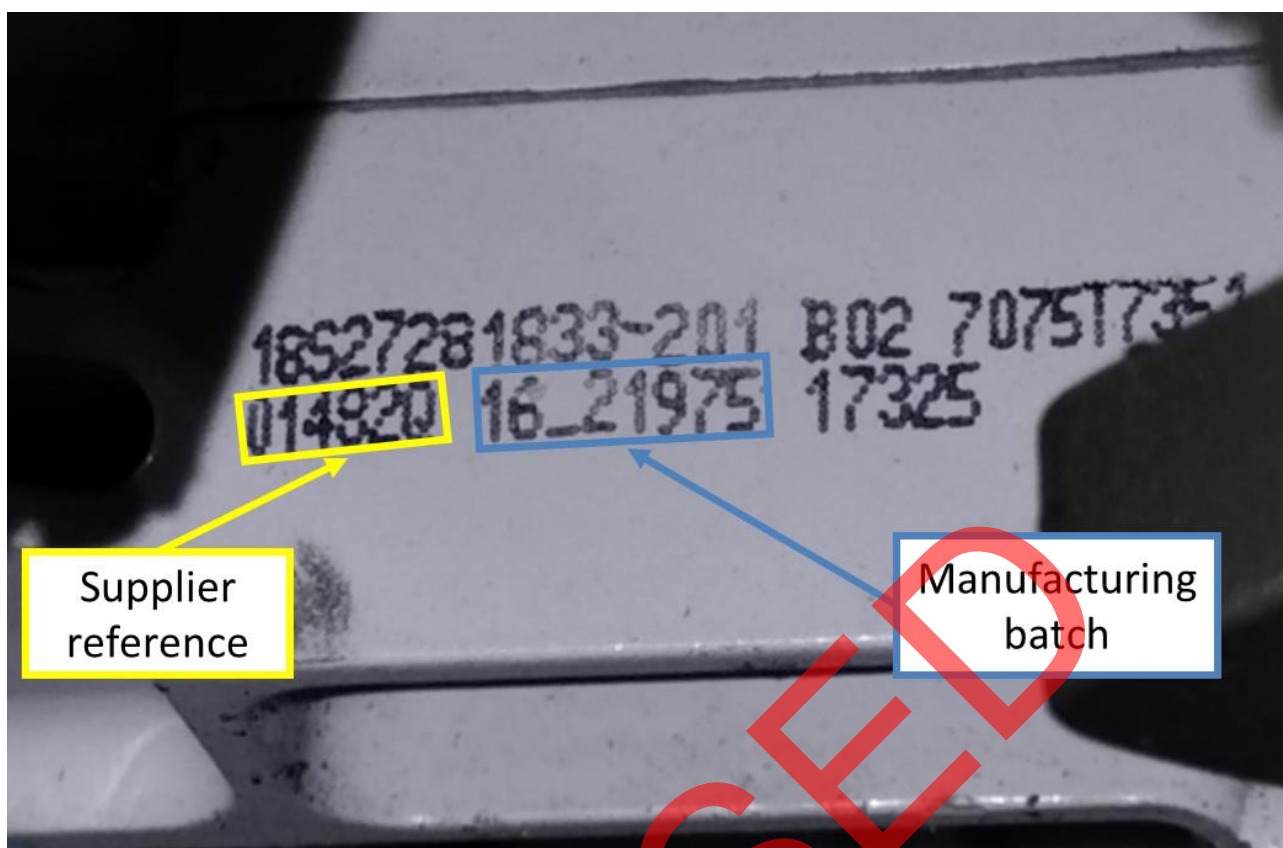
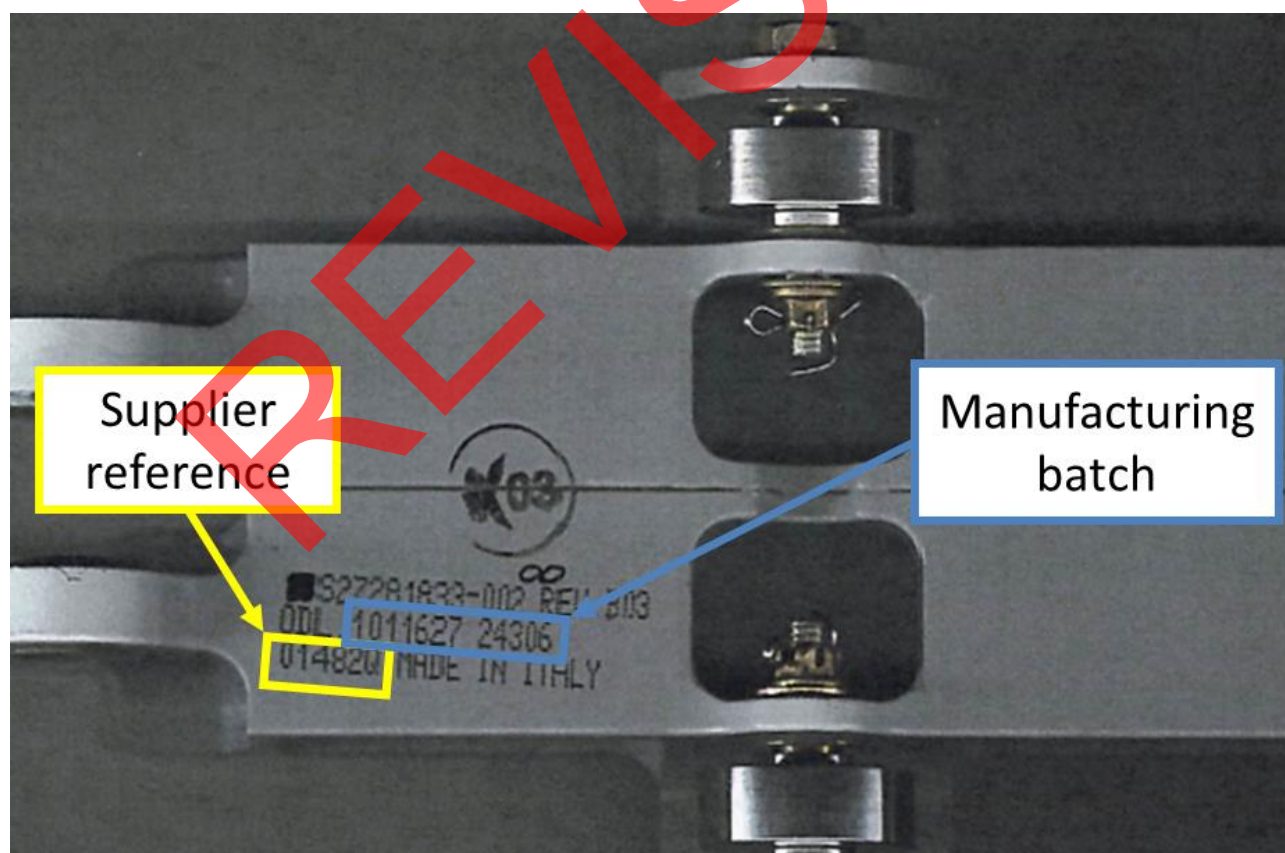
Appendix 1 - TLU Supplier Code and Manufacturing Batch Identification

Note 1: The supplier code and the manufacturing batch of the TLU lever can be identified directly on the part; an example is provided in Appendix 1 of this AD.
