Airworthiness Directive

AD No.: 2024-0096R1

ATR 42 and ATR 72 aeroplanes

ATA 27 – Flight Controls – Rudder Travel Limiting Unit – Inspection

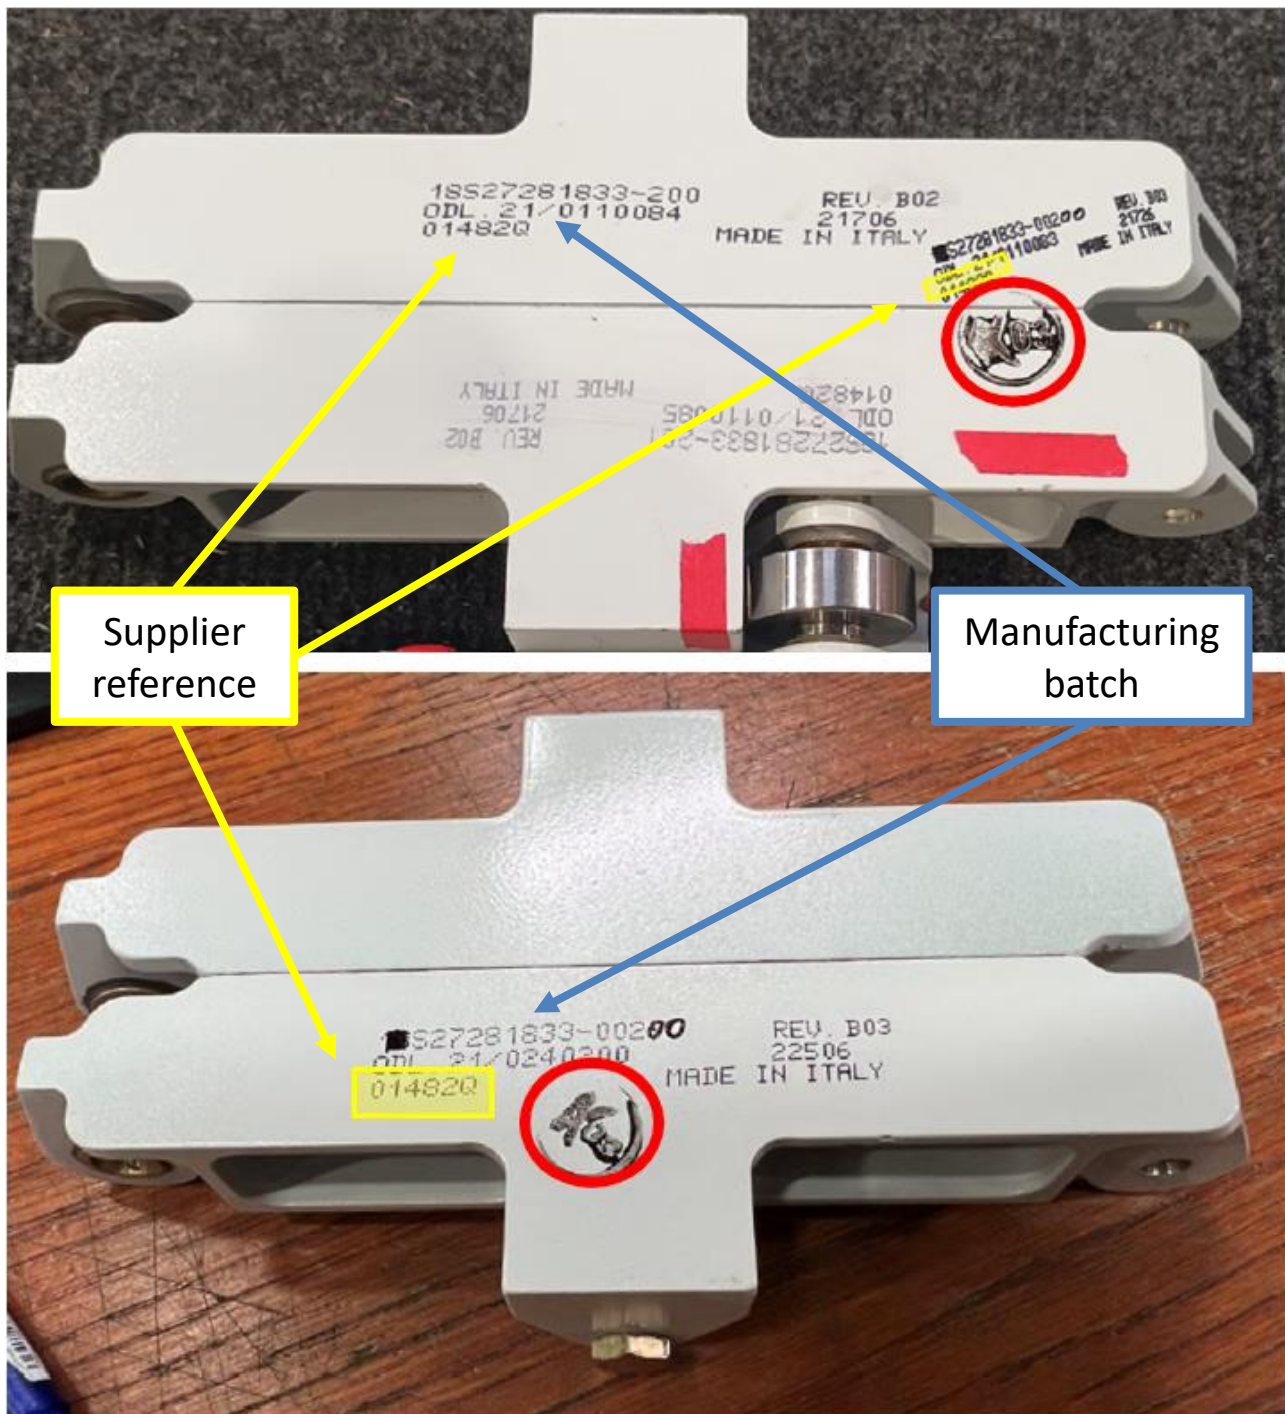
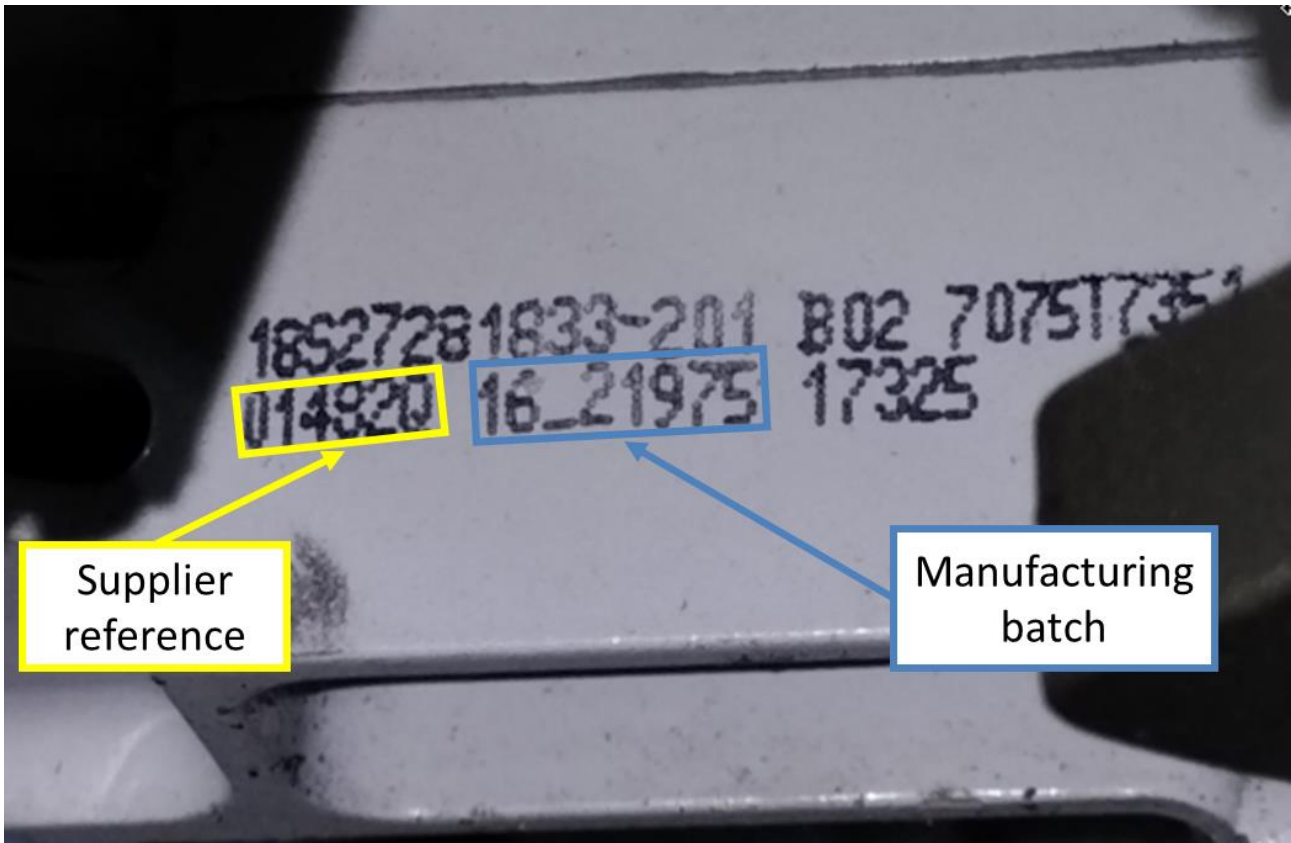
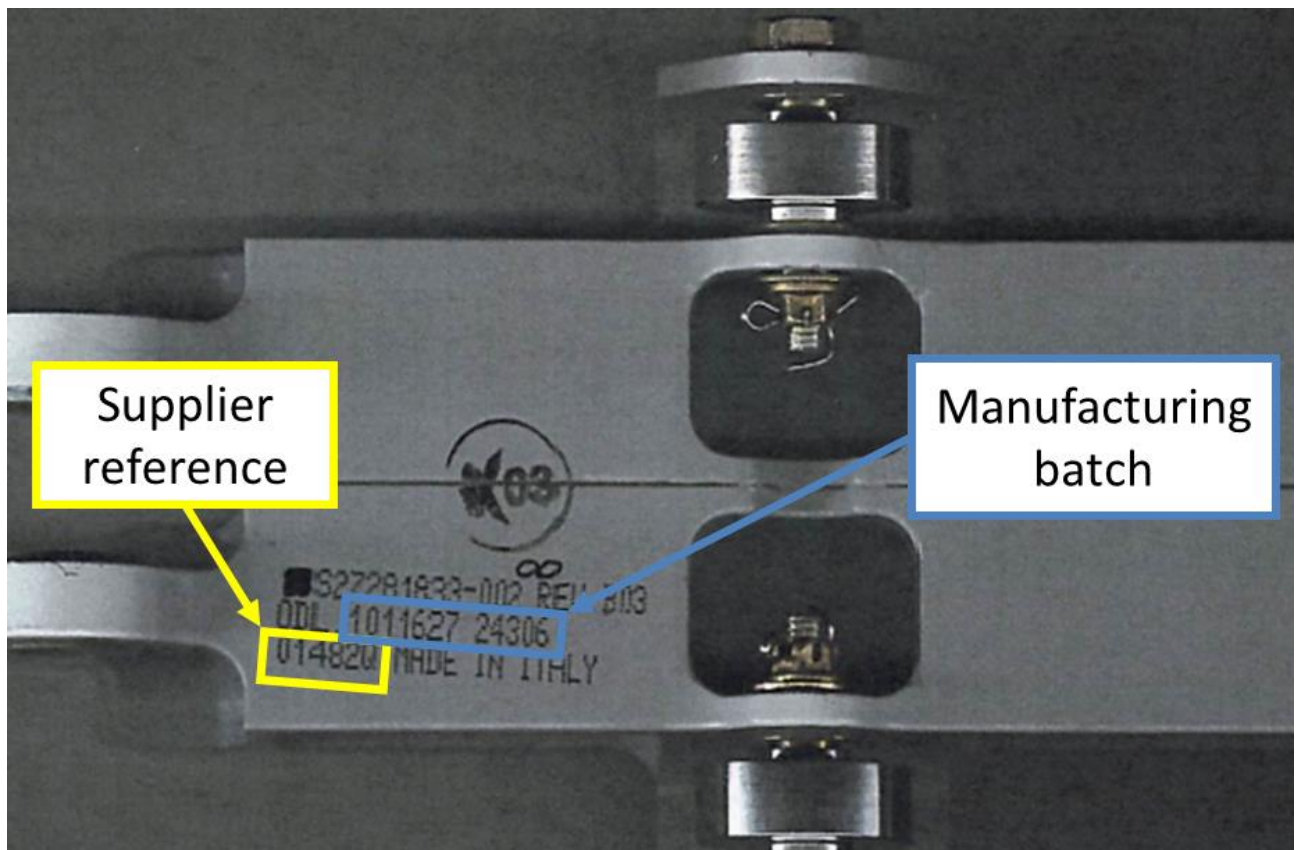
Appendix 1 - TLU Supplier Code and Manufacturing Batch Identification

Note 1: The supplier code and the manufacturing batch of the TLU lever can be identified directly on the part; an example is provided in Appendix 1 of this AD.
