Airworthiness Directive

AD No.: 2024-0119

A330 aeroplanes

ATA 26 – Fire Protection – Engine Pylon Fire Detector – Replacement

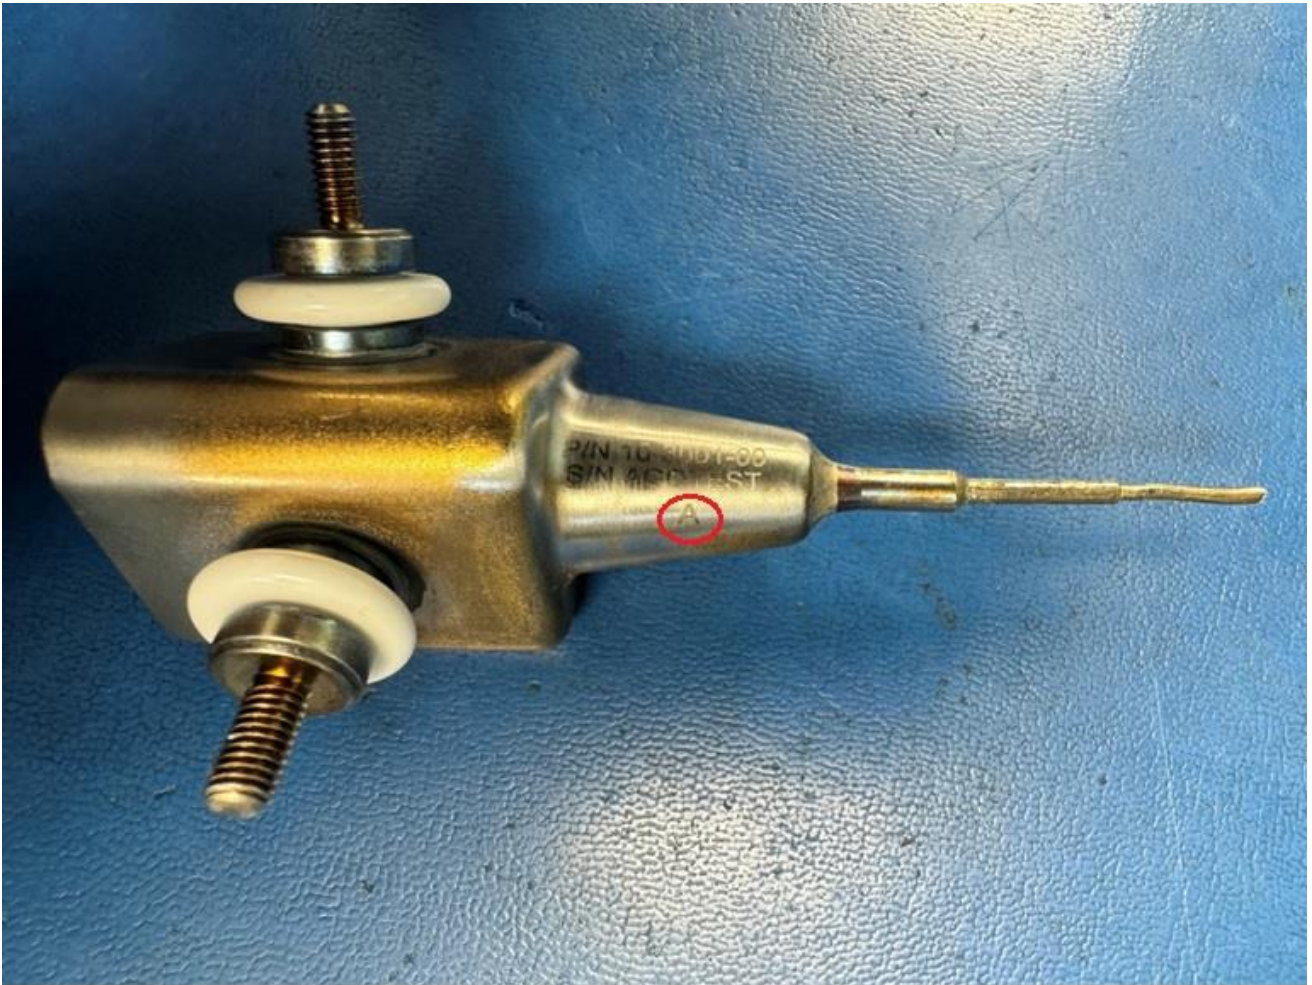
Marking of Parts

Affected part: Engine pylon fire detector having Part Number (P/N) 10-3001-00 or P/N 10-3002-00, and a serial number (s/n) listed in Appendix A of the SB, except those marked with an additional 'A' engraved in the direct vicinity of the s/n (see Note 1 of this AD).

Note 1: The engraved 'A' is in addition to the 'A' part of the s/n of an affected part (i.e. AExxxxx). Refer to Appendix 1 of this AD, showing the typical location of the engraved 'A'.
