Emergency Airworthiness Directive

AD No.: 2024-0179-E

ELIXIR AIRCRAFT

ATA 71 – Power Plant – Engine Mount Bolts – Replacement

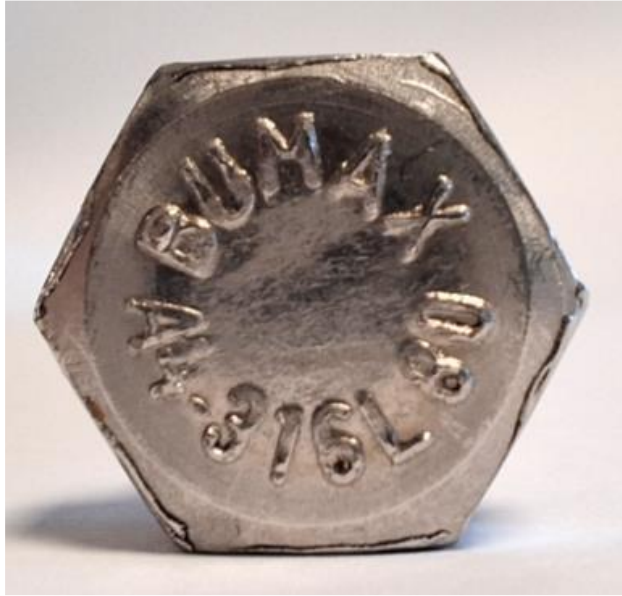
Annex 1 - Affected Part Identification

Affected part: Engine mount bolt having Part Number PRD-00100696 and marked “BUMAX” on its head, which:

- has been installed in production on MSN 002, 011, and 013 to 028 inclusive; or
- has batch number 2011070000000029; or
- for which the batch number is not known.

See picture in the Annex 1 to this AD.

During engine installation on a new aeroplane in production, incorrect bolts were identified.

This condition, if not detected and corrected, could reduce the structural integrity of the engine attachments, potentially leading to damage to other aeroplane systems or detachment of an engine resulting in loss of control of the aeroplane.

For the reason described above, this AD requires replacement of all 4 engine mount bolts for Group 1 aeroplanes with serviceable parts, and prohibits (re)installation of affected part.

(1) For Group 1 aeroplanes: Before next flight after the effective date of this AD, replace all 4 engine mount bolts, as identified in Figure 1 of the ASB, with serviceable parts in accordance with the instructions of the ASB.

(3) For Group 1 and Group 2 aeroplanes: From the effective date of this AD, do not install an affected part on any aeroplane.
