| | | <b>AIRWORTHINESS DIRECTIVE</b> | |
| | | <b>DA RA N° 2024- 05-01 R1</b> | |
| <b>Manufacturer</b><br><br>LAVIA SA | | <b>Aircraft Type-Model</b><br><br>PA25 / PA25-235 / PA25-260, INCLUDING AIRCRAFT MANUFACTURED BY PIPER, CHINCUL, LAVIASA and FAdE SA | |
| <b>Subject</b> | Corrosion found in front and rear spar of left and right wings and cracks found in front spar. | | |

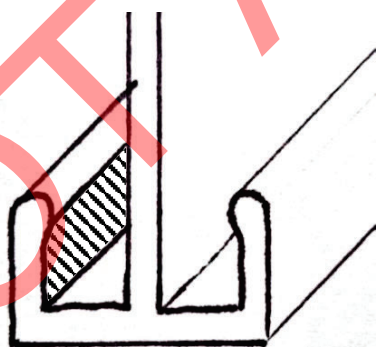
**Area 1:** Front spar cap flange,  
leading edge fitting area

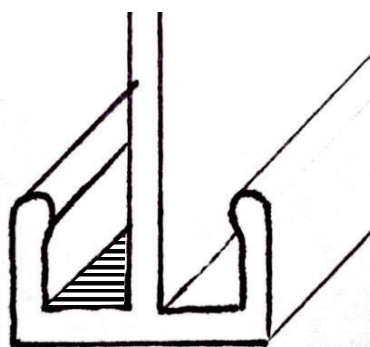
**Area 2:** Inside of spar cap

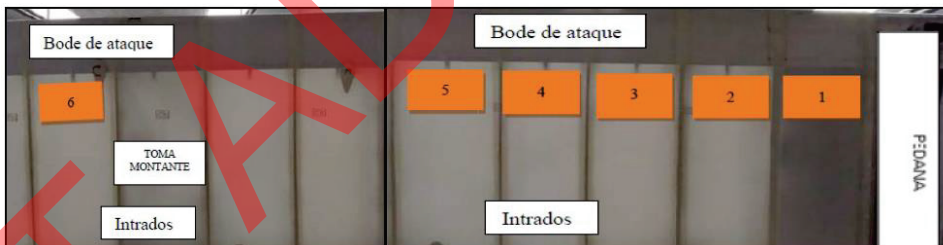
**Figure 4A** – Inspection access cover area according to SB25-57-11.

Access the UPPER spar cap areas through inspection access covers N.º 1 and N.º 2 and the LOWER spar cap areas through inspection access cover N.º 6 in the wing intrados, in accordance with SB25-57-11.

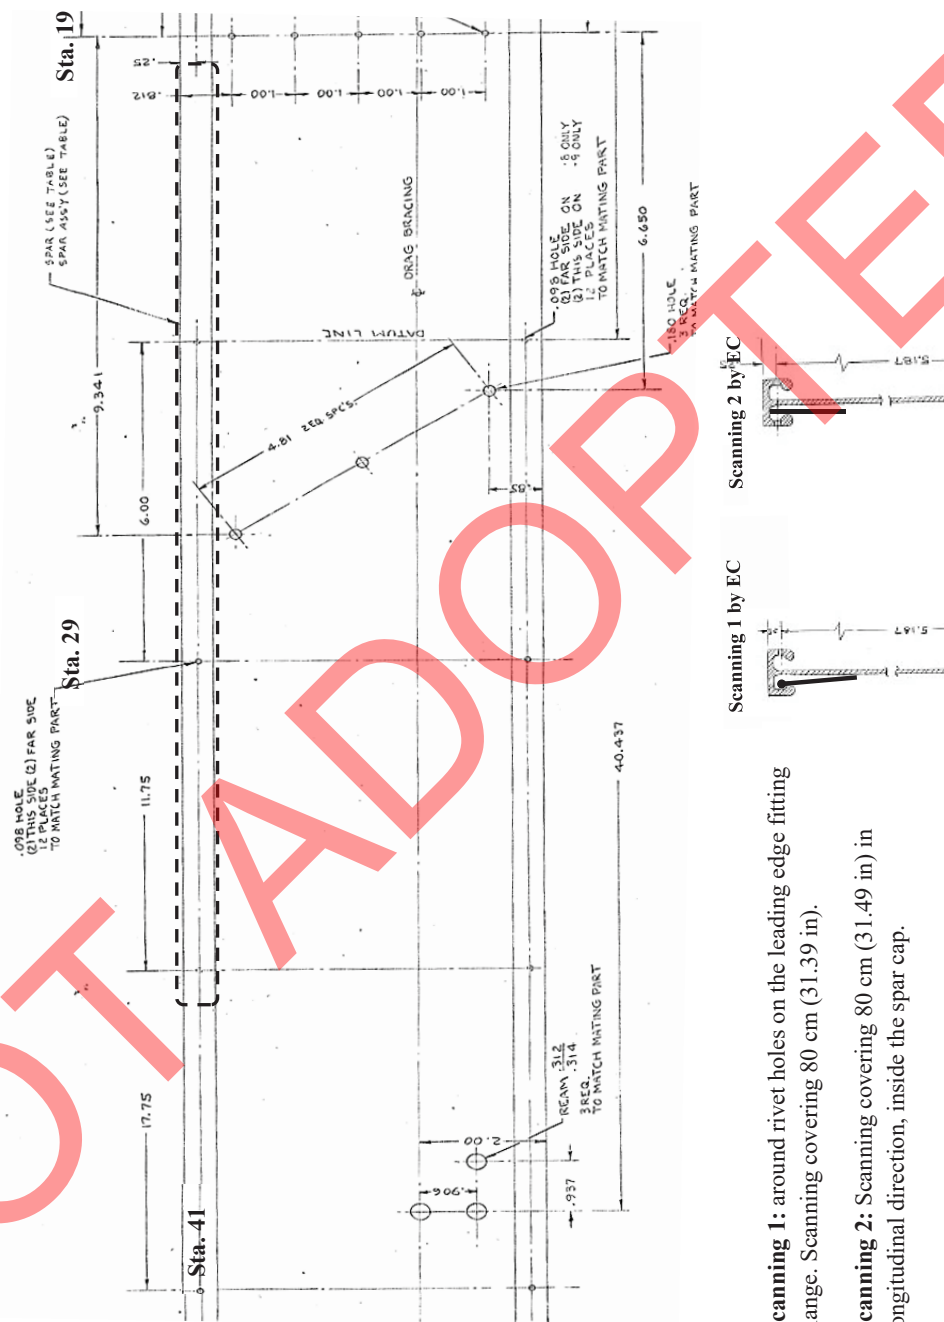
### Figure 7D – Spar Caps Location

The first scanning must be performed by accessing **inspection access covers N.º 1 and N.º 2** by placing the SPO-3611 probe or equivalent on the inside of the **upper spar cap flange** and by accessing **inspection access cover N.º 6** by placing the SPO-3611 probe or equivalent on the inside of the **lower spar cap flange** over the entire length and between adjacent ribs, particularly on the edges of the existing holes.

## ACCESS COVERS N° 1 AND N° 2 – UPPER SPAR CAP

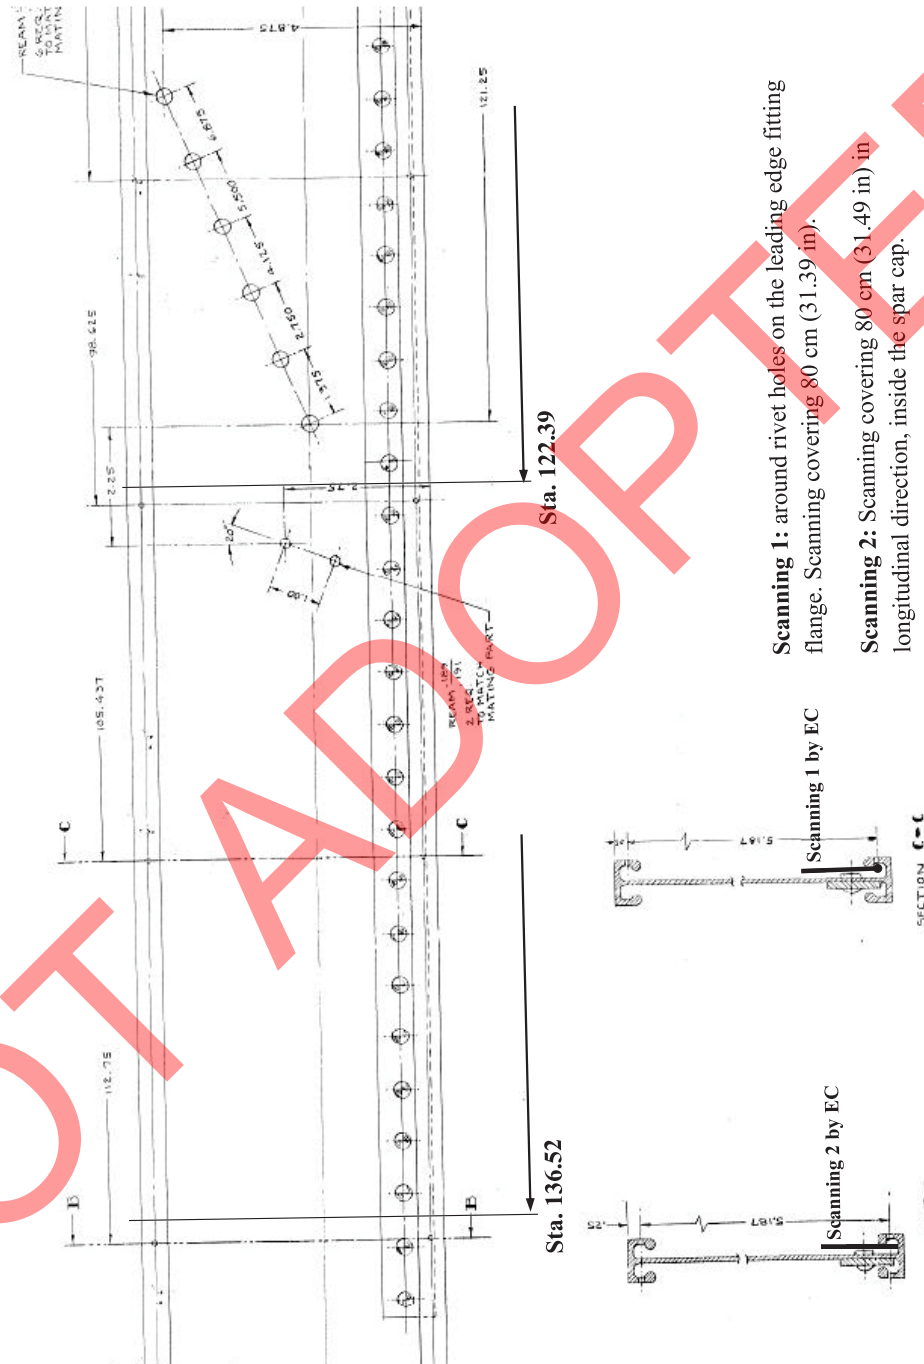
**Figure 7D – Spar Caps Location (Cont.)**

The second scanning must be performed by accessing inspection access covers N.º 1 and N.º 2 over the entire length and between adjacent ribs by placing the TPEN9100-6 probe or equivalent on the inside basis of the **upper spar cap** and by accessing **inspection access cover N.º 6** over the entire length and between adjacent ribs by placing the TPENFLX-6 probe or equivalent on the inside basis of the **lower spar cap**.

**ACCESS COVER N° 6 - LOWER SPAR CAP**

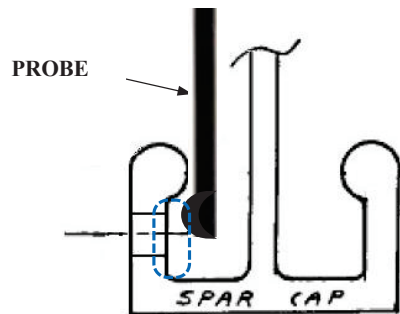
**Scanning 1:** around rivet holes on the leading edge fitting flange. Scanning covering 80 cm (31.39 in).

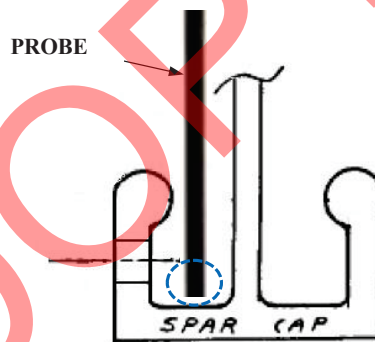
**Figure 7E** –Inspection areas and scanning

E. The actual scanning of the areas to be inspected, as shown in **Figure 7E**, should cover 80 cm (31.49 in) especially around the holes, gouges, scratches and dents, and corrosion pits.

**Scanning 2:** Scanning covering 80 cm (31.49 in) in longitudinal direction, inside the spar cap.
