EASA	COMMENT RESPONSE DOCUMENT

<p>EASA PAD No. 15-041</p> <p>[Published on 15 April 2015 and officially closed for comments on 29 April 2015]</p>

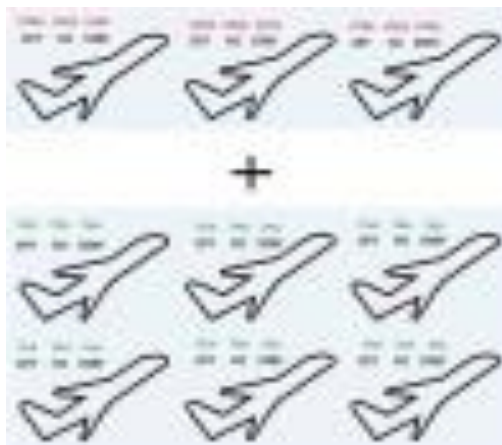
Initial situation:

- Uninstall the 6 UTAS sensors at the Captain and First Officer positions of the 3 fully UTAS a/c's MSN 5877, 5940, 5885.
- Uninstall the 6 Thales sensors at the Standby position of a/c's fully Thales (-AB) and with ELAC L97+ MSN 6450, 6483, 6510, 6518, 6535, 6557.
- Install the removed 6 UTAS sensors at the Standby position of a/c's fully Thales (-AB) and with ELAC L97+ MSN 6450, 6483, 6510, 6518, 6535, 6557.
- Install the removed 6 Thales sensors at the Captain and First Officer positions of the 3 fully UTAS a/c's MSN 5877, 5940, 5885
- The result is: 9 aircrafts with the intermix AoA sensors configuration 2 Thales – 1 UTAS (the same configuration that results from the application of SB A320-34-1610 / PAD 15-041 / future AD). Graphically, the proposed modification can be explained as follows:

Comment understood, but not agreed. There is no Airbus published document to replace standby Thales probes with UTAS probes, but on a case-by-case basis, Airbus may provide approved instructions to allow such replacement, strictly as a temporary solution.

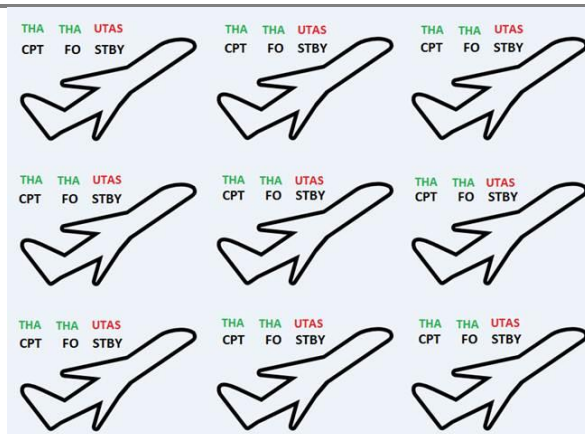
Final situation:

However, this action is not permitted by PAD 15-037 paragraph 17:

(17) For an aeroplane on which Thales P/N C16291AA and Thales P/N C16291AB AOA sensors are installed, from the effective date of this AD, or after modification of the aeroplane as required by paragraph (11) of this AD, as applicable, do not install any AOA sensor with a P/N as listed in [Table 2] of this AD on that aeroplane.
