## COMMENT RESPONSE DOCUMENT

EASA PAD No. 15-128R1

[Published on 15 April 2016 and officially closed for comments on 29 April 2016]

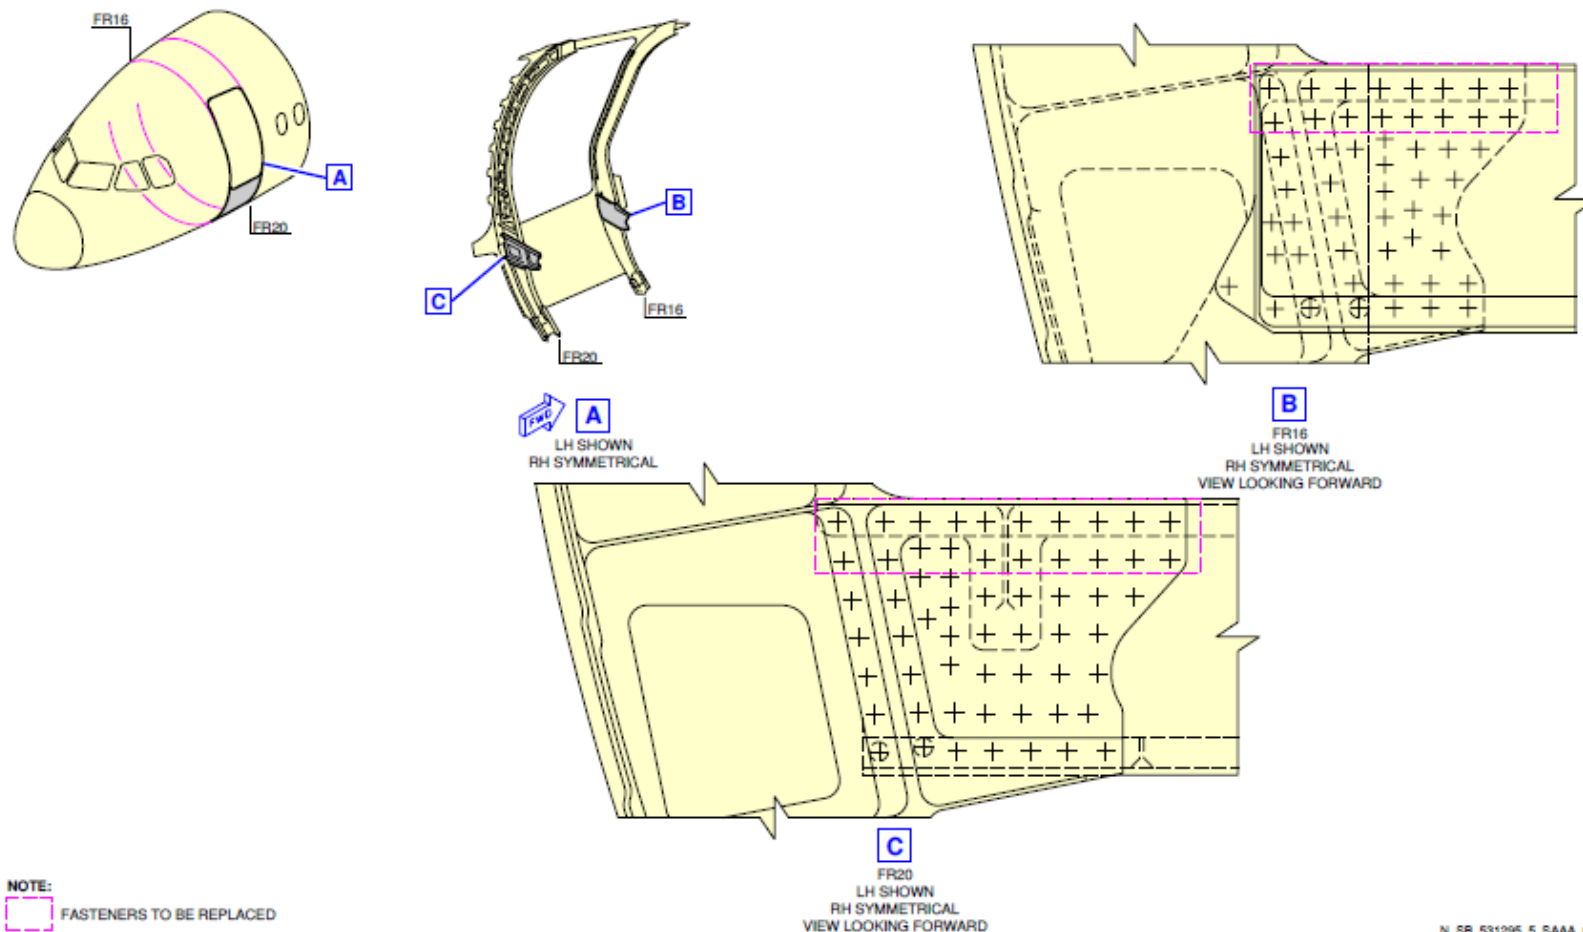
Figure A-FSAAA - Sheet 01

Good day,  
Only one comment this time:  
Could you please specify the area for which acc. paragraph 4 no fasteners EN6114 have to be installed during previous repair? I suppose you mean the modification area as stipulate in SB A320-53-1295 but I would appreciate if you clarify this in the final AD.

**Comments agreed: the installation of the wrong countersunk is limited to the SB area. The AD has been updated accordingly.**
