Airworthiness Directive

AD No.: 2018-0043

A380 aeroplanes

ATA 71 – Power Plant – Rear Engine Mount Assembly – Inspection

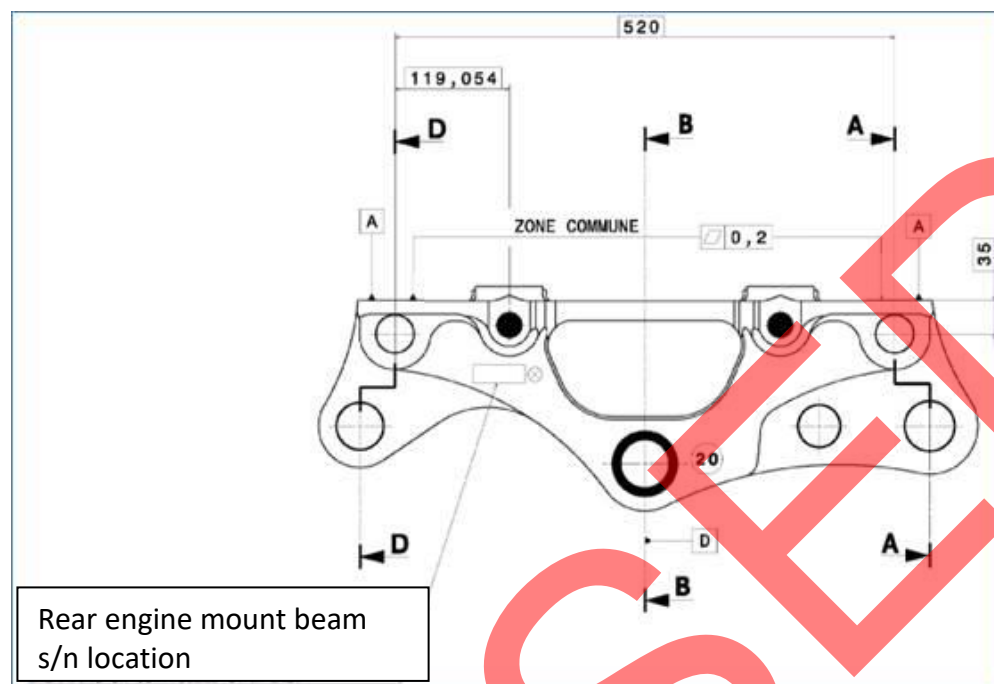
Figure 1 – Rear engine mount beam

Affected part: Rear engine mount beams, Part Number (P/N) L7121076120000, except those with a serial number (s/n) as listed in Appendix 1 of this AD. For the location of the s/n of the beam, see Figure 1 of Appendix 2 of this AD.

Note 2: The s/n of the beam (in some cases with a prefix added by Airbus) is provided on the main body (back face) of the part, as shown in Figure 1 above.

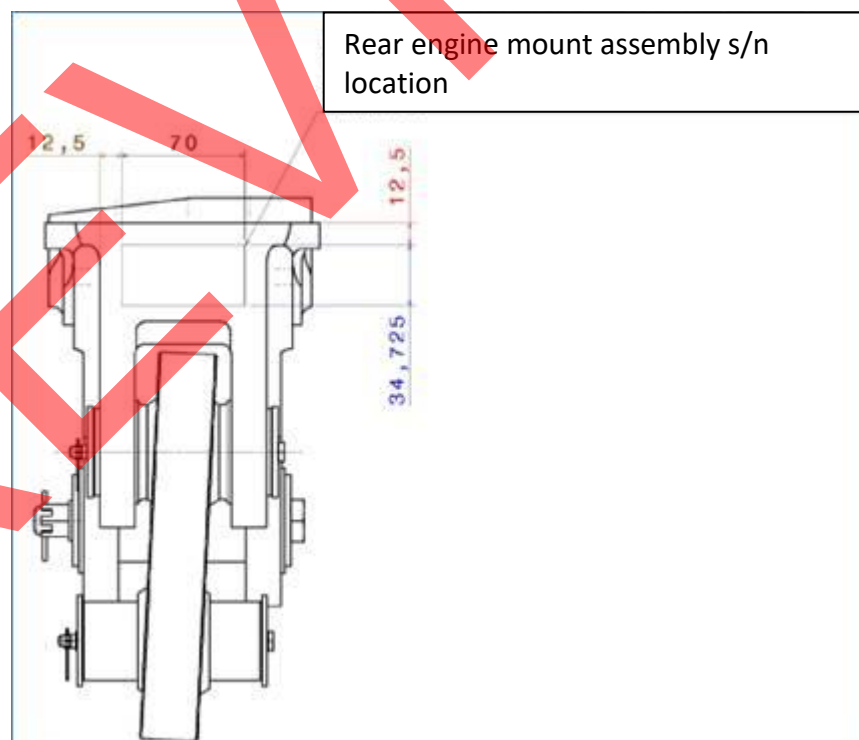
Figure 2 – Rear engine mount assembly

Affected assembly: Rear engine mount assemblies, P/N L7121016002000, P/N L7121016200000, and P/N L7121016500000 (where the number of zeros at the end of the P/N can vary), having an affected part installed, except those assemblies with a s/n as listed in Appendix 1 of this AD. For the location of the s/n of the assembly, see Figure 2 of Appendix 2 of this AD.

Note 3: The s/n of the rear engine mount assembly is provided on the left side of the part, as shown in Figure 2 above.
