Notification of a Proposal to issue an Airworthiness Directive

PAD No.: 17-073R2

A380 aeroplanes

ATA 71 – Power Plant – Rear Engine Mount – Inspection

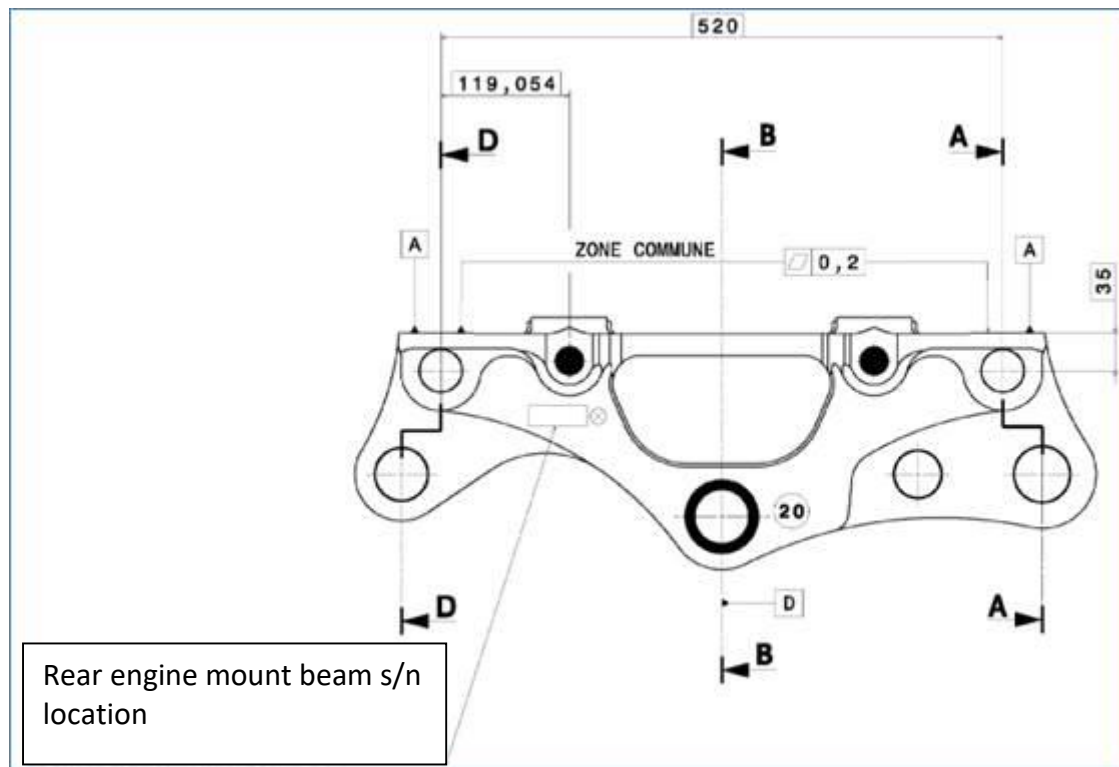
Figure 1 – Rear engine mount beam

The s/n of the rear engine mount beam P/N L7121076120000 (in some cases with a prefix added by Airbus) is provided on the main body (back face) of the part, as shown on Figure 1 of this AD.

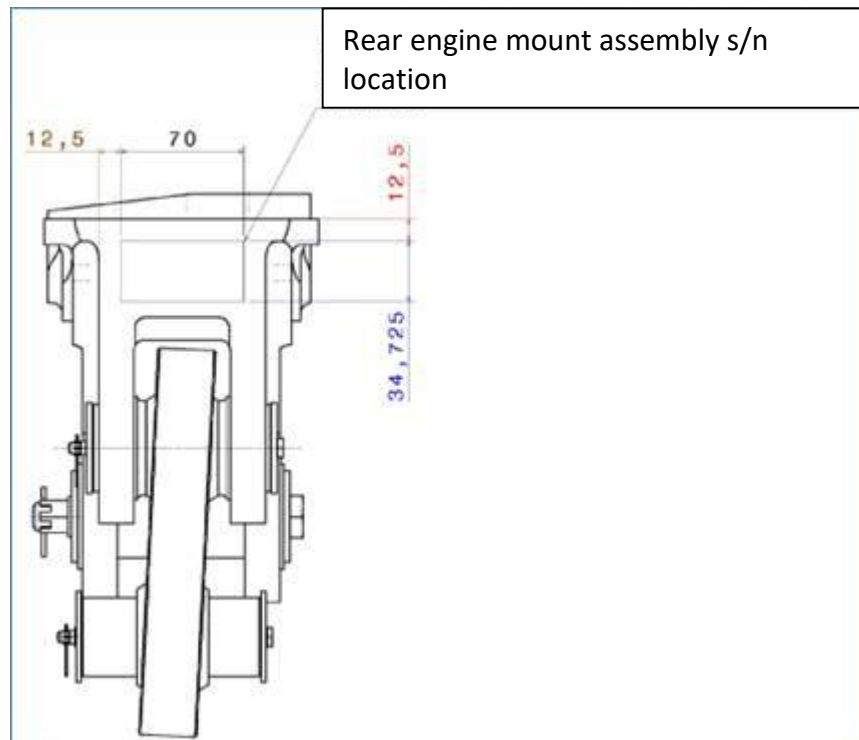
Figure 2 – Rear engine mount assembly

The s/n of the rear engine mount assembly P/N L7121016002000, L7121016200000 or L7121016500000 is provided on the left side of the part, as shown on Figure 2 of this AD.
