COMMENT RESPONSE DOCUMENT

EASA PAD No. 17-073

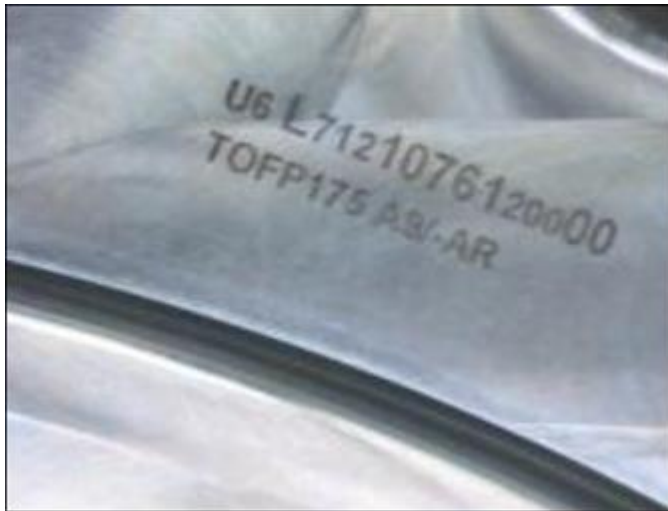
5. A statement in the AD is missing that only PN and SN are affected that are listed in Airbus SB A380-71-8013.
6. Airbus SB refers to P/N L7121076120000 and lists several SN that are not affected by SB and therefore by AD. On the part itself you find a prefix to the SN showing where the marking was applied by Airbus. Because it is not possible (for the person checking the serial number) to see that the prefix is not part of the serial number a note should be added in the AD stating that the serial number has a two digit prefix. Please see a picture below as an example.

6. Comment agreed. We have amended the revised PAD accordingly.

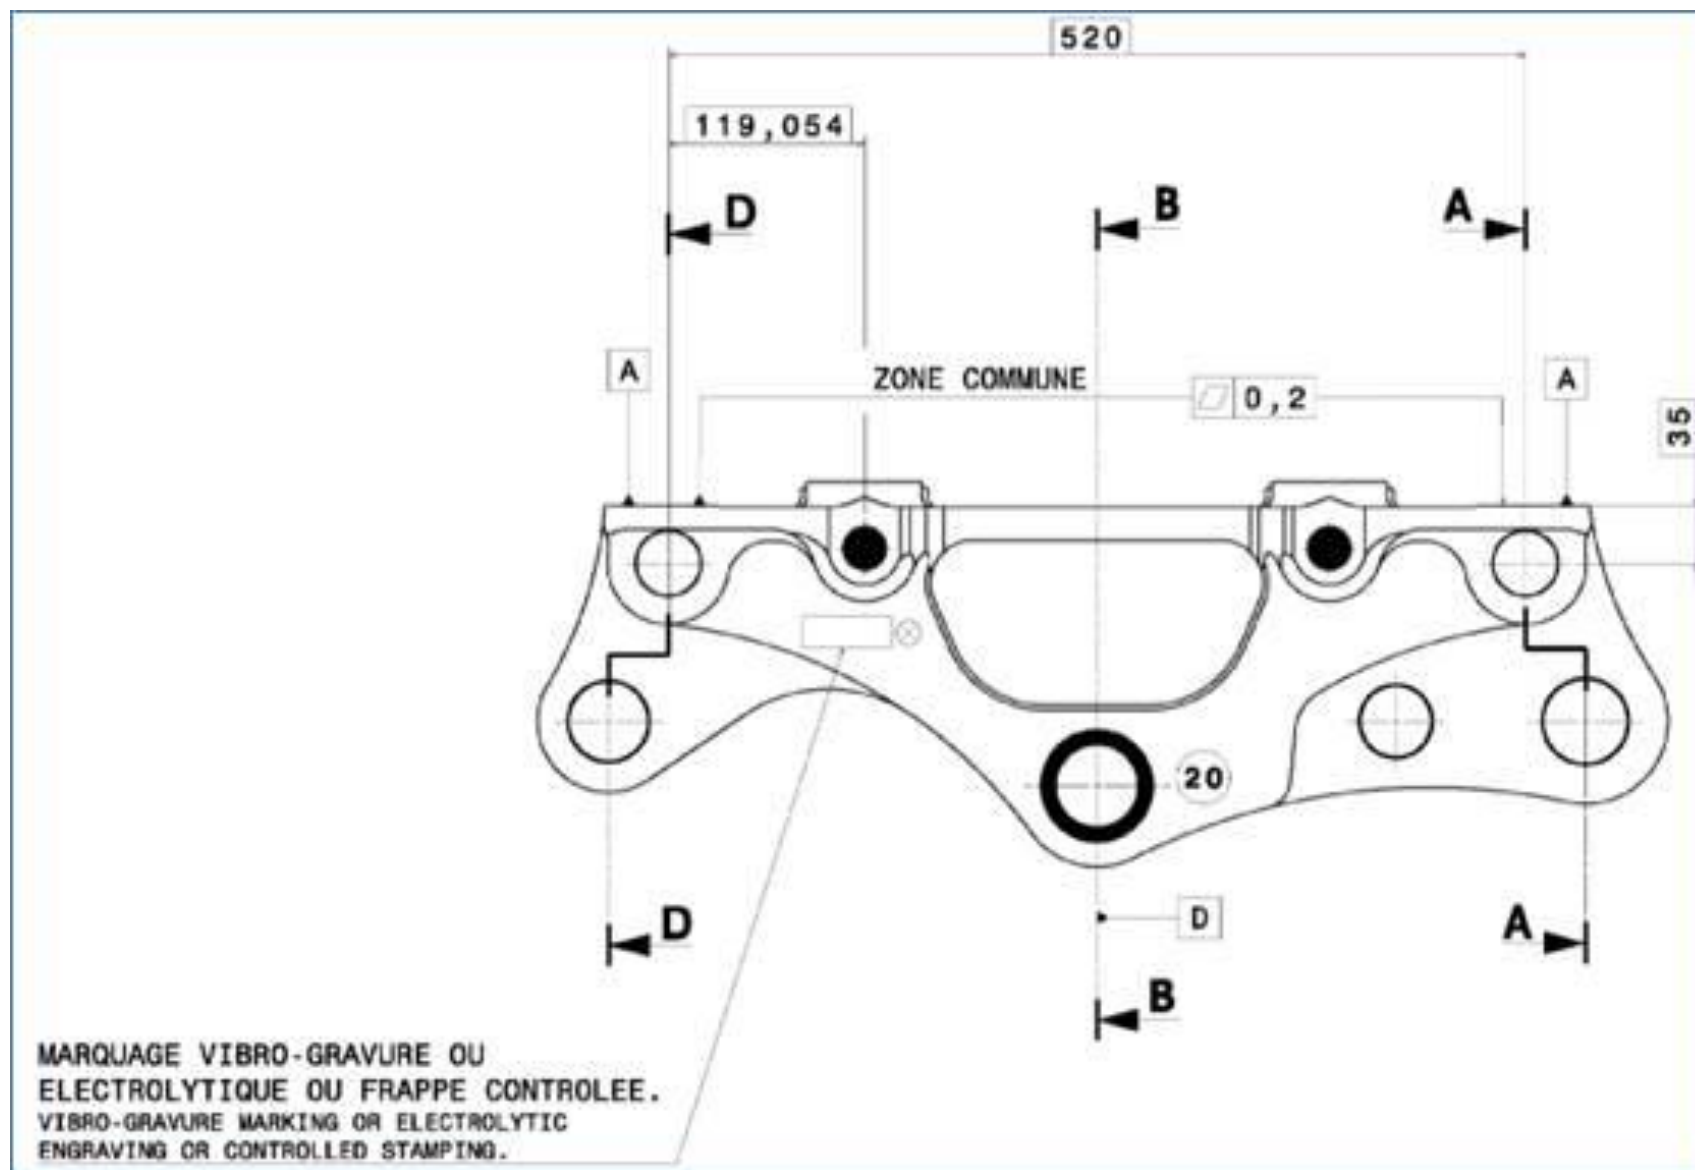
Figure 1

2. *Comment noted: The serial numbers with format SEXXXXX are provided for the rear mount assembly; in the SB we ask to check the serial number provided for the simple part L71210761200 in the front of the part, see Figure below for marking area. Basically the S/N number is usually provided in the same area, as the P/N L71210761200 see Figure 1.*
The serial number provided for the rear mount assembly is located on the side of the part, see Figure 2 below, and this serial number is linked to assembly number given in answer to question 1:
We have amended the revised PAD accordingly.
