COMMENT RESPONSE DOCUMENT

EASA PAD No. 18-091

[Published on 10 July 2018 and officially closed for comments on 07 August 2018]

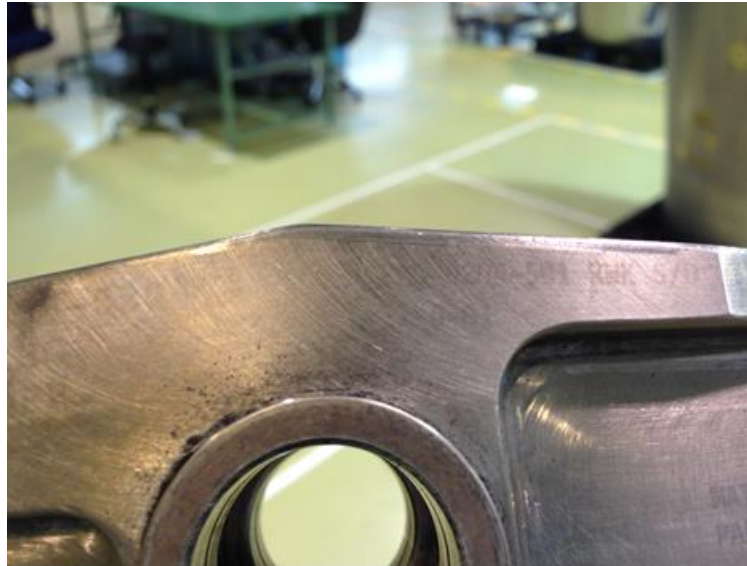
- A. How to find out PN of the crossbeam: According to the latest Airbus SB A320-71-1073 or GOODRICH VSB RA32071-168, we must check for the PN marked on the crossbeam. However on the many of the crossbeam, PN worn away and can't be read or is highly difficult to be read in our experiences. Please see attached photo. Therefore operators can't exactly obey forthcoming AD instructions without alternate means.

Fortunately geometry of the PN 642-2002-503 and PN 238-0204-501 is totally different and can be differentiated from these appearances. ANA strongly hope Airbus and GOODRICH will revise their SB's (both) accordingly since Airbus said they are coordinating such revisions before AD issuance. If they won't, AMOC to allow us to identify the PN from the parts appearance will be required.

- A. Comment noted: AIRBUS confirms revision of the SB. No changes have been made to the Final AD in response to this comment.***
- B. Comment not agreed: "dry ice" method is not considered by Goodrich and Airbus as alternative solution. Should ANA want to use this method, ANA has to do application to their local NAA (JCAB) for agreement. EASA may provide technical position on JCAB request only. No changes have been made to the Final AD in response to this comment.***
