COMMENT RESPONSE DOCUMENT

EASA PAD No. 18-098

[Published on 18 July 2018 and officially closed for comments on 15 August 2018]

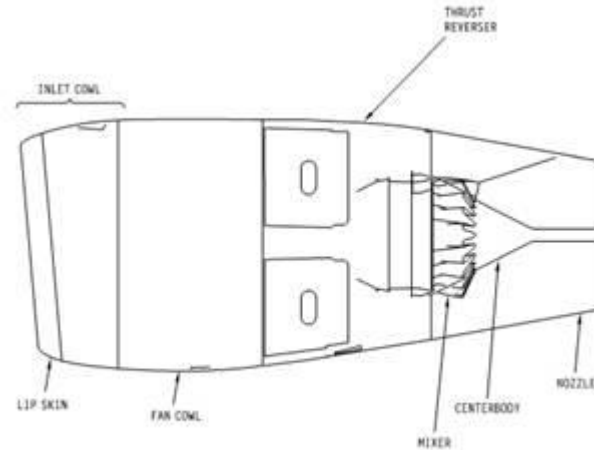
Extract from CMM 78-11-21 (mixer description and operation 1.A (1)): “A bracket assembly on top of the mixer holds the front of the exhaust nozzle assembly in place when the thrust reverser doors are open.”

Extract from CMM 78-11-11 (Nozzle assembly- description and operation page1):

(3) When the thrust reverser C-ducts are closed, the nozzle attaches to the thrust reverser V-blade via a V-groove on the nozzle.

(4) When the thrust reverser C-ducts are opened, the nozzle rests on the mixer support pins and a six o'clock strut between the nozzle and mixer.

The 2 CMM explain that Nozzle Assembly rest on the mixer only when the TRU is opened, i.e. only for ground loads. For in-flight conditions, the CNA is only attached to the TRU thru the V-blade (configuration used for actual fleet plan).
