## Airworthiness Directive

**AD No.:** 2020-0097

ATR 42 and ATR 72 aeroplanes

### ATA 53 – Fuselage – Passenger Seat Tracks – Inspection / Repair / Replacement

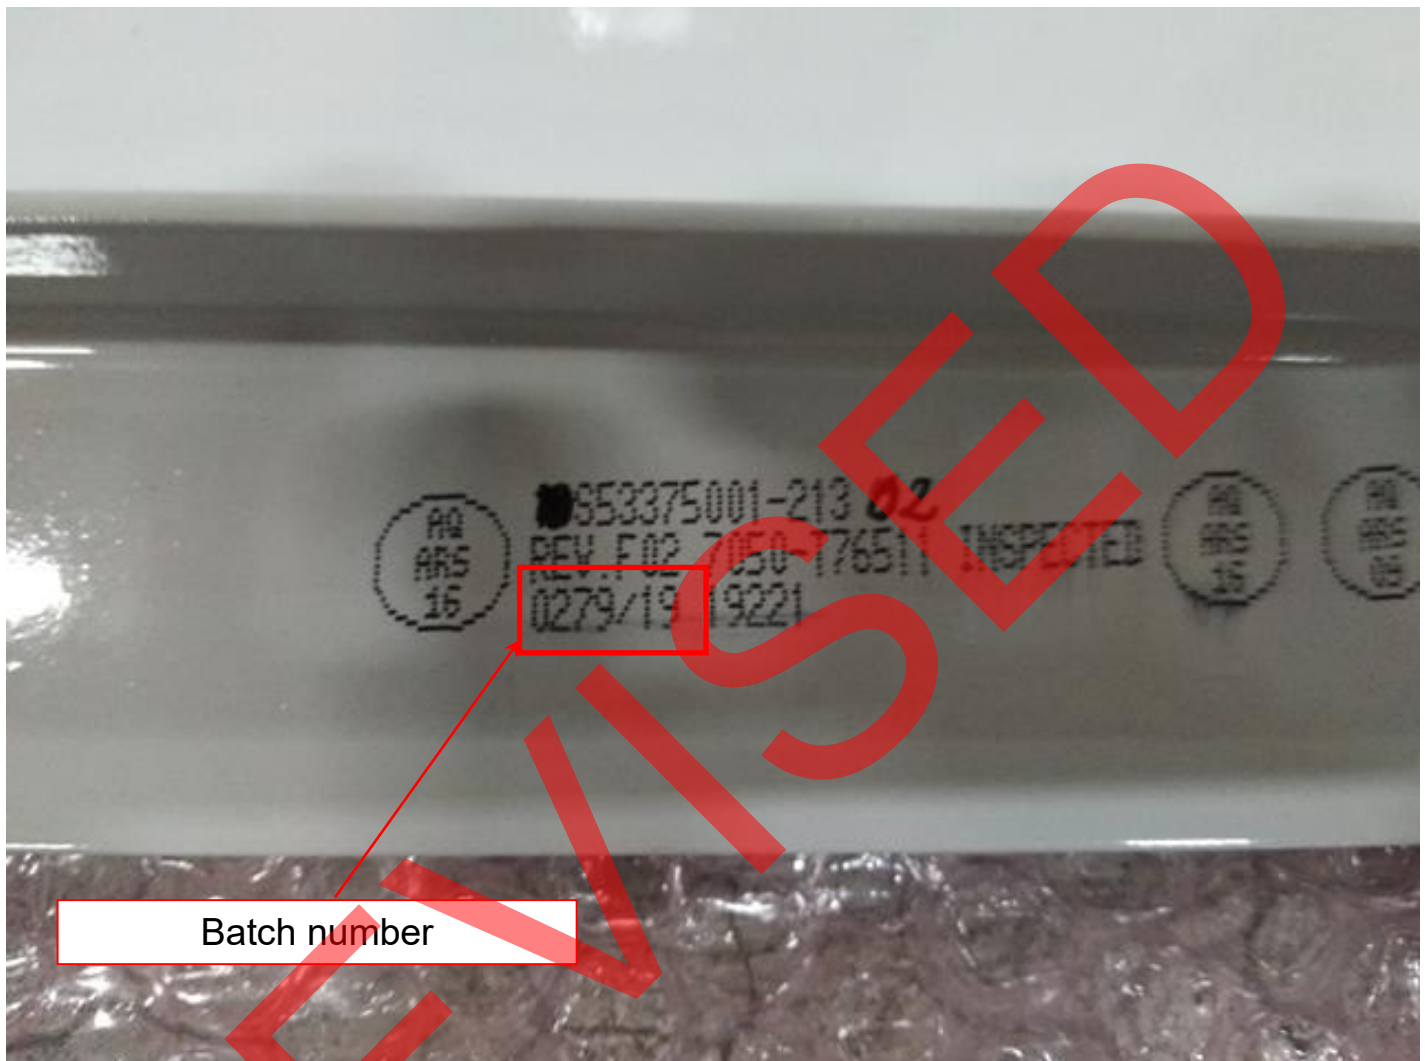
## APPENDIX 1 – Seat Track Manufacturing Batch Number

The batch number is located on the lower face of the seat track.  
The batch number of the represented seat track above is 0279/19.  
/19 represents the production year of the seat track.  
All the seat tracks with a batch number having /12 up to /17, or with a batch number not visible/legible, have to be considered as potential affected parts.
