Notification of a Proposal to issue an Airworthiness Directive

PAD No.: 20-056

ATR 42 and ATR 72 aeroplanes

ATA 53 – Fuselage – Passenger Seat Tracks – Inspection / Repair / Replacement

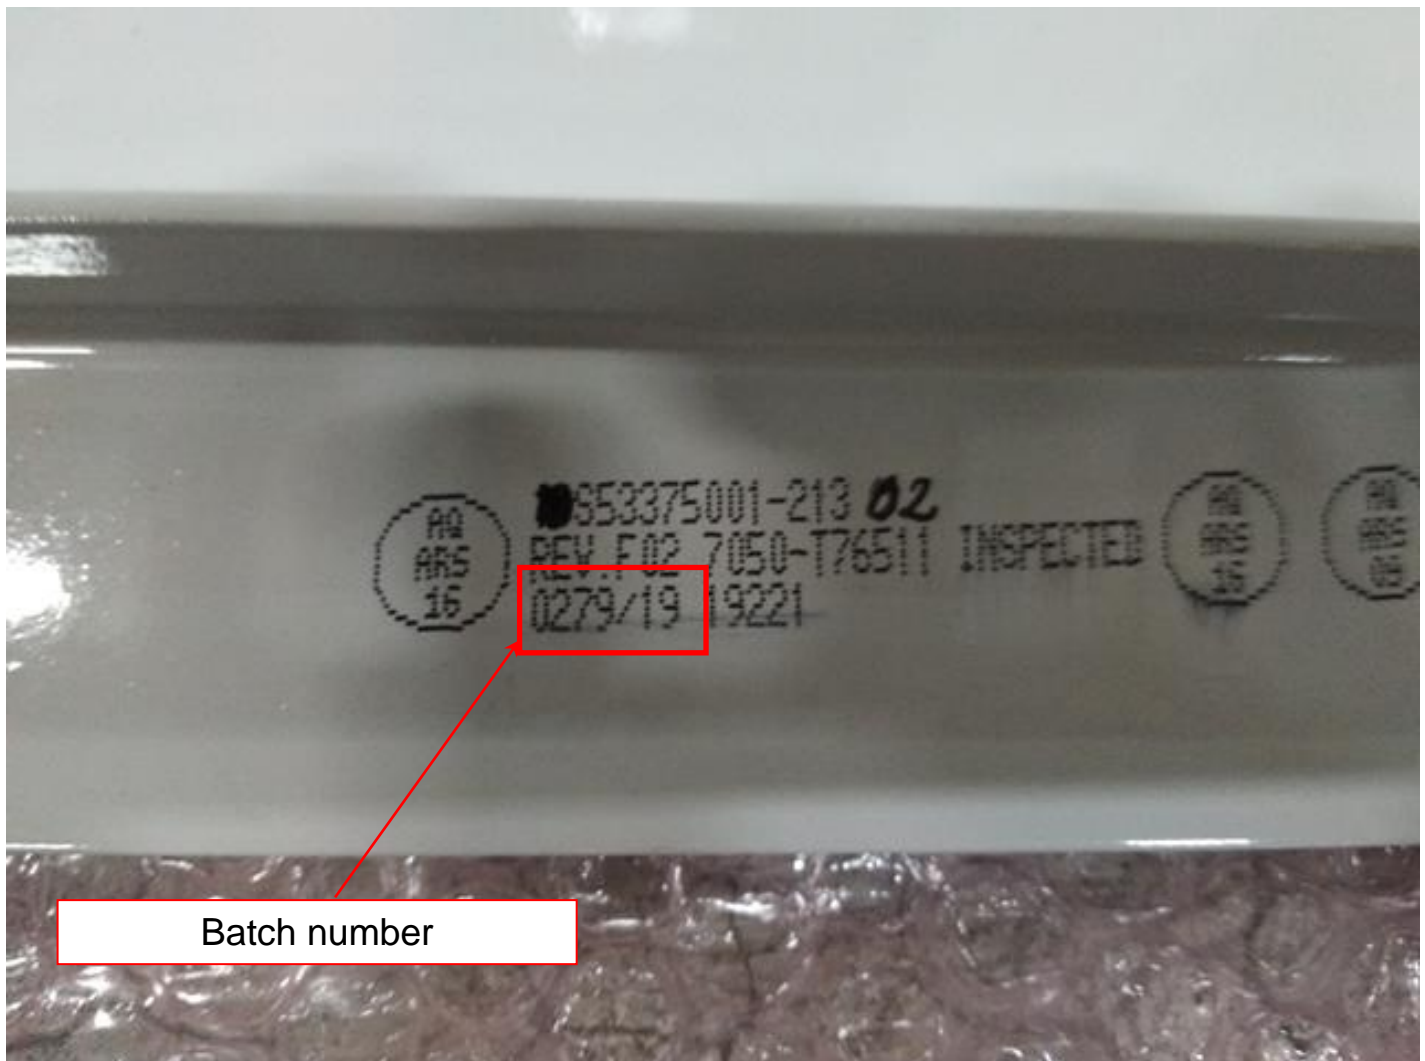
APPENDIX 1 – Seat track manufacturing batch number

The batch number is located on the lower face of the seat track.

The batch number of the represented seat track above is 0279/19.

/19 represents the production year of the seat track.

All the seat tracks with a batch number having /12 up to /17, or with a batch number not visible/readable, have to be considered as potential affected parts.
