COMMENT RESPONSE DOCUMENT

EASA PAD No. 20-168

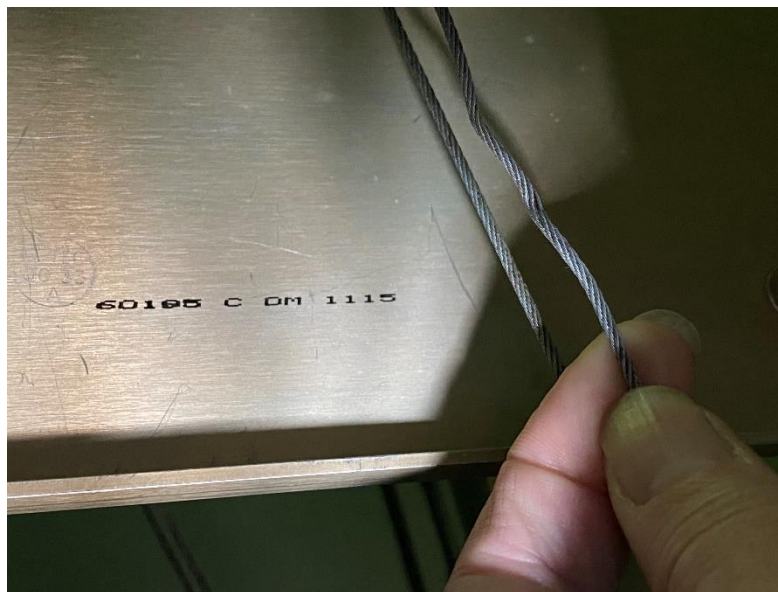
Recently we carried out the scheduled 1000Hr cable inspection on P68C s/n 502C and found damage to the stabilator trim cable, please see attached photo [inserted below]. The cable appeared crushed as if it had been clamped on installation, possibly to aid fitment around the pulley cluster at the stabilator trim actuator on Frame 16. The cable was replaced.
